**REPORT#:** 17MI127

## Construction Laborer Died in Trench Wall Collapse

## Michigan Fatality Assessment and Control Evaluation (FACE) Program

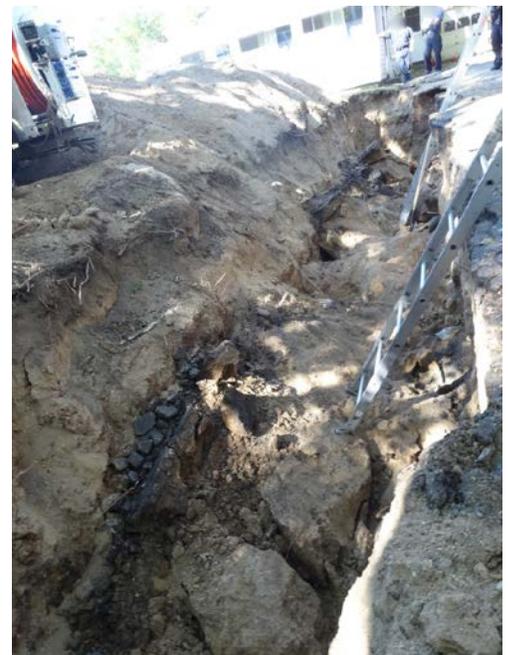
*Photo 1. Overview of incident scene near driveway trench wall collapse, looking north.*

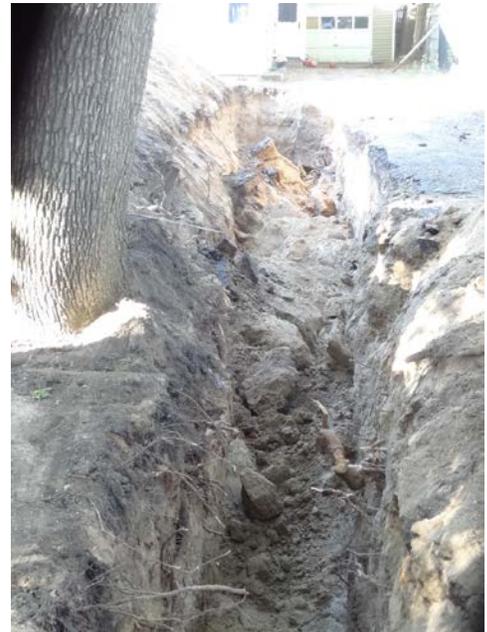
The south end of the trench was approximately the width of the excavator bucket. He sloped the south end of the trench to enable entrance to the base and did not place a ladder in the trench to assist with entering and leaving (See Photo 2).

*Photo 2. Overview of incident scene looking north.*

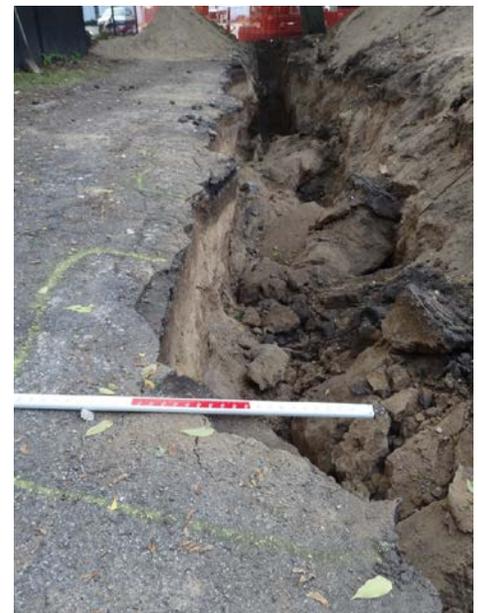
The trench was 70 feet long, approximately 7- to 8-feet deep, 3- to 4-feet wide at the base and 5- to 6-feet wide at the top. The trench was located adjacent to the west side of the rental property's asphalt driveway. The west side trench wall was excavated to a 74-degree angle. The east side of the excavation, which was adjacent to the driveway, was nearly vertical (See Photo 1). MIOSHA noted that the soil consisted of dry, coarse, brown sand with a gravel mix.

*Photo 3. Area of trench wall collapse, looking south.*

Employees engaged in excavation activities did not have the sides of the excavation cut to the proper angle. No shoring or trench box was utilized. The excavation was approximately 70 foot and 7-to 8-foot deep. The west side of the excavation was at a 74-degree angle. The east side of the excavation was near vertical. The soils consisted of dry, coarse, brown sand with a gravel mix. Employees were along the west side of the driveway.

***Recommendation #1: Employers should ensure that employees working in excavations are protected from cave-in by an appropriate protective system, such as trench boxes, shields, benching and/or appropriate sloping of trench sides designed in accordance with MIOSHA Construction Safety Standard, Part 9, Excavation, Trenching, and Shoring. To ensure this is done correctly, a qualified person must inspect and approve the excavation, adjacent areas, and supporting systems on an ongoing basis.***

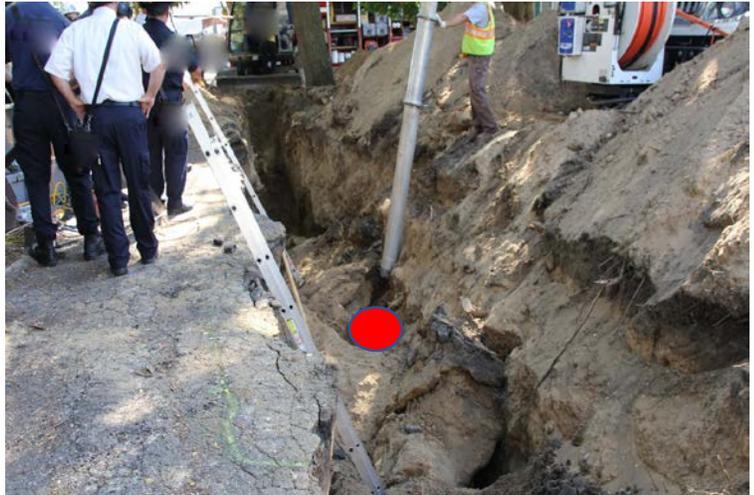
A local Trench Recovery team arrived and started to prepare the scene for recovery of the decedent. An excavator was brought to the site to remove a portion of the spoils to permit a vacuum truck to be positioned near the decedent's location to remove the dirt surrounding him (See Photo 4). The vacuum truck could not get close enough to remove a sufficient amount of soil from around the decedent. The walls of the trench were not secure. The trench recovery team stabilized the trench walls by placing shoring and bracing around the decedent before he could be extricated. When the decedent was uncovered, he was bent at the waist with his chin against his chest. The decedent was removed from the excavation approximately three hours after the trench wall collapsed.

*Photo 4. Vacuum truck removing soil from around decedent. Red circle is location of decedent.*

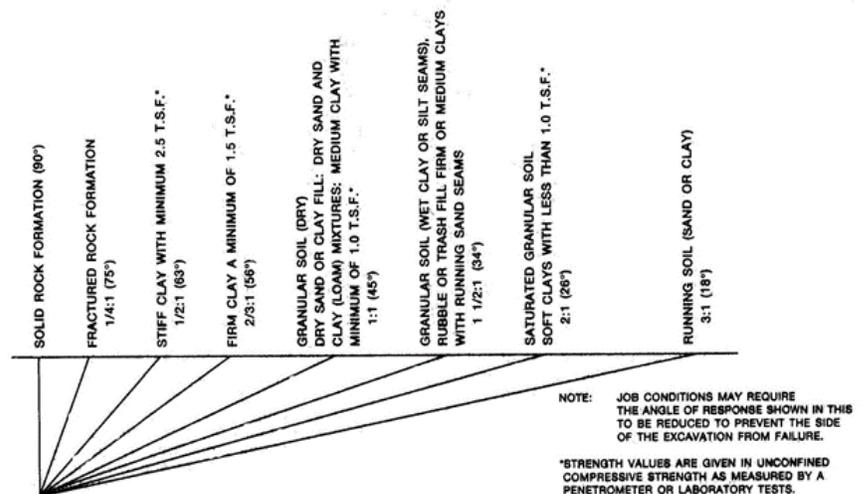
**TABLE 1**  
MAXIMUM ALLOWABLE ANGLE OF REPOSE FOR THE SIDE OF AN EXCAVATION IN EXCESS OF 5' DEPTH

Employers should consult Table 1 of Part 9 that details the maximum allowable angle of repose for the side of an excavation in excess of five-foot depth that is required, which depends upon the soil and environmental conditions present
