REPORT#: 17MI208

Marina Owner Drowned in Six-foot Deep Water in Marina Slip

Michigan Fatality Assessment and Control Evaluation (FACE) Program

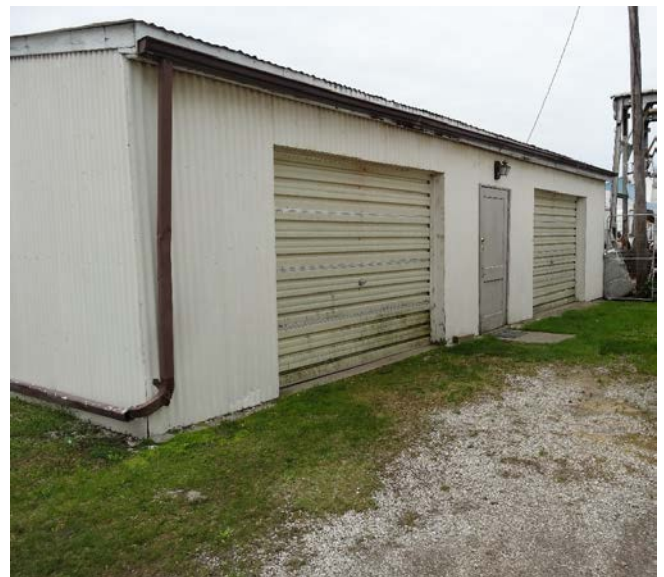
Photo 1. Marina building

The marina was located on a river. The marina consisted of a single level building that was fenced in (Photo 1). Access to the boats from the roadside was provided by two overhead doors and pedestrian doors. The inside of the building, including the walkways between boats were cluttered. There were five marina slips of different sizes (approximately 10-12 feet wide) to accommodate different boat sizes.

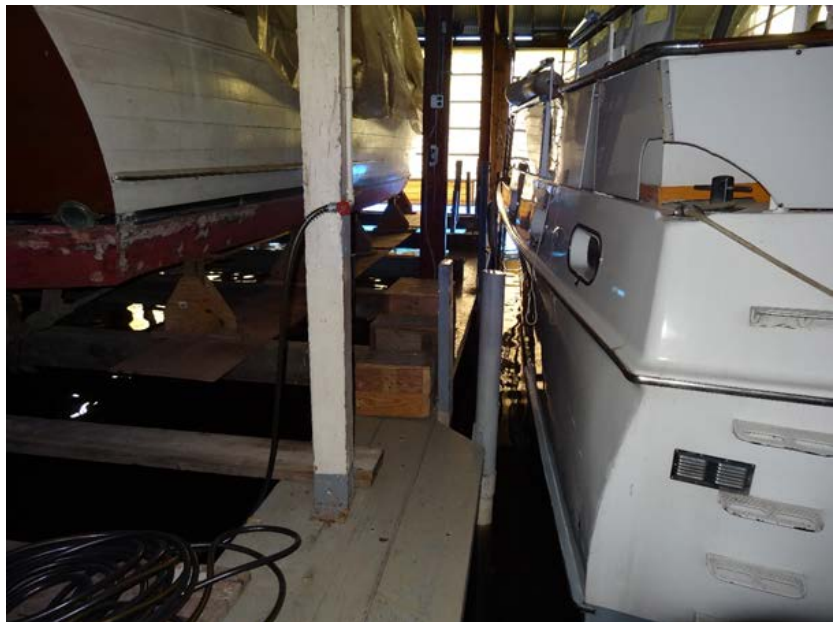
Wood plank walkways between boats provided access to/from boats (Photos 2, 5, and 6). The walkways consisted of two eight-inch wood planks anchored together. The walkways also supported boats undergoing maintenance. There were no railings on either side of the walkways. Wooden access steps to the boats were placed on the walkways. Posts supporting the roof trusses were placed in the middle of the walkways

Photo 2. Example of boat slip walkway

Recommendation #3: Boat slip walkways should have a non-slip surface to minimize a slip and fall while getting on/off boats and while walking.

Discussion: There are numerous ways to experience a slip and fall while working. An individual can slip and lose balance due to a wet/icy/snowy surface, trip over objects in the walkway, or fall from an elevated position above the ground. MIFACE recommends, and MIOSHA requires that walkways are maintained free of hazards such as sharp or protruding objects, loose boards, corrosion, leaks, spills, snow, and ice. In this incident, the walkways were near water. Walkways near water should have a slip-resistant coating or slip-resistant tape applied to minimize a slip and fall occurrence. Selection of an anti-slip products should take into consideration a wet environment.

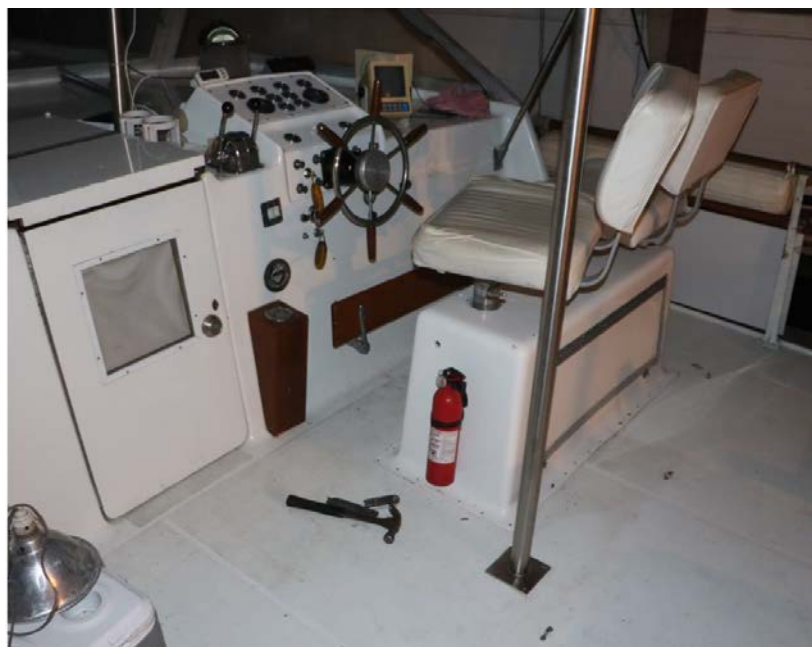
Photo 3. Boat A where sheriff found tools, keys in ignition and work light

Sheriff pictures taken at the scene show Boat A in slip 3 with tools on the deck, keys in the ignition, a work light, and the side deck access doors open on each side of the boat (Photos 3 and 4). In slip 4, on a horizontal plank running across the slip width holding a boat aloft there is an empty coffee can. The sheriff pictures taken at the scene show the same coffee can location as the MIFACE picture (Photo 6).

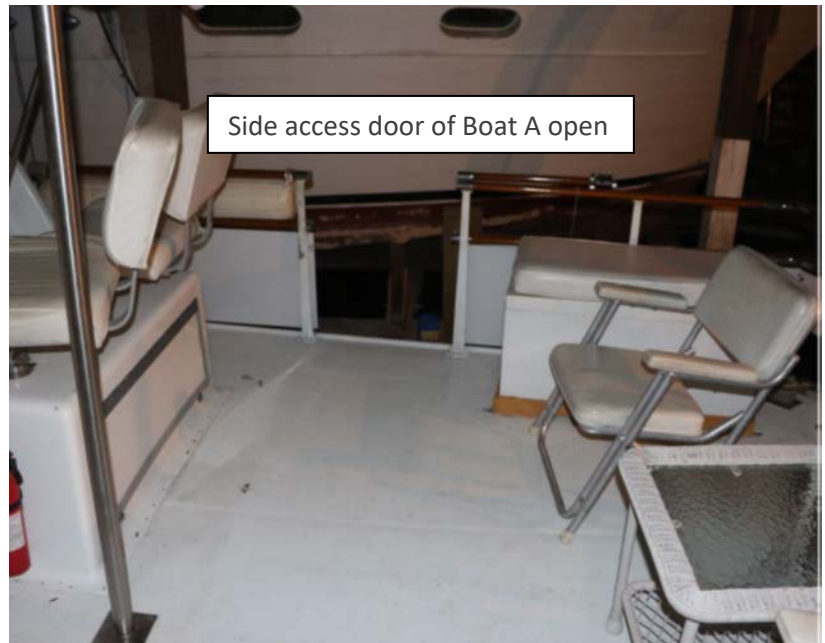
Side access door of Boat A open

Photo 4. Boat A – Decedent may have been working on this boat

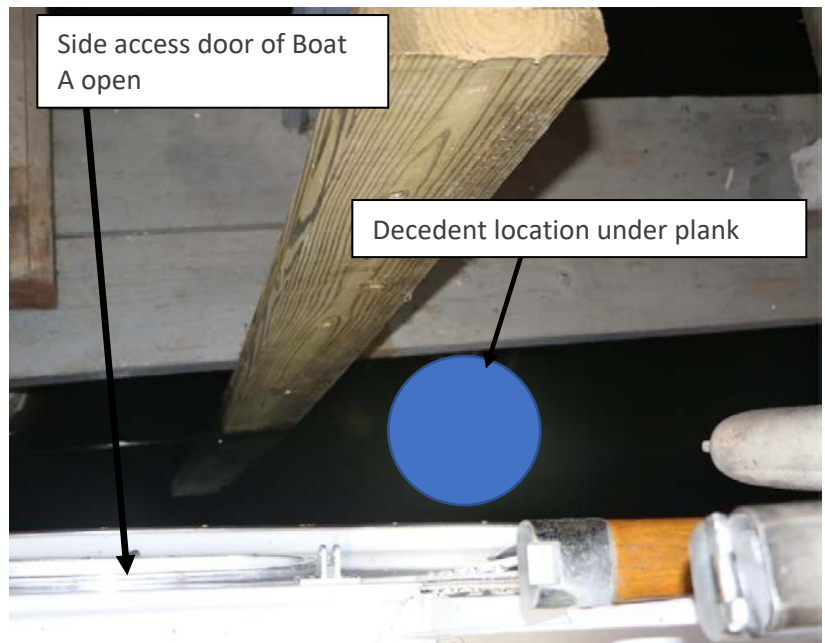
Photo 5. Boat A, open access door, location of decedent in water

The sheriff arrived and found the decedent, unresponsive and floating upright, in the water under the planks between Boat A and Boat B (Photos 5 and 6). The crown of his head was visible. He was not restrained in any way under the water. For reasons unknown, the decedent fell into the water. Because he was working alone, there was no one to assist him and no safety ladder available, he was unable to pull himself up out of the water and eventually drowned. He was declared dead at the scene.

Recommendation #2: Place safety ladders and life rings throughout the marina.

Discussion: The marina did not have any securely anchored fixed safety (emergency) ladders at any of the five boat slips in the marina, providing an opportunity to exit the water. The *Planning and Design Guidelines for Small Craft Harbors, ASCE Manuals and Reports on Engineering Practices No. 50* recommends:

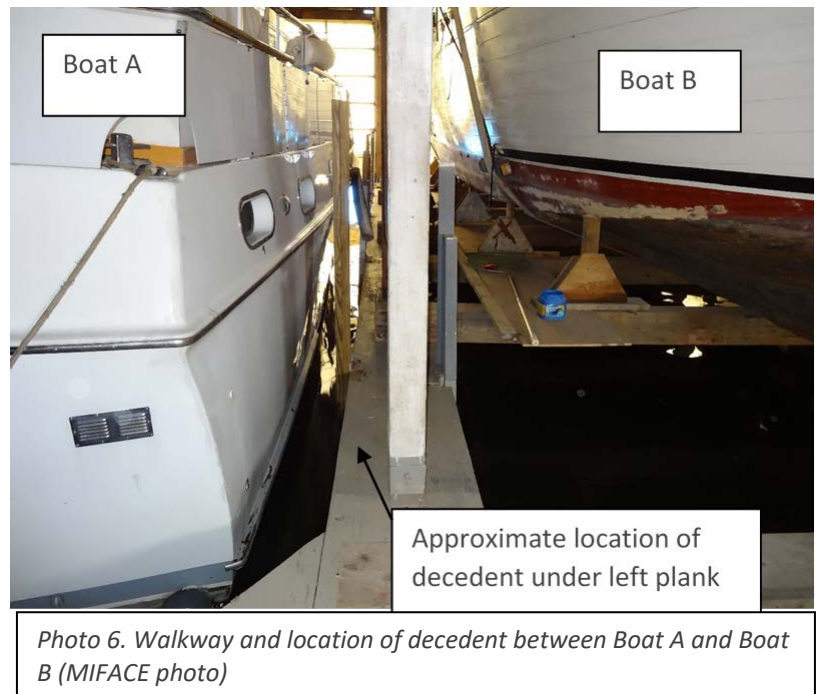
Photo 6. Walkway and location of decedent between Boat A and Boat B (MIFACE photo)
