**FATALITY ASSESSMENT AND CONTROL EVALUATION
PROGRAM (CA/FACE)**

**A Solar Company Owner Dies When He Falls Through a Skylight
Case Report: 17CA005**

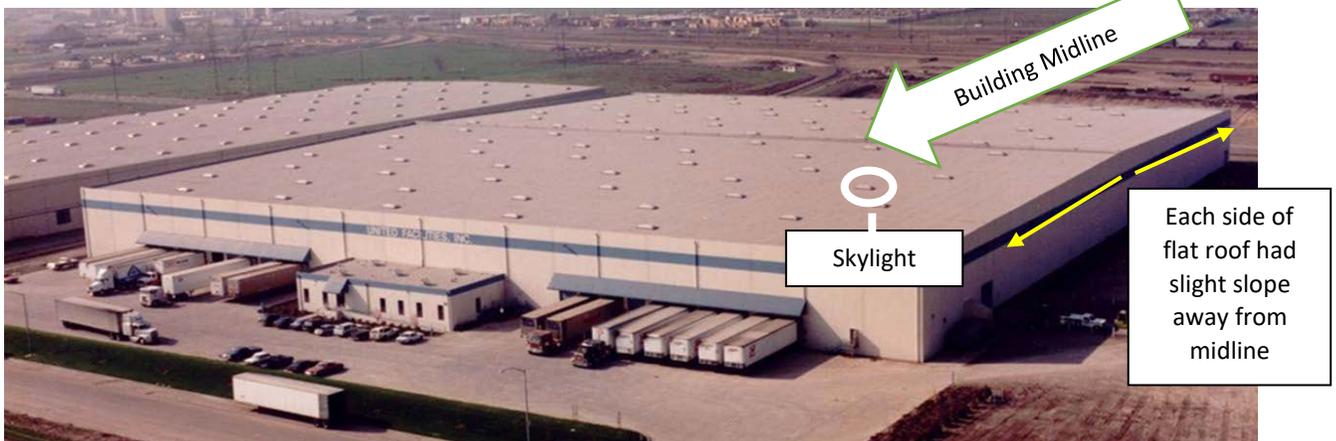
Exhibit 1. The warehouse involved in the incident.

Exhibit 1 shows the aerial view of the warehouse. The flat roof of the warehouse contained 84 skylights, with 42 located on each side of the roof. The roof was divided by a midline with each side sloping away from the midline at a slight angle. The dimensions of the skylights were 4' x 8', with each skylight located 36 feet from an adjacent skylight. The roof was accessed by climbing a 40-foot ladder (Exhibit 2) inside the building. Exhibit 3 shows the entrance to the roof. The skylights that were being replaced were approximately 30 years old. A solar company manager stated he thought that the skylights were made of plexiglass.

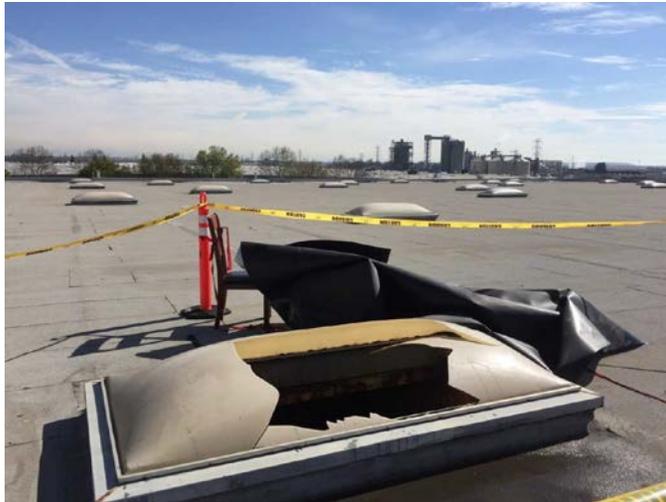
No one at the company was aware that the victim had fallen until a warehouse worker found him unconscious on the floor, approximately 15 minutes after he fell. The warehouse worker immediately called 911. Emergency services arrived in less than ten minutes. The victim was transferred to a local hospital where he died later that day. Exhibit 4 shows the broken skylight. Exhibits 5 and 6 show the underside of the broken skylight from inside the warehouse.

Exhibit 4. The skylight the victim fell through.

Recommendation: Ensure that employees performing work within six feet of a skylight use skylight screens, covers, guardrails, nets, or personal fall protection systems—even for short-duration tasks such as periodic inspections or maintenance.

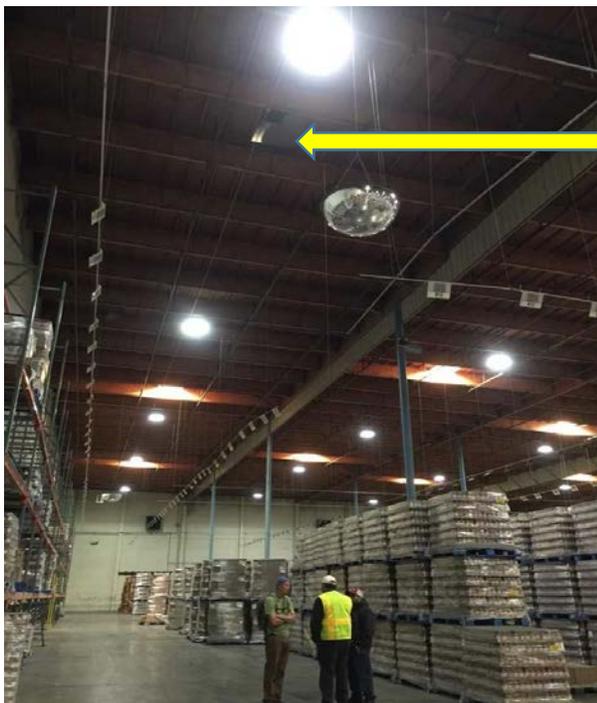
Exhibit 5. Broken skylight from inside the warehouse.

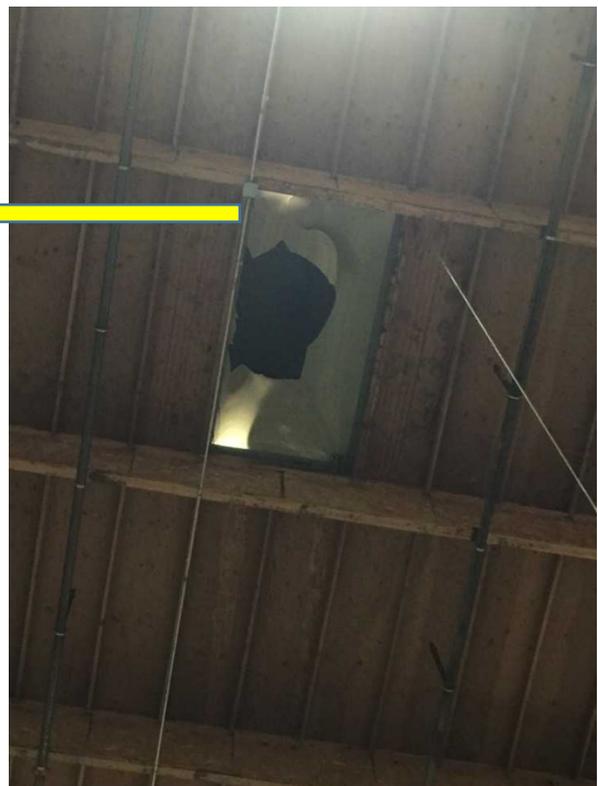
Exhibit 6. Close-up of broken skylight from inside the warehouse.
