REPORT#: 18KY007

REPORT DATE: 11-5-18

Police Officer Drives into Flood Waters and Drowns

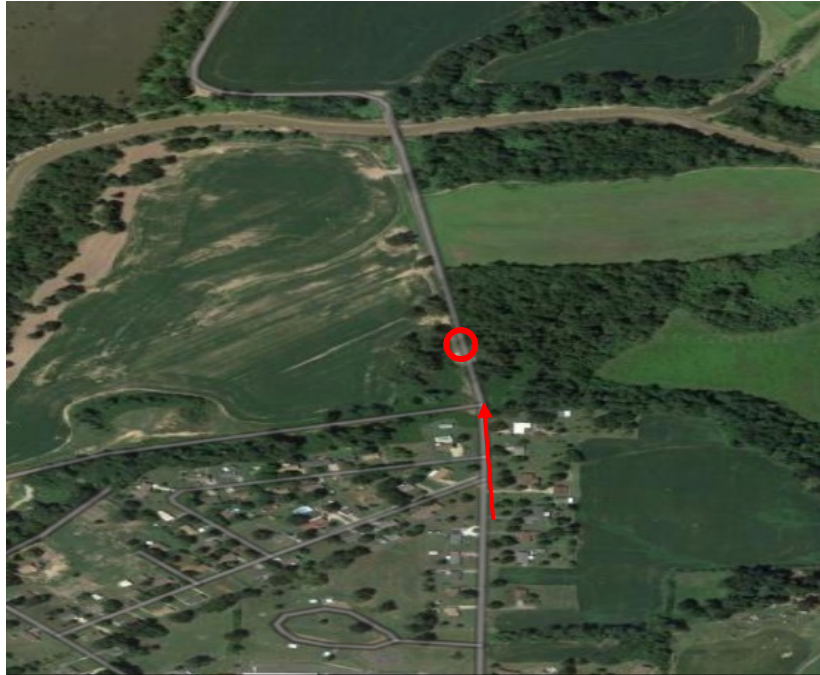
Photo 1. Aerial photo of the scene with creek at normal levels. Arrow indicates direction of travel; circle indicates where the vehicle entered the water. Photo courtesy of Google Earth.

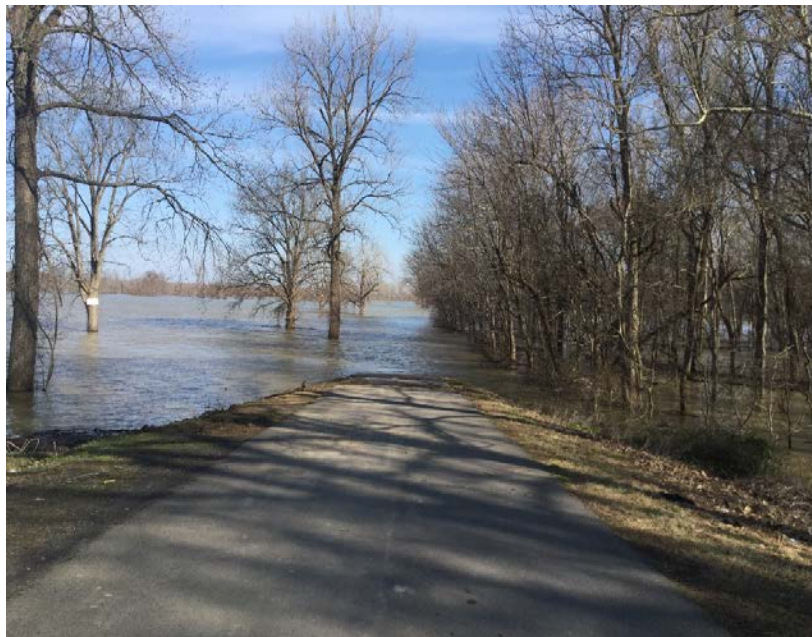
Photo 2. Scene where the victim and his vehicle entered the water.
Photo property of KY FACE.

When interviewed, the police chief stated he was not sure why the victim was in that area since it had been flooded for several days due to heavy rain. The victim had worked the night before the incident from 7:00pm to 7:00am, and the chief felt sure that he was aware of the flooding in that area. When interviewed, the incident commander stated that because it was a Friday night, and because teenagers frequented the street to party, the officer might have been patrolling the area to look for underage drinking. As he travelled on the road, the victim crested a hill and drove approximately 500 feet before his vehicle struck and entered the water. As water submerged the vehicle, it slowly drifted towards the driver's side off the road and into the flooded field. Due to the limited light, it is likely the officer was unaware that the terrain he had entered quickly sloped downwards, creating a pool of water approximately 12-15 feet deep.

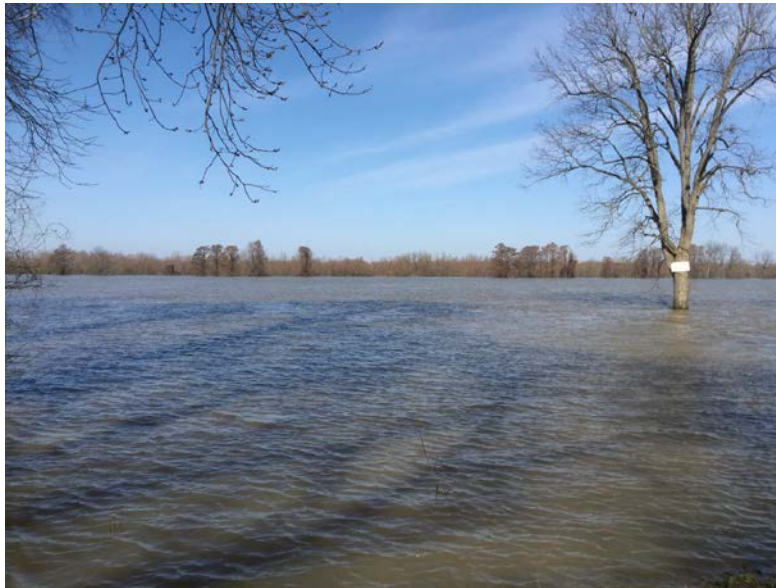
Photo 3. The flooded field from which the victim and his vehicle were retrieved. Search and rescue divers located both approximately 150 yards northwest of the marked tree. Photo property of KY FACE.

Additional officers, as well as the Fish and Wildlife rescue dive team were on-site by 9:24 pm, and at 9:33 pm, incident command was established. The Fish and Wildlife dive team entered the water and discovered the vehicle approximately 150-200 yards from where it had entered the water. The vehicle was discovered on its side before swift waters rolled the vehicle onto its top. Due to strong underwater currents, the rescue diver could only dive to a depth of 12 feet at the time, making it difficult to locate the victim. In order to locate the victim, the dive team had to drag the surrounding area. The dive team worked through the night in an attempt to recover the victim. At 5:10 am, the officer was located and brought to shore where the coroner on the scene pronounced him dead.

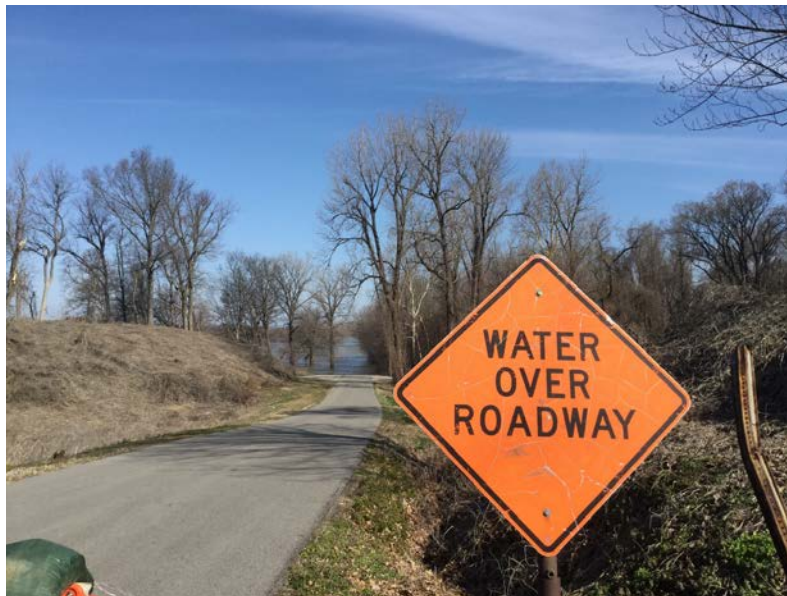
Discussion: When questioned why there were no barriers to prevent vehicles from accessing the area, the chief of police stated the reason was that boaters would use the natural downward slope of the road to launch their boats into the water while the road was flooded, since the permanent dock for launching was under water and inaccessible. At the time of the incident, the only signage warning drivers of floodwaters was a permanent sign stating “Water Over Roadway”; however, since the sign was permanent and not removed during the dry season, it may have been easy for drivers to become complacent and ignore the sign. After the incident, two orange barrels holding a removable sign stating “Road Closed” was placed on the road blocking access to the water. The sign, however, was small and lightweight, and a driver could easily move the sign in order to obtain access to the water. To prevent all vehicles from entering the flooded area, the county road department should consider installing a roadway sign that warns of quick flooding during heavy rains and close the road as quickly as possible with temporary barricades when the road becomes impassible.

Photo 4. Permanent ‘Water Over Roadway’ sign.
Photo property of KY FACE.

Recommendation #1: County road department should install a roadway sign that warns of quick flooding during rain and close the road as quickly as possible with temporary barricades.

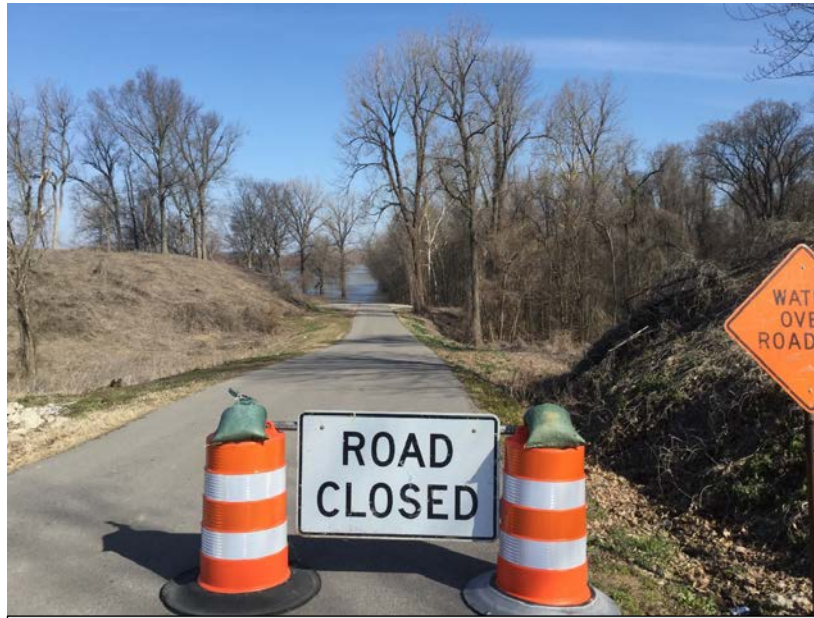
Photo 5. 'Road Closed' sign and barrels added post-incident.
Photo property of KY FACE.
