**REPORT#: 18KY024**

**REPORT DATE: 11-12-18**

## Dump Truck Operator Electrocuted After Truck Bed Contacts High Voltage Line

On June 22, 2018, a 61-year-old dump truck owner-operator was transporting crushed rock to fill a sinkhole, when he raised the bed of the dump truck and contacted high voltage power lines, resulting in a rear tire catching fire. As the dump truck operator attempted to exit the vehicle, he stepped off the metal running board while holding onto the side of the truck, and was electrocuted.

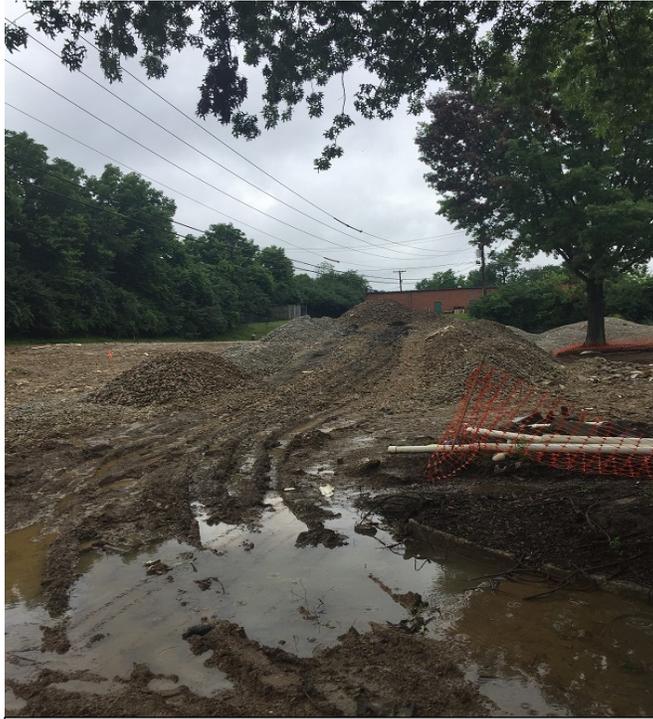
The incident took place on a construction site on which a set of townhouses had recently been demolished. Because of the amount of debris and displaced soil, a pile of rubble measuring three feet in height was present. Due to the saturated ground and the weight of the vehicle, the victim would often drive his dump truck onto the pile of rubble while performing his responsibilities. With the buildup of debris and the truck bed extended the full 24 feet, the top of the truck bed measured 27 feet from the ground. The overhead power lines that the dump truck contacted measured 24'9" from the ground because of the buildup of debris.

Photo 1: Incident site. Photo property of KY FACE.

The Public Service Commission investigated the scene and checked the height of the overhead power lines. They determined the power line that was contacted was found to meet or exceed the required clearance of 26 feet from the original elevation, and the raised elevation of the site caused by debris allowed the bed of the truck to reach the high voltage wires at 24'9".

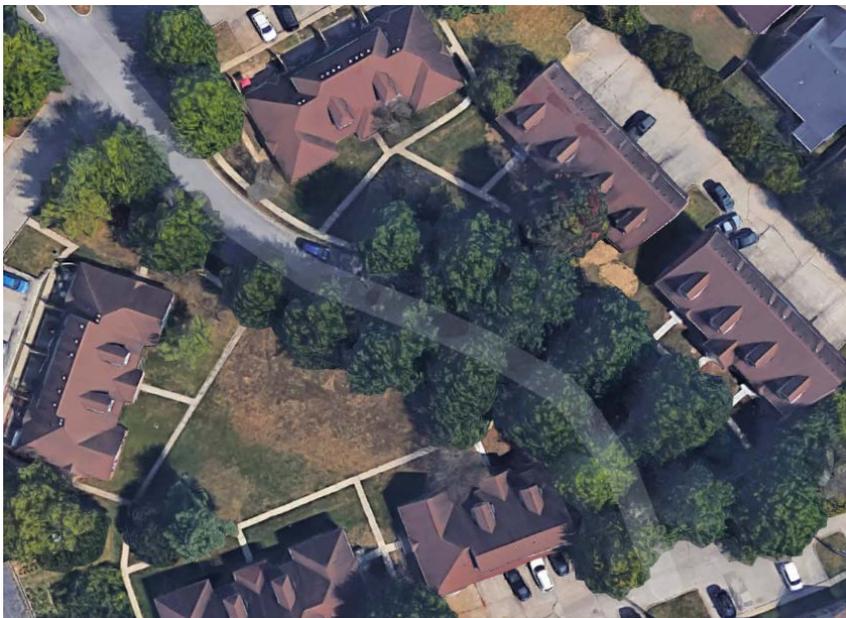
Photo 2: Overhead view of the worksite. All townhouses featured in photo were demolished at the time of the incident.  
Photo courtesy of Google Maps.

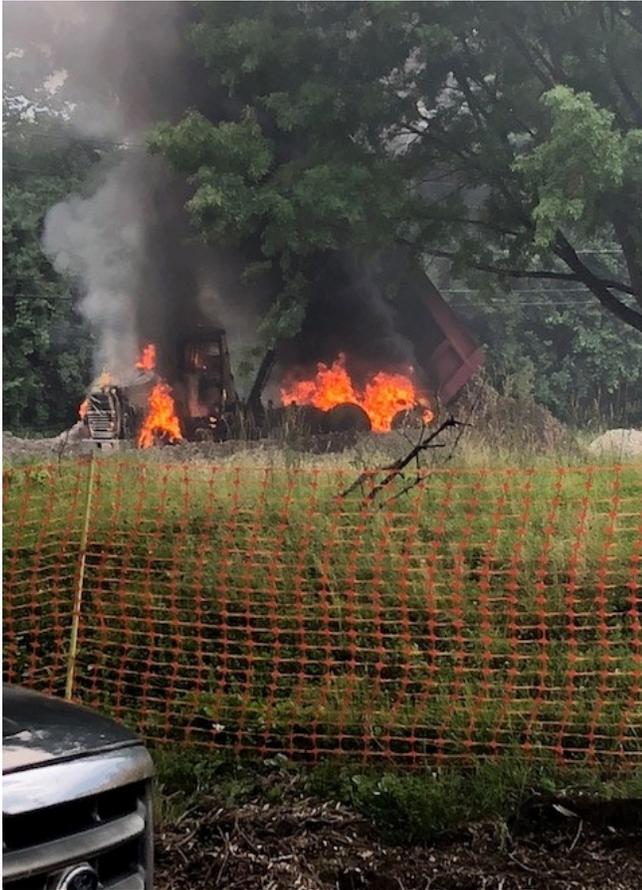
At approximately 4:35 pm, as the victim was raising the truck's bed, he slowly backed up to dump a load of large concrete debris into the rock crusher. As the bed of the truck extended to its full raised height of 24 feet above the ground, it made contact with overhead electrical lines carrying 7,200 volts. This caused electricity to travel through the vehicle and catch the back tires of the truck on fire. Realizing the truck was on fire, the victim honked the horn to attract the attention of his brother-in-law who was getting a drink of water. The brother-in-law saw that the truck's tire had begun burning, and ran towards the truck. The driver, after getting his co-worker's attention, attempted to exit the vehicle in order to escape the flames. The victim opened the door, stepped onto the metal running board with his hand on the exterior of the truck, stepped off with one foot, and contacted the ground. Due to being in contact with both the ground and the electrified dump truck, the victim became grounded, completed the circuit, and was immediately electrocuted. The victim's co-worker and employees from the primary construction company were able to pull him away and doused him with a fire extinguisher to put out the flames on his body. The victim sustained charred electrical burns as well as thermal burns caused by his blue jeans catching on fire. The electrical current entered and exited his feet and hands.

Photo 3: Dump truck while burning.  
Photo property of KY FACE.

Discussion: When a vehicle contacts electrical power lines, best practice is for all passengers to remain in the vehicle and call 911. Due to the high voltage carried within power lines, electrical current can easily travel through the vehicle and into the ground below, electrifying a radius of up to 30 feet from the vehicle. In this instance, one of the dump truck’s tires caught fire, requiring the victim to exit the vehicle before the power could be disconnected. In situations where employees must exit a charged vehicle, it is recommended to jump away from the truck as far as possible with both feet launching and then landing simultaneously. As you move away from the vehicle, do not lift your feet to walk. Instead, keep your feet on the ground and scoot away, not allowing the heel of one foot to move past the toe of the other. Continue this method until you are 30 feet from the vehicle. If a tingle is still felt in the body after 30 feet, continue shuffling away from the vehicle until you no longer feel this effect<sup>5</sup>.

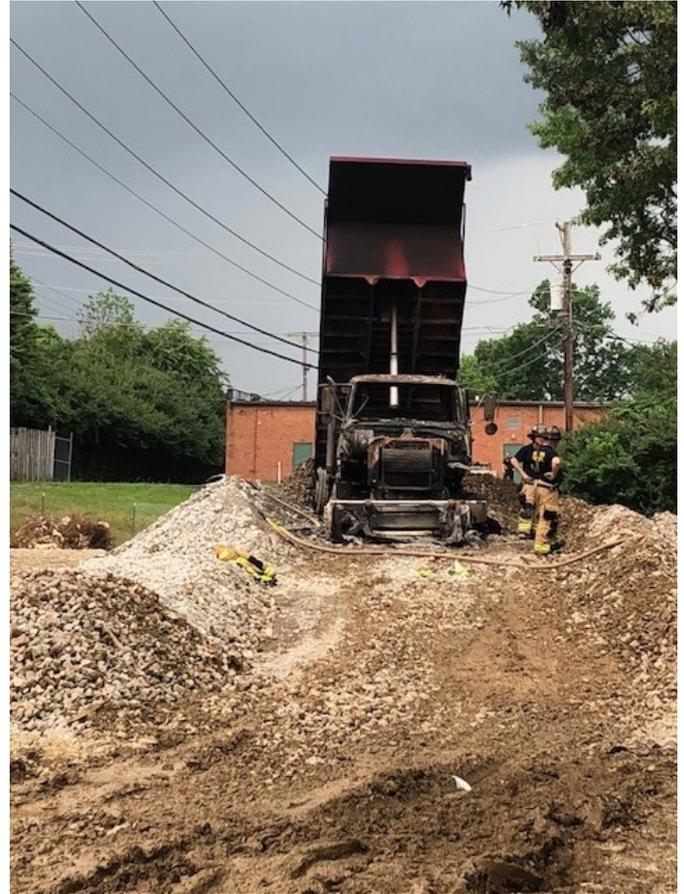
Photo 4: Dump truck post-fire.  
Photo property of KY FACE
