TIME: 12:15 pm **REPORT#: 18KY054**

Teen Roofer Electrocuted when Ladder Contacts High Voltage Power Line

Fatality Assessment and Control Evaluation (FACE) Program

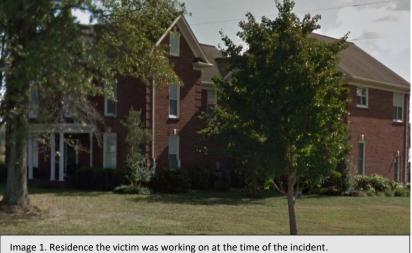
Image 1. Residence the victim was working on at the time of the incident. Photo property of KY FACE.

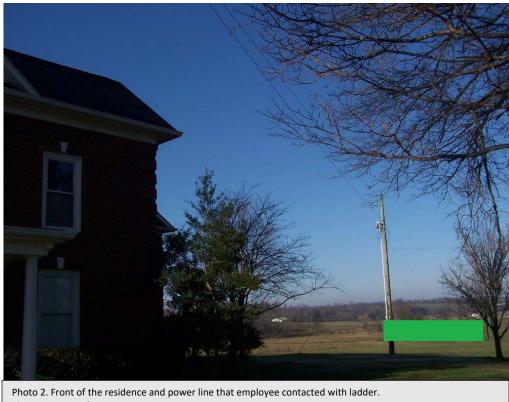
Photo property of KY FACE Program.

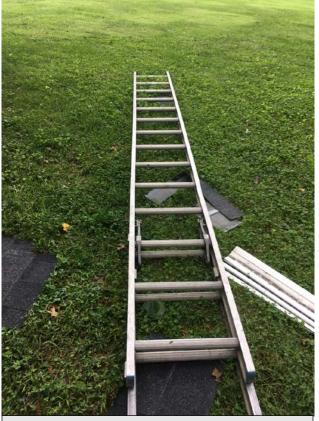
Photo 3. The ladder used by the victim. Photo property of KY FACE.

Discussion: At the time of the incident, the victim was using an aluminum ladder to access the roof. Aluminum has an electrical resistivity (ρ ($\Omega \cdot m$)) – the measure of how strongly a material opposes the flow of electric current – of 2.82×10⁻⁸ at 20°C. Inversely, aluminum has an electrical conductivity (σ (S/m)) – the measure of how well a material conducts an electrical current – of 3.5×10⁷ at 20°C. Because of its extremely low resistivity and extremely high conductivity, aluminum is one of the best electrical conducting metals, behind only silver, copper, annealed copper, and gold⁶. As the ladder contacted the overhead power line, 7,200 volts and 16 amperes (amps) travelled through ladder, into the victim, and exited his body via the stomach and each foot's fifth (pinky) toe. At values as low as 100 milliamps (.1 amps), death can occur⁷. Due to the high amount of amperes that entered the victim's body, cardiac arrest occurred instantly.

Discussion: The victim was moving a model D1828-2EQ Werner aluminum extension ladder that weighed approximately 56 pounds. When collapsed, the ladder was 14 feet tall and had a maximum open extended length of 25 feet. At the time of the incident, the victim, who measured 5'10" tall and weighed 165 pounds,

was moving the ladder, which was extended to the maximum length of 25 feet. As the ladder became unstable and began to fall, the victim may have been unable to support the ladder's top-heavy design while standing on uneven terrain, which allowed it to contact the power line.

In order to prevent similar incidents, the employer should consider using a non-conductive ladder, such as those made of a fiberglass-reinforced polymer, when working around live power lines. Due to its low electrical conductivity and high resistance to corrosion, these ladders would make a safe and practical choice when working outdoors around electricity. However, employers should ensure that these fiberglass ladders are maintained properly as required by 29 CFR 1926.1053. Unmaintained ladders may accumulate excess dirt or moisture that can conduct electricity in the event it encounters a high voltage line.

In instances where an extension ladder needs to be relocated, employees should lower the extended portion of the ladder until it is appropriately collapsed, carefully lay the ladder down, and transport it horizontally while grasping the ladder's middle section with both hands in order to safety manage its weight. Once the ladder is placed in the necessary area, ensure the base is secure and re-extend the ladder to the appropriate height. Had the ladder been lowered and transported horizontally, the high voltage line could have been avoided.

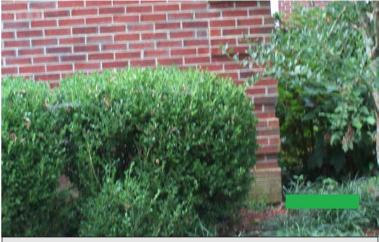
Photo 4. The box wood bush the victim was attempting to work around. Photo property of KY FACE.
