**REPORT#:** 2018OR030

**REPORT DATE:** July 8, 2020

## Pipefitter Struck by Pressurized Pipe and Killed

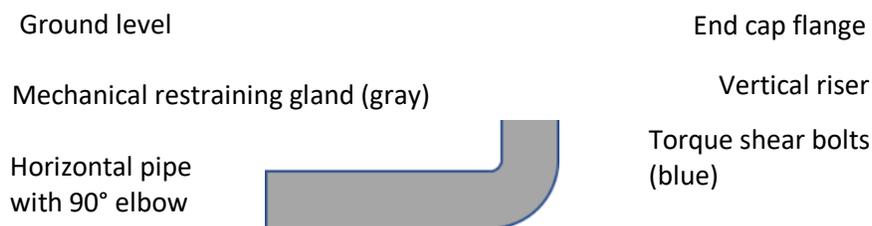
**Diagram 1. Schematic of vertical riser connection to horizontal section of pipe, with mechanical restraining gland and torque shear bolts.**

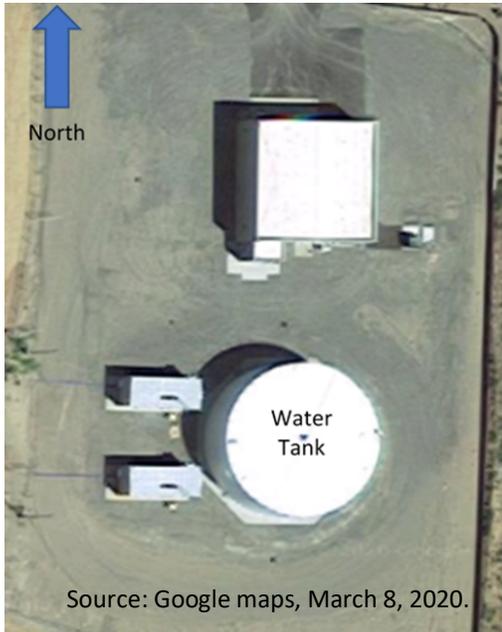
**Photo 1. Incident scene, aerial view, after construction completed.**

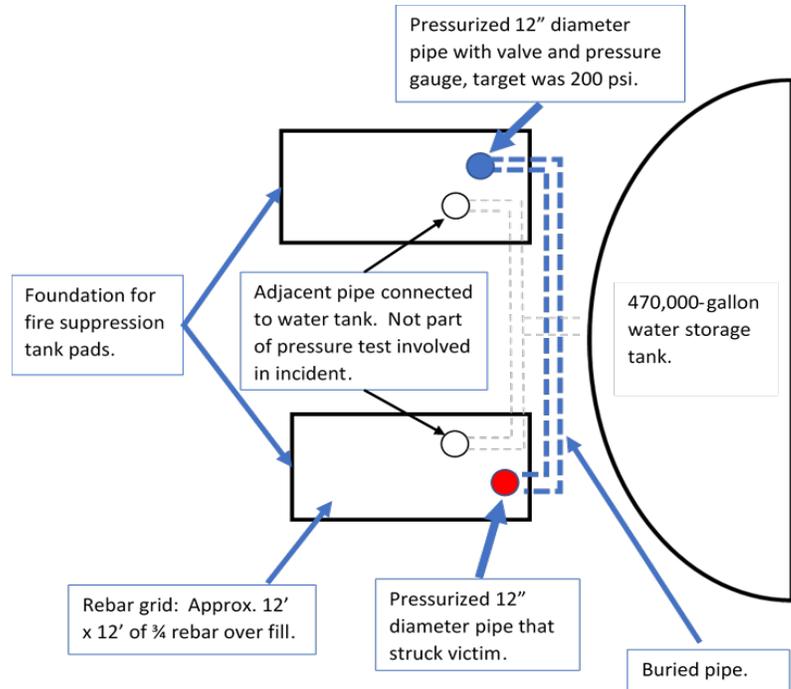
**Diagram 2. Schematic of Incident scene.**

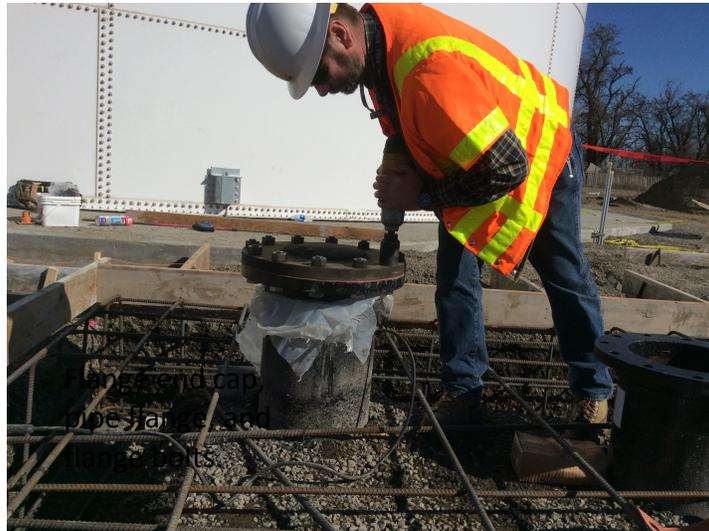
The hydrostatic pressure test on the pipe that ran between the tank pads took place after the pipes had been backfilled and the foundation forms and rebar for the tank pads had been constructed (see Photo 2). The vertical risers were backfilled with gravel so that 48 inches of the risers were below grade and 16 inches above grade. In preparation for the hydrostatic pressure test on the morning of March 6, 2018, the north riser was capped with a threaded port to which a hydrostatic pumping unit was installed, and the south riser was capped after the pipe was filled with water and secured with flange bolts (see Photo 2).

**Photo 2. Simulation of work performed by victim prior to incident. Note backfill and rebar lattice.**  
*(Photo courtesy of OR-OSHA.)*

During the hydrostatic pressure test, the pressure was approaching the target pressure of 200 PSI, but would not hold, indicating there was a leak. The crew looked for leaks on exposed pipe flanges and observed a small amount of water between the south riser flange and the end cap (*see Photo 2*).

One pipefitter and the excavation/pipe superintendent returned to the hydrostatic pumping unit on the north riser. The other pipefitter (decedent) stayed at the south riser and used an electric impact driver (*see simulation in Photo 2*) to tighten the bolts connecting a pipe flange and end cap. The water pressure in the 12-inch pipe was between 175-190 PSI as the decedent worked his way around the flange and end cap, leaning over it to tighten flange bolts with the impact driver held close to his chest.

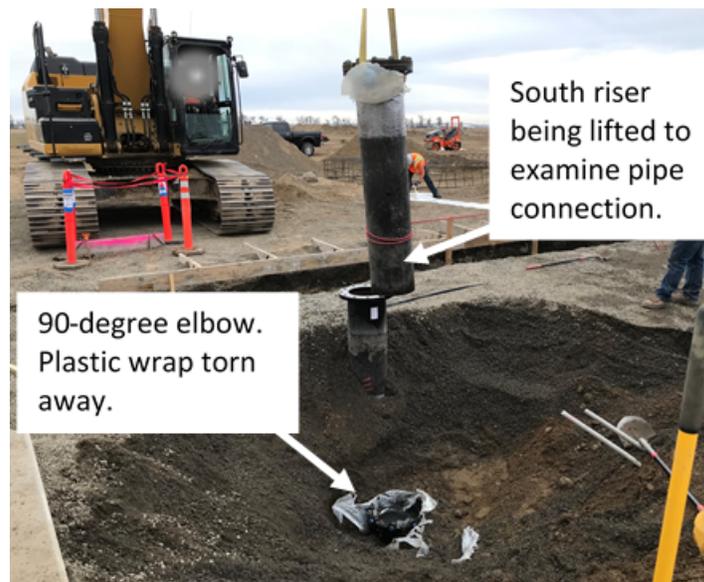
At approximately six feet of depth from top of riser, the connection joint between the vertical riser and the 90-degree elbow of the horizontal pipe section was visible (*See Photo 3*). The 90-degree elbow had a flange with 12 silver-colored flange bolts connected to the mechanical joint restraining gland, which had 12 blue torque shear bolts to connect and hold the vertical riser to the flange on the elbow of the horizontal pipe.

**Photo 3. Post-incident excavation. South vertical riser to connection point with 90-degree elbow of horizontal pipe section. (Photo courtesy of OR-OSHA)**

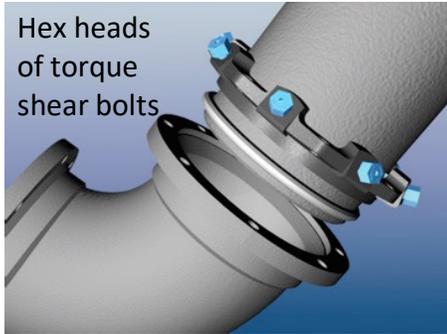
**Image 1.** Mechanical joint restraining gland (dark gray, with blue torque shear bolts) fitted onto end of pipe.

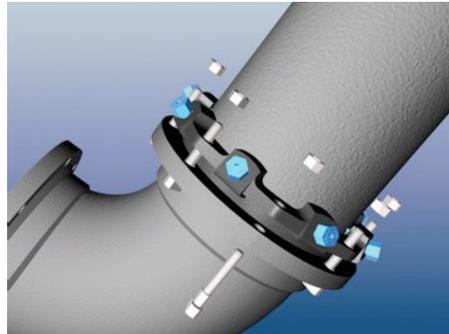
**Image 2.** Flange bolts (silver-colored) are inserted through elbow flange and secured to gland.

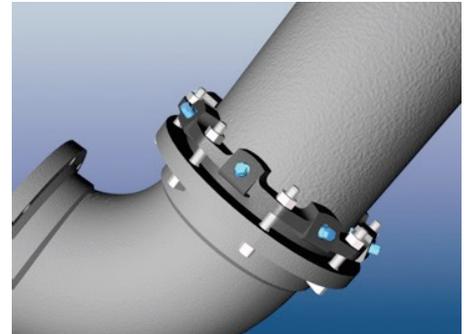
**Image 3.** The hex-heads of the torque shear bolts (blue) are broken off when sufficiently tightened.

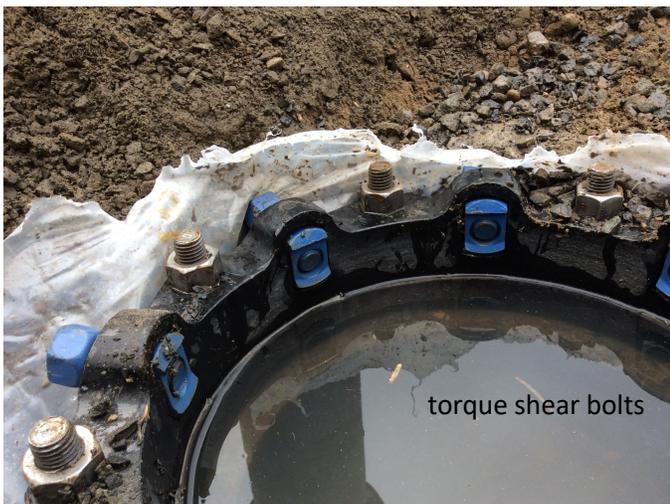
When the plastic wrap was torn away, observers noticed that the hex heads of the torque shear bolts on the gland were intact, indicating that the torque shear bolts had not been tightened sufficiently (see *Photo 4*). When the south vertical riser was removed and inspected, there were no torque shear bolt marks on the pipe, which would have been visible had the torque shear bolts been tightened sufficiently (see *Photo 5*).

**Photo 4.** Flange bolts (silver) and torque shear (blue) on gland. Vertical riser has been removed. Note hex-heads of torque shear bolts are still attached.  
(Photo courtesy of OR-OSHA.)

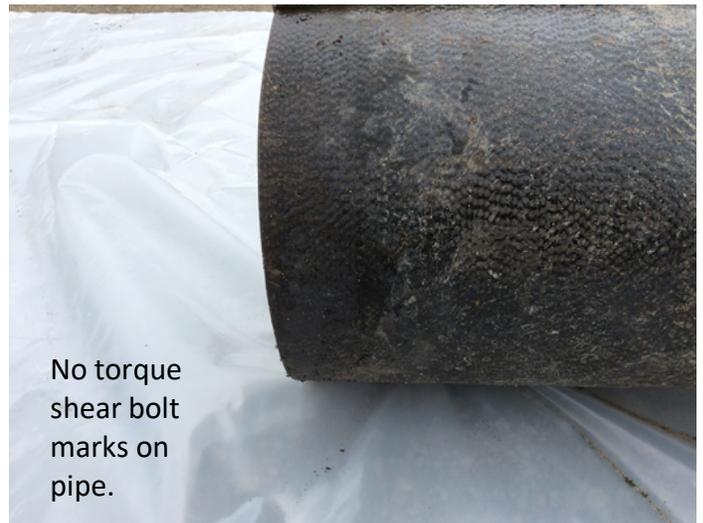
**Photo 5.** Bottom end of south vertical riser. Note there are no torque shear bolt marks on the outside of the pipe, indicating torque shear bolts were not tightened.  
(Photo courtesy of OR-OSHA.)
