REPORT#: 18MA001

REPORT DATE: May 7, 2020

Landscape Construction Laborer Compressed between Compact Excavator and Steel Beam at Residential Site—Massachusetts

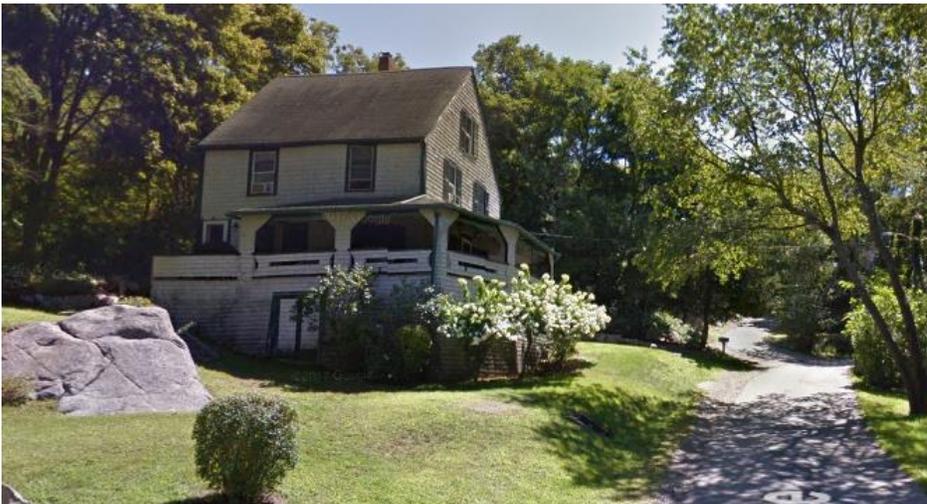
Figure 1 - View of home, facing uphill, before work began

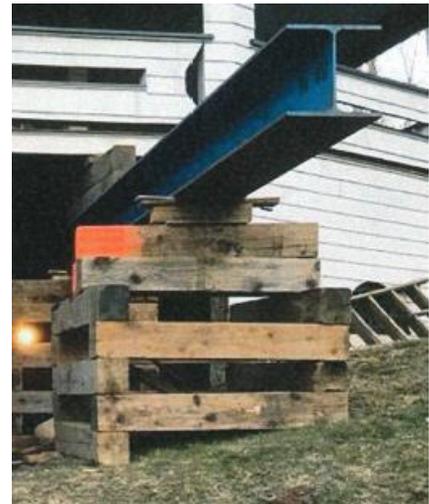
Figure 2- Steel support beam and cribbing

As described previously, the home was shored on steel beams that were supported on two cross beams and cribbing. It appears that after warming up the area and the equipment, the victim had positioned the excavator, partially underneath one of the beams and lowered the left and right stabilizers. The excavator was perpendicular to the overhead beam, but the beam was likely out of the forward view of the victim as he sat in the operator's seat.

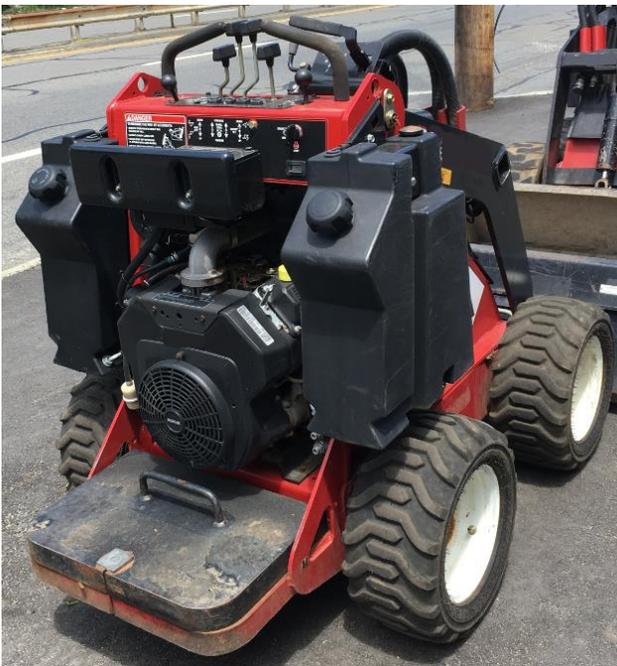
Figure 3 - Base power unit

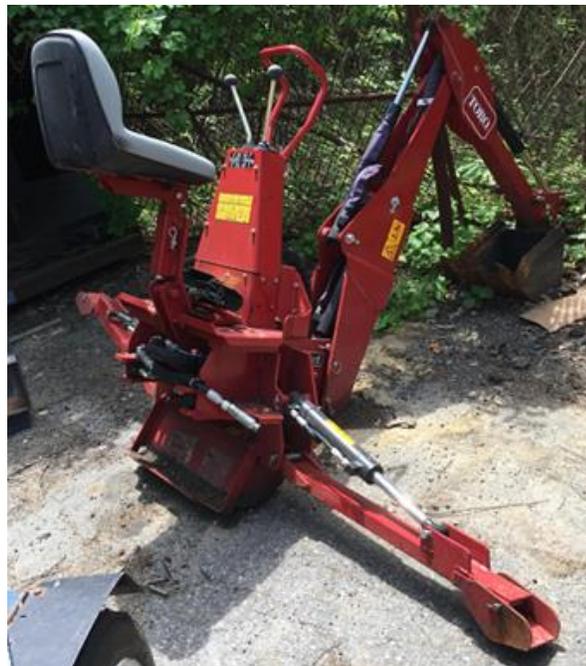
The backhoe attachment mounted on the front of the base unit and tapped into the hydraulic system. It had an operator's seat and a separate set of controls for operating the stabilizers and excavation boom, dipperstick, and bucket (Figure 4). When the backhoe attachment was installed, the unit was driven into position using the rear controls and then the user would set the engine speed, divert hydraulic flow to the accessory hoses, and install an interlocking cover over the drive controls. This would enable the second set of controls near the backhoe operator's seat. The backhoe attachment was designed without a protective cab for the operator.

Figure 4 - Excavator (backhoe) attachment involved in the incident

In this case, the manufacturer designed the loader's backhoe attachment without a protective cab, but had equipped the control area of the backhoe attachment with a bar guard. The bar guard provided some protection to the levers, from physical damage or incidental activation. In this situation, incidental activation or the inability to stop activation of the control levers led to the crushing of the operator. If a protective cab was part of the design of the backhoe attachment the victim might not have been compressed.

This equipment, which is still being manufactured with the same features, serves as an example of the potential for eliminating or minimizing injury risks through a comprehensive PtD review of the equipment. If PtD was applied to this equipment, the potential for the worker and equipment interaction that led to the incident might have been identified and highlighted the need to redesign and/or incorporate additional engineering controls to the operator area. For example, a protective cab could have been added to the backhoe attachment and the controls could have been redesigned with a guard or shield that encompasses the entire area, which would better prevent an un-expectant engagement of the controls. PtD could also have led to a more advanced load sensing system that would detect when the equipment comes up against a stationary object while its controls are still engaged, and sound an alarm and automatically lower the equipment a few inches. This system could also incorporate additional features that detect if the equipment is stuck in a position while the controls are continuously activated for a period of time.

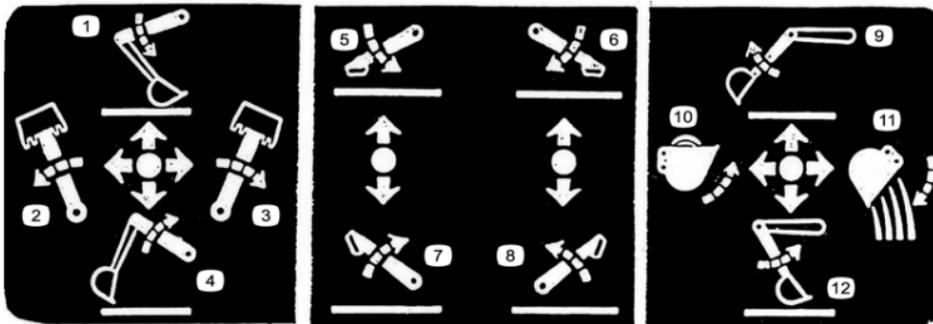
Figure 5 - Decal image of control functions

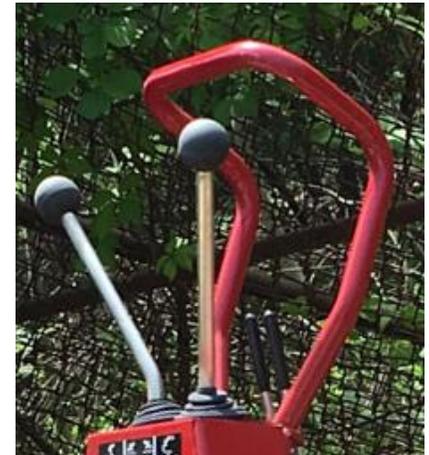
5). These control levers were partly protected by a guard made of steel tubing that wrapped in front of and over the two larger control levers (Figure 6).

Figure 6 - Excavator controls

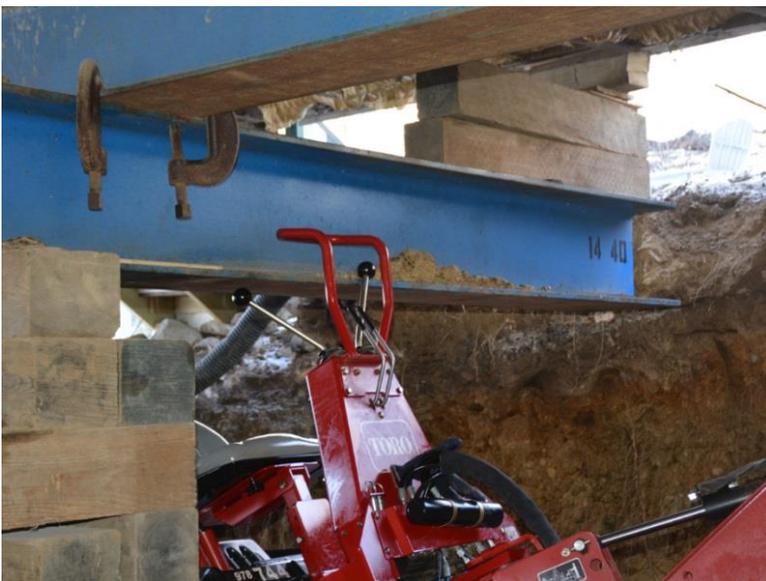
The victim was working alone at the time of the incident, but evidence indicates that the victim was operating the excavator when his body made contact with the overhead steel beam. This contact would have pushed him forward in the operator's seat such that he could not move out of the way of the controls and the guard and he became trapped. The boom and bucket were found in an extended position, which suggests the left main control lever was forced in the forward direction after coming in contact with the beam (Figure 7). Having the left main control lever continuously engaged would have caused the boom to extend or move in a downward direction, lifting the front of the unit and the stabilizers off the ground. This continuous pressure was compressing the victim's back and neck against the beam and the front of the victim against the top of the unit. Because the hydraulic system was still trying to move the boom, which could not move any further, the system started to leak hydraulic fluid onto the ground.

Figure 7 – The excavator's left control lever against the overhead beam

The medical examiner listed the cause of death as asphyxia due to compression of neck and chest.

Recommendation #2: Employers should ensure that ride-on equipment without a protective cab is not operated in the vicinity of overhead obstructions.

When deploying the outriggers or, even as in this case, when digging with the backhoe attachment the entire loader can raise, including raising the operator in the loader's seat. Employers should ensure that ride-on equipment that does not have overhead protection is not operated in areas with low ceiling clearance or other overhead obstructions. Additionally, the knowledge of this type of hazard could be made more prominent in the warning decals and training materials for the equipment (discussed further in Recommendation 5).
