**REPORT#:** 2019OR01

**REPORT DATE:** June 29, 2023

## Two Workers Killed in Boom Lift Rollover - Oregon

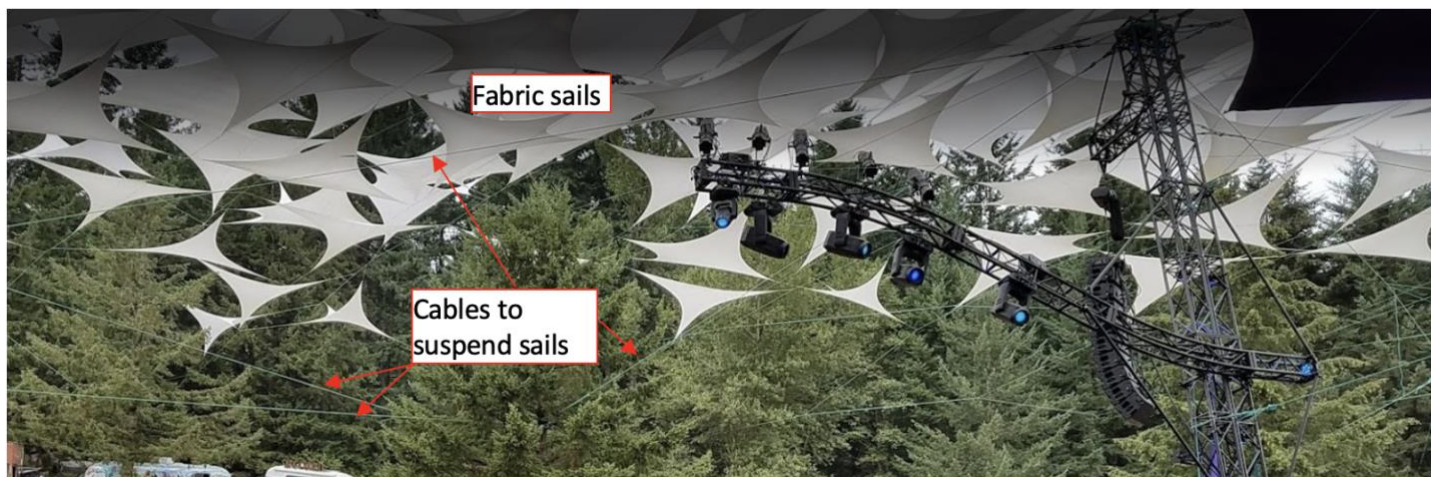
**Image 1.** Image of a fabric sails installation at the music festival venue. Note the cables attached to the sails are secured to trees in the background.

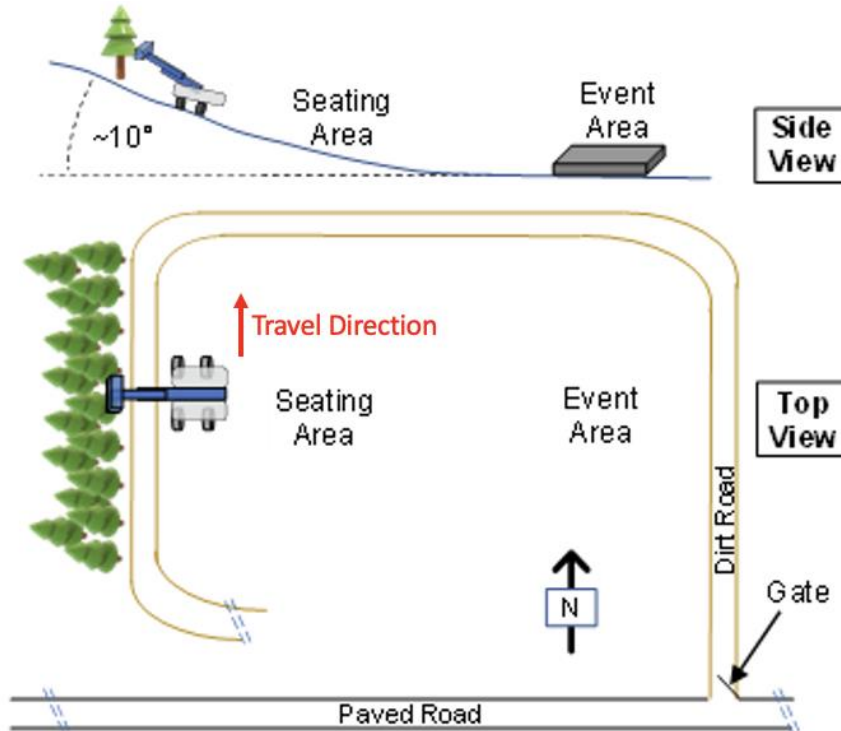
The incident occurred on a sloping hillside of a private farm field bordered by tall trees on the west and north side (*See Image 2*). The trees are used to anchor cables that suspend fabric over the audience seating area, the event stage, and other event areas. The highest elevation of the field is on the west side, sloping downward approximately 10° to the east, where it flattens out, creating a bowl shape. The field is made available as a music venue for about two weeks during the summer, including set-up and tear-down of equipment and effects.

**Image 2.** Side and top view of the incident scene. Wheels on boom lift are parallel to the dirt road to the west. Not to scale.

The boom lift was a Genie S-85 four-wheel drive diesel engine and a straight boom. Prior to the incident, the boom lift was being operated on the west side of the hill near the tree line and just east (below) a dirt road. The wheels of the boom lift were parallel to the dirt road. The first stage of the boom was extended approximately 40 feet westward toward the trees. The basket where the operators were standing was approximately 60 feet in the air. The counterweight was on the downhill slope of this hillside. Just before the incident, operators (decedents) moved the boom lift to the north, extending the boom.

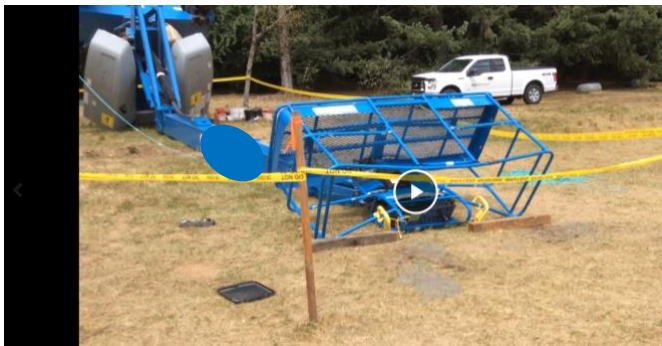
The boom lift was being used on a sloped surface with the boom extended. The platform was positioned uphill with the counterweight positioned downhill. According to the equipment specifications, the maximum slope rating for the lift with the counterweight positioned downhill and the boom stowed is 30% or 17°. With the counterweight uphill and the boom stowed, the maximum slope rating is 45% or 24°. The operator's manual instructions indicate that the boom should only be raised or extended on a firm, level surface. The operator's manual was located in the platform compartment of the boom lift at the time of the incident.

The wheels on the west side lifted off the ground, rolling the boom lift eastward down the hill, where it came to rest (*See Image 3*).

**Image 3.** Incident Scene. Location and orientation of boom lift post-incident. Still image taken from video recorded by the OR-OSHA Safety Compliance Officer.

- **Recommendation #2: Do not move the boom lift equipment with the boom extended.**

Discussion: Moving the boom lift with the boom extended destabilizes the equipment, especially if operating the boom lift on sloping ground. The Oregon Administrative Rule (OAR) for the Construction Industry (Division 3), incorporating federal OSHA standard on Aerial Lifts by reference, states that "An aerial lift truck shall not be moved when the boom is elevated in a working position with men in the basket, except for equipment which is specifically designed for this type of operation in accordance with the provisions of paragraphs (a)(1) and (2) of this section". (OAR 437-003, Section L, adopting 1926.453(b)(2)(viii) by reference).
