**FATALITY ASSESSMENT AND CONTROL EVALUATION PROGRAM
(CA/FACE)**

A stationary engineer died when the multi-piece tire
and wheel he was disassembling exploded

Case Report: 19CA002

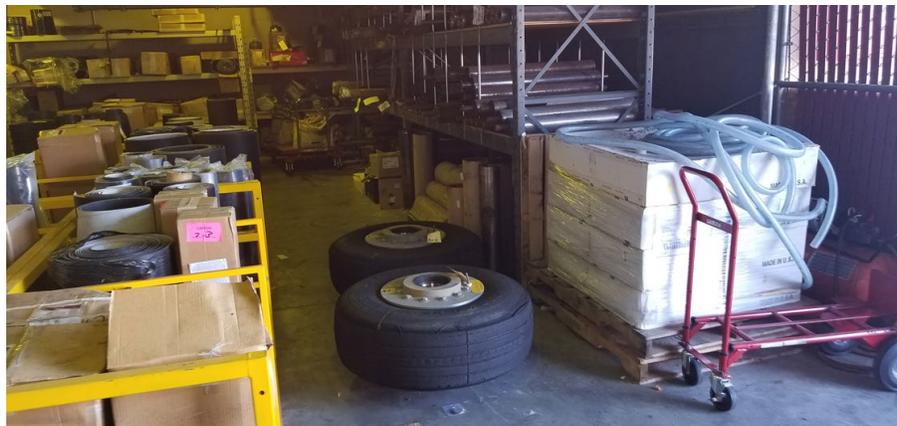
Exhibit 1. The incident scene.

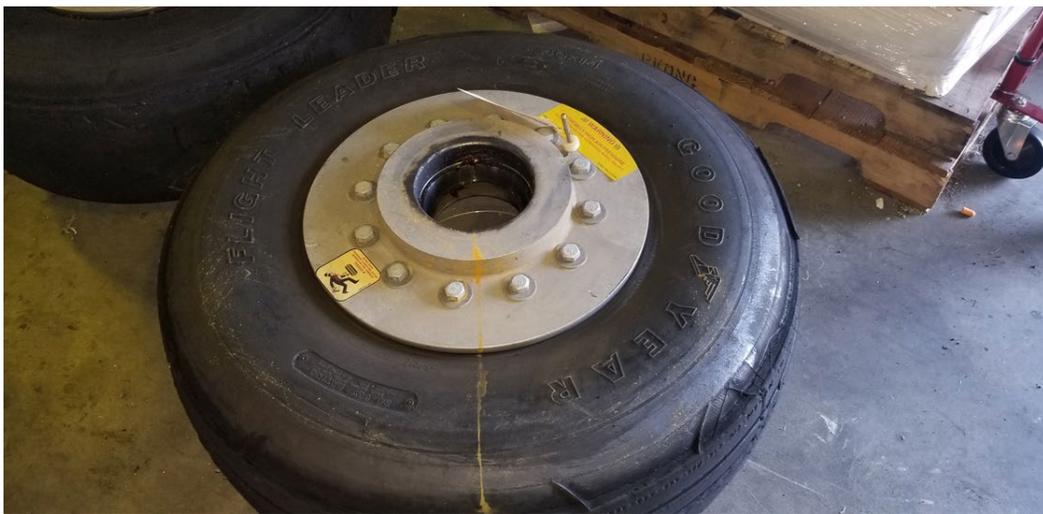
The pneumatic rubber tires on the passenger boarding bridge were 24-ply tubeless tires designed to carry 27,700 pounds of load. The size of the tire was 40 X 14 inches, and when properly inflated, the air pressure could reach 200 pounds per square inch (psi). The tire was part of a multi-piece wheel assembly that was held together with the 12-bolt pattern (Exhibit 3).

Exhibit 3. Tire and wheel assembly similar to the one involved in the incident, showing the 12-bolt pattern holding the wheel assembly together.

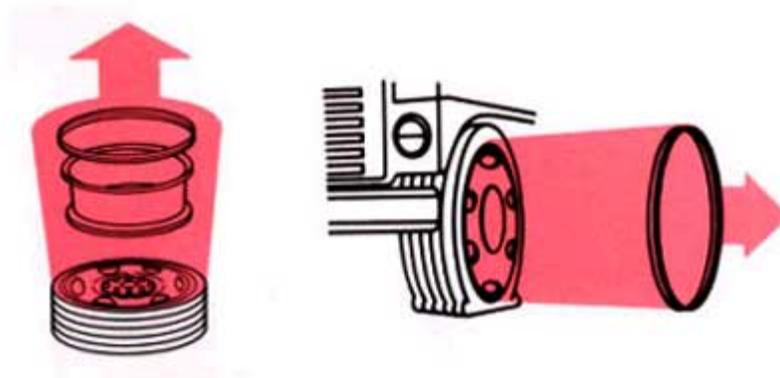
A multi-piece wheel consists of two or more parts, one of which is a side or locking ring designed to hold the tire on the wheel by interlocking components when the tire is inflated. The principal hazard of multi-piece wheels is pressurized air that, when suddenly released, can cause the tire or wheel assembly to be thrown through the air, potentially striking anyone who is near (Exhibit 4). In a multi-piece rim wheel incident, the wheel components separate and are released with a violent force. The risk of injury or death is greater with larger multi-piece wheel assemblies like the one in this case.

Exhibit 4. Trajectory of multi-piece rim parts placed on the ground and mounted on a vehicle.

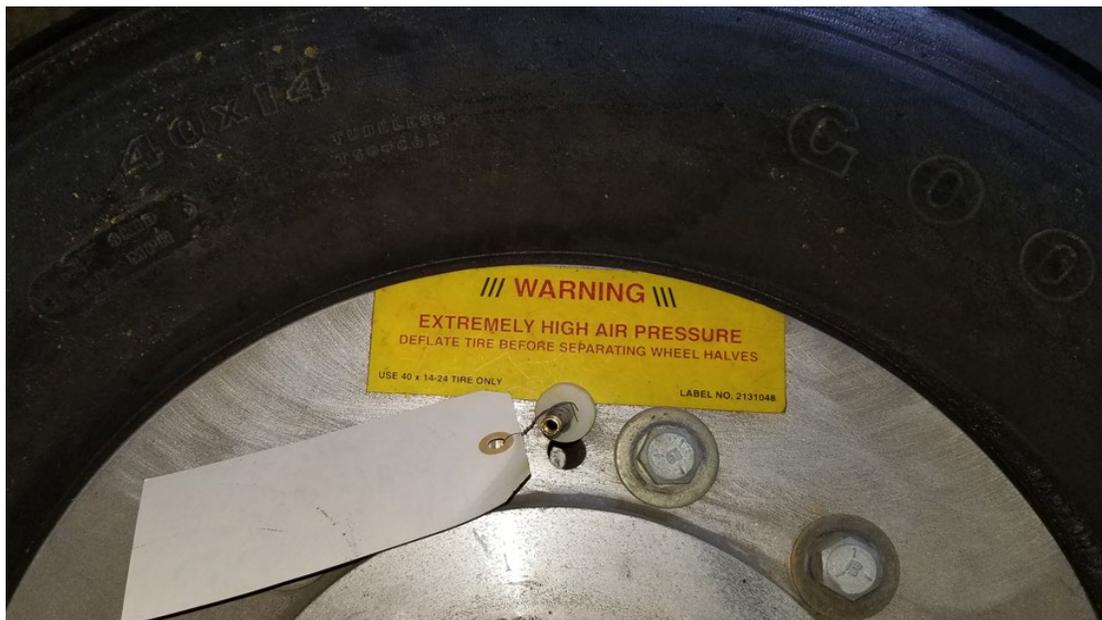
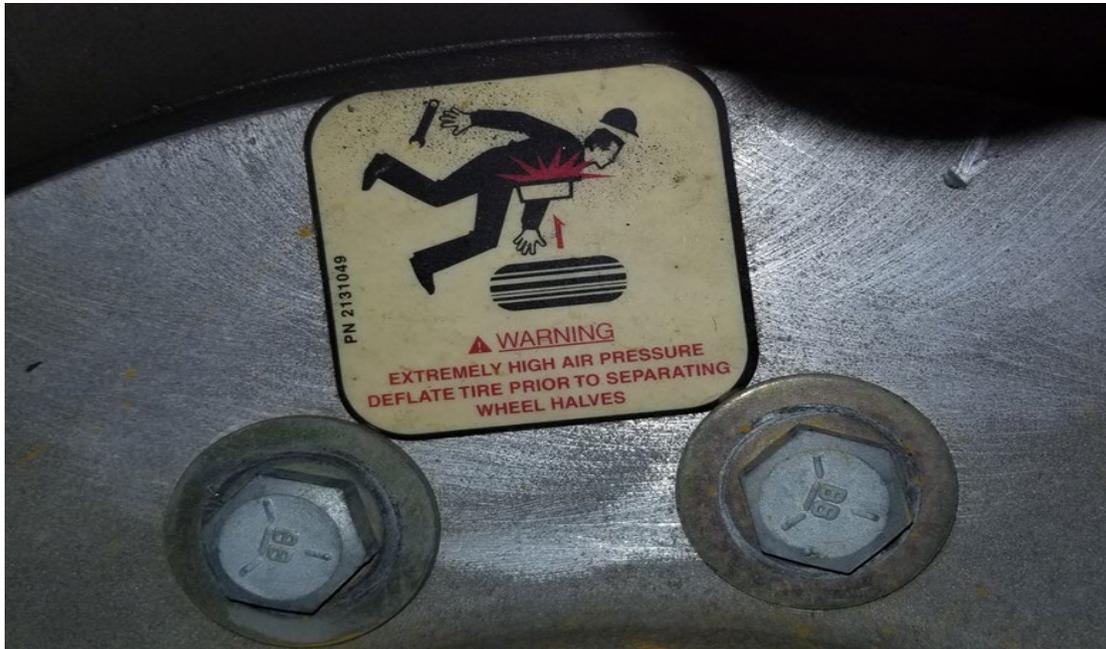
Discussion: In this incident, the victim and co-worker began working on the wheel assembly without deflating the tire. The employer had written safety procedures and training that included the deflation of tires, and the victim had performed this task many times in the past. According to employer procedures, the workers on the previous shift were responsible for deflating the tire prior to removal from the boarding bridge. It is not known why the tire was not deflated at the time it was removed and placed in the maintenance shop. It is also not known if the victim assumed that the tire was deflated prior to beginning work. The warning label (Exhibits 5 & 6) regarding deflation was present on the tire, and the valve was still present.

Exhibit 5. Warning sticker placed on all tire/wheel assemblies used on passenger boarding bridges.

Exhibit 6. Second warning sticker placed on all tire/wheel assemblies used on passenger boarding bridges.

Recommendation #1: Implement policies and procedures as part of a safety program to ensure that tires are deflated prior to wheel disassembly.
