**FATALITY ASSESSMENT AND CONTROL EVALUATION PROGRAM
(CA/FACE)**

A water truck operator died after being struck by a pressurized hose
Case Report: 19CA003

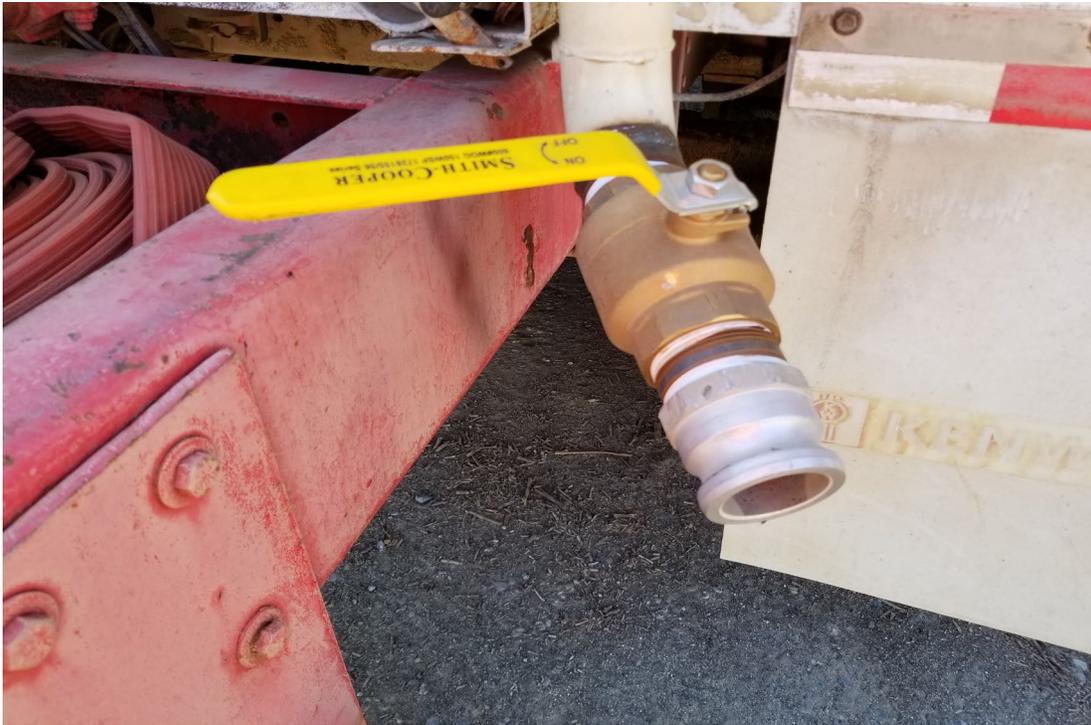
Discussion: In this incident, the victim began transferring water from the hydrant without first opening the intake ball valve on the truck. Because this valve was not turned on first, pressure in the hose caused it to swell and then burst, knocking the victim to the ground.

Exhibit 3. The inlet ball valve on the rear of the water truck.

Recommendation #2: Implement policies and procedures as part of a safety program to ensure that unsafe conditions are identified, and safe work practices are followed.

The victim was an experienced seasonal employee and had transferred water safely on numerous occasions in the past. However, this type of water transfer was not the typical source that was used. The employer had written safety procedures and training that included the safe transfer of water. Their correct procedure was to first connect the hose to the water tank hydrant outlet ball valve, then to the inlet ball valve on the truck. Once the hose was secured in place, the ball valve on the truck was to be opened first, followed by the ball valve on the hydrant. In this incident, the victim connected the hose to the truck and hydrant, then he opened the water tank valve but did not open the valve on the truck. Although the employee had received safety training, there was no communication or method to ensure that the proper procedure occurred. For example, written check-off sheets and/or periodic and regular safety audits with direct observation can be used to ensure that safe work practices are followed. In addition, employee safety training should be verified through written testing, oral confirmation, or demonstration. If these procedures had been implemented, the victim may have realized that the truck valve was not open, and this incident could have been prevented.

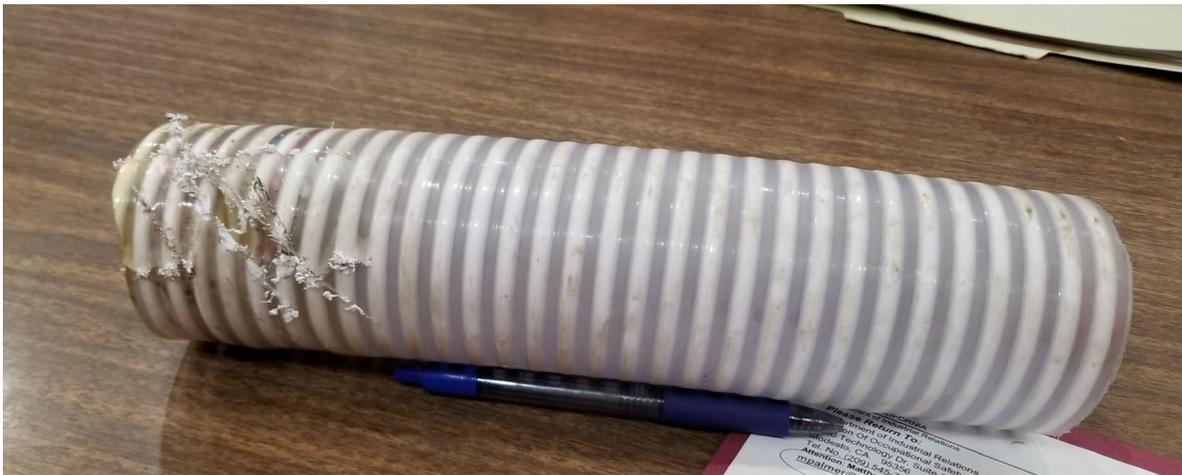
Discussion: In this incident, the hose used to transfer water from the water tank to the truck was a thermoplastic rubber bulk water discharge hose with polyethylene helix reinforcement (Exhibit 4). This type of hose can only withstand a maximum working pressure of 50 psi. A more adequate hose would have been an ethylene propylene diene monomer (EPDM) bulk water discharge hose with spiral-ply synthetic fabric reinforcement, a vinyl nitrile water discharge hose with wire helix reinforcement, or a polyvinyl chloride (PVC) bulk water hose with a rigid PVC helix reinforcement. EPDM bulk water discharge hoses are used for pumping water in quarries, mines, construction sites, and other abrasive environments and can withstand working pressures up to 300 psi. This type of hose was not on the truck and thus not available for the victim to use. Had a hose with the proper design been used to fill the truck, pressure from the hydrant would not have caused the hose to burst, thereby preventing this incident.

Exhibit 4. A portion of the hose involved in the incident.

Recommendation #1: Ensure that the machinery and equipment provided to transfer high-pressure water can safely withstand all reasonably anticipated loads.
