REPORT#: 19MA015

Laborer Crushed Between Two Large Stone Slabs at a Manufacturing Facility— Massachusetts

Fatality Assessment and Control Evaluation (FACE) Program

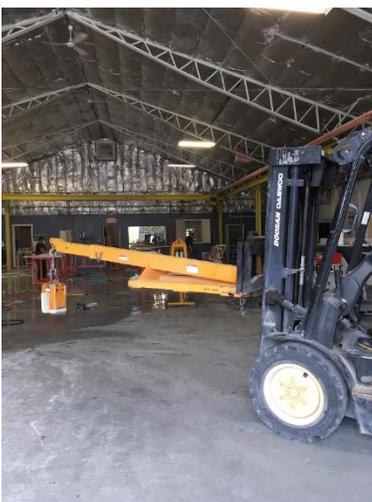
A propane-powered forklift was being used at the time of the incident (Figure 1). The company had a long-term rental agreement for the forklift, and the machine was in overall good condition. The forklift had four wheels, a three-stage mast with a maximum lift height of 15 feet and six inches, and a load capacity of 5,000 pounds. The forklift had a boom attached to its tines and a slab lifter attached to the end of the boom (Figure 1 and 2). Both the boom and the slab lifter were manufactured by the same company and were designed specifically for lifting slab material.

The telescoping boom attachment consisted of two rectangular steel tube sections. Specifications from the manufacturer indicated the boom weighed 286 pounds, had a maximum rated load capacity of 3,300 pounds when fully retracted, and a maximum load capacity of 1,320 pounds when fully extended. The telescoping range of the boom was from approximately 6.8 feet to 11.7 feet in three increments of 19 inches. The boom could only be extended manually and had a series of pins and clips to hold it in position. The boom attached to the forklift by sliding onto the forklift tines and was secured by two bolts and two restraint pins (Figure 1).

Figure 1 – The forklift inside the shop with the boom and slab lifter attached.

Discussion: Employers have to comply with federal and state requirements before allowing employees to operate forklifts. In Massachusetts, employers are required to provide OSHA-approved forklift training to employees who will operate forklifts and ensure that the employees have obtained a specific operator's license issued by the Office of Public Safety and Inspections (OPSI). Obtaining a license to operate hoisting machinery, (forklifts are officially included under the category of hoisting machinery), requires training and passing a written or practical examination.

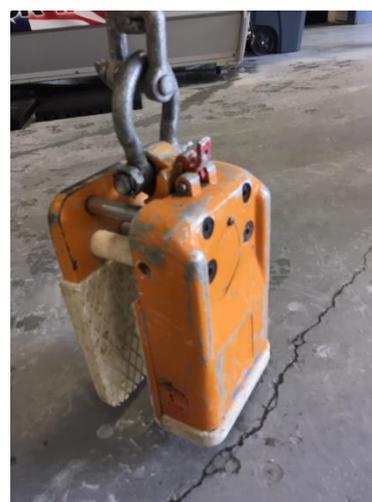
Figure 2 – The slab lifter.

The slab lifter was an accessory attachment for the boom that was used for gripping, lifting, and moving slab loads (Figure 1 and 2). The slab lifter had a spring-loaded latch incorporated into the design. The spring-loaded latch would automatically release the grip of the lifter from the slab once the slab had been fully lowered to the ground.

Once the slab was lowered onto the rack, the slab lifter grip automatically released. As the forklift operator was lifting the boom up to move the forklift way from the slab and rack, it appears that the slab lifter became hung up on the horizontal top beam of the rack. As a result, the forklift and boom were not able to move away from the rack. The stone slab was blocking the forklift operator's view of the rack, therefore the operator could not see what the issue was and what was causing the slab lifter and boom to be stuck. The victim walked over to the slab lifter to assess and fix the issue.

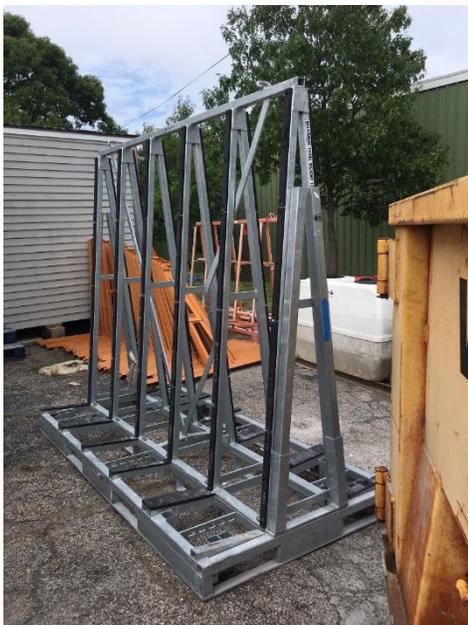
An A-frame rack was in use at the time of the incident and was designed to hold slabs in a range of sizes (Figure 3). The rack was equipped with removable caster wheels that were in place at the time of the incident. The caster wheels consisted of 8-inch diameter roller bearing wheels that were rated at 2,000 pounds each. Two of the four wheels were swivel casters with brakes and the other two wheels were rigid. The rack's rated capacity was 8,000 pounds, 4,000 pounds for each side of the rack with the installed wheels (it had a 10,000 pound capacity, 5,000 pounds per side, without the optional wheels installed). The rack was equipped with four hold-down ratchet straps to secure the slabs being stored on the rack. It was also equipped with four safety posts, two for each side, to prevent a slab from tipping off the rack and provide safe access of unstrapped loads that may shift unexpectedly. The rack was 96 inches long by 28 inches wide and 99 inches high (88 inches high without the optional caster wheels).

Figure 3 - A-frame rack involved in the incident without the caster wheels attached and the safety posts not installed.

It appears that the safety posts were infrequently used at this company. If A-frame racks with removable safety posts have to be used, employers should make sure the safety posts are being used by securing them in place at all times. This will help ensure the stone slabs don't tip over uncontrollably when using the racks. In addition, slabs that are not being accessed and will remain on the A-frame rack should be tied down to ensure that these slabs will not move unexpectedly.

In this case, as soon as it was realized there was an issue while placing the marble slab on the A-frame rack, the forklift operator should have stopped the task and the situation should have been evaluated. At this point because the safety posts were not being used, the safety post should have been immediately installed by the worker on the ground. While installing the safety posts the worker must stay out of the fall shadow. If this was performed when the stone started to tip the safety posts would have stopped the slab and prevented the injury.

Recommendation #1: Employers should use slab racks designed with fixed safety posts and individual compartments for each slab.

Discussion: This fatal incident underscores the need to use slab racks designed with fixed safety post and individual compartments for each stone slab. If a rack with fixed safety posts was being used, the hazard of the slab tipping uncontrollably while it was being placed in the rack would have been eliminated. By eliminating the potential uncontrolled tipping hazard the fatal injury that occurred would have been prevented.²

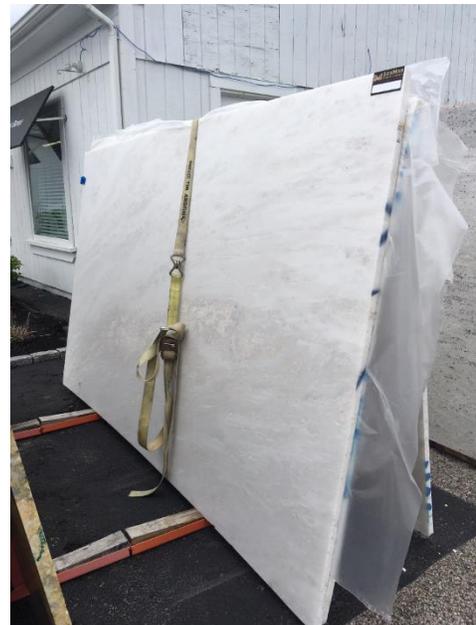
Figure 4 – The marble slab involved in the incident.

On the day of the incident, the victim arrived at approximately 7:30 a.m. to the company location. The victim would have been performing his normal work tasks the morning of the incident. Prior to the incident occurring, a customer arrived to view a stone slab and the positioning of a countertop template onto the slab. The stone slab that was involved in the incident was a marble slab measuring 114 inches long by 69 inches high by 1 1/8 inches thick. This marble slab weighed approximately 719 pounds (Figure 4).

While the victim was positioned near the center of the rack and marble slab, within the fall shadow of the slab, he was having trouble releasing the slab lifter from the slab. The forklift operator tried raising the boom a couple more times, but as the boom raised the slab lifter was still getting caught on the top of the rack, causing the slab lifter to push out towards the victim. This pushing motion of the slab lifter caused the slab to also be pushed out towards the victim. At this point, the marble slab tilted and became free from the slab lifter and tipped uncontrollably towards the victim. The slab pushed the victim into another stone slab on a rack behind him. The victim was standing and was crushed/caught between two large stone slabs. At this point, the company owner and the forklift operator realized what happened and, with another co-worker, pushed the marble slab off the victim and back onto the A-frame rack. A call was immediately placed for emergency medical services (EMS). EMS arrived within minutes to the incident location and the victim was transported to a local hospital where he was pronounced dead later that same day.

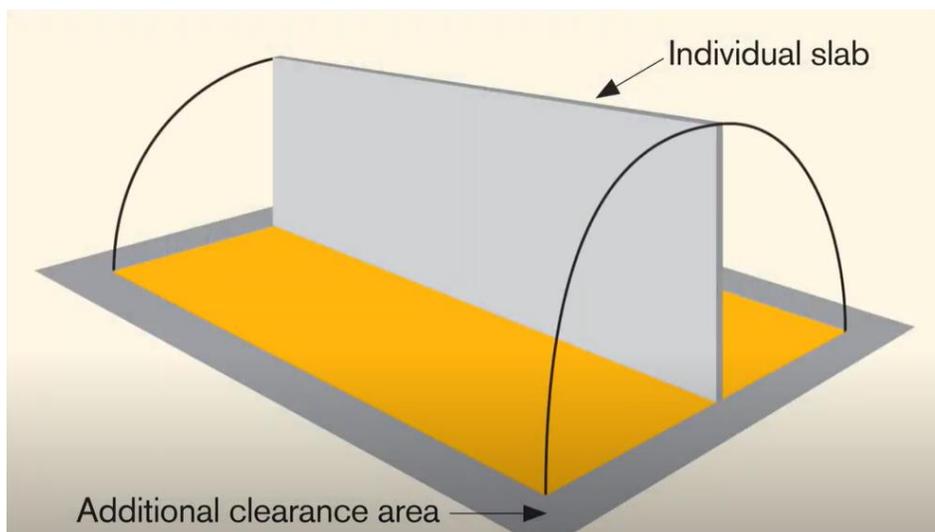
Discussion: The fall shadow of a stone slab is the potential path the slab will take as it tips and falls uncontrollably.³ The fall shadow is located on both sides (Figure 5). The fall shadow will become larger when the slab is lifted. The higher the slab is lifted, the larger the fall shadow becomes. Ensuring employees are always positioned outside of the fall shadow will help prevent employees from being crushed or struck-by an uncontrolled stone slab.

Figure 5 – Example of the fall shadow. The yellow area is where the slab would land if it tipped over.

Recommendation #2: Employers should ensure that employees are never located in the fall shadow of a stone slab while the slab is being accessed to be moved.

To ensure employees are positioned outside of the fall shadow, employers must make sure employees are standing at the ends of the slab and not at the center of the slab, or anywhere along the flat sides of the slab. Employees should keep, at a minimum, an arms-length away from the ends of the slab.
