REPORT#: 19NY038

REPORT DATE: 8/10/22

Mechanic Service Technician Fatally Struck by Order Picker Carriage — New York

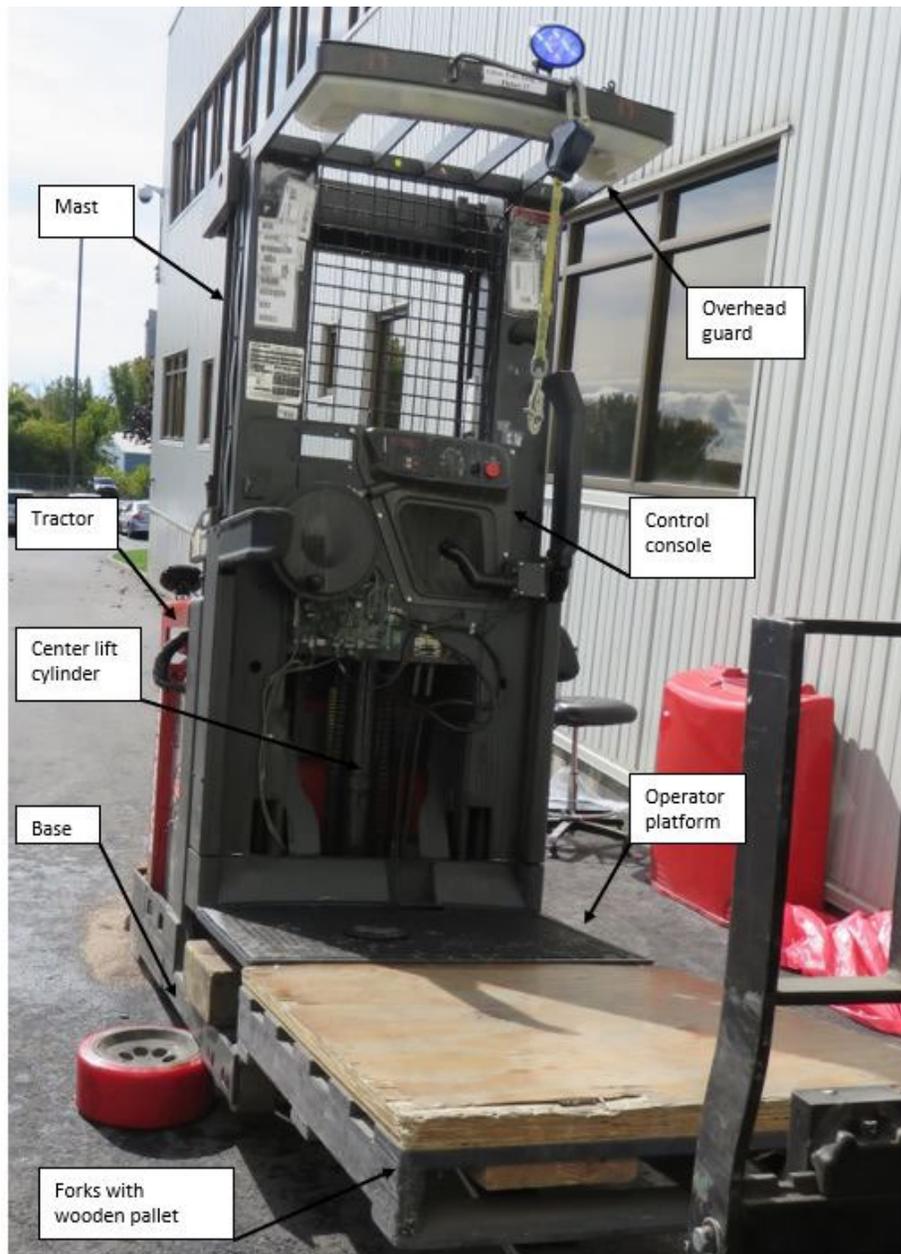
The chassis is the basic frame of the order picker: It is composed of the tractor, base, and mast (Photo 1). The carriage, which consists of the overhead guard, the control console, the operator's platform, and the forks, can move up and down on the mast. The carriage movement is actuated by a center lift hydraulic cylinder and a pair of side lift cylinders along with a set of chains and pulleys. The hydraulic pressure of the center lift cylinder was approximately 2,000 lbs. per square inch (psi), and the system hydraulic pressure is 6,000 psi.

Photo 1. The order picker that was involved in the incident with the console cover removed (Photo courtesy of OSHA).

The order picker had a wooden pallet attached to the forks. According to OSHA, the total weight of the carriage including the wooden pallet was approximately 1,163 lbs. When elevated, the carriage is held solely by hydraulic pressure: The order picker does not have built-in locking mechanism to prevent the platform from free falling in case of a hydraulic system failure. The manufacturer warned that no one should be allowed to stand or pass under load or the lifting mechanism.

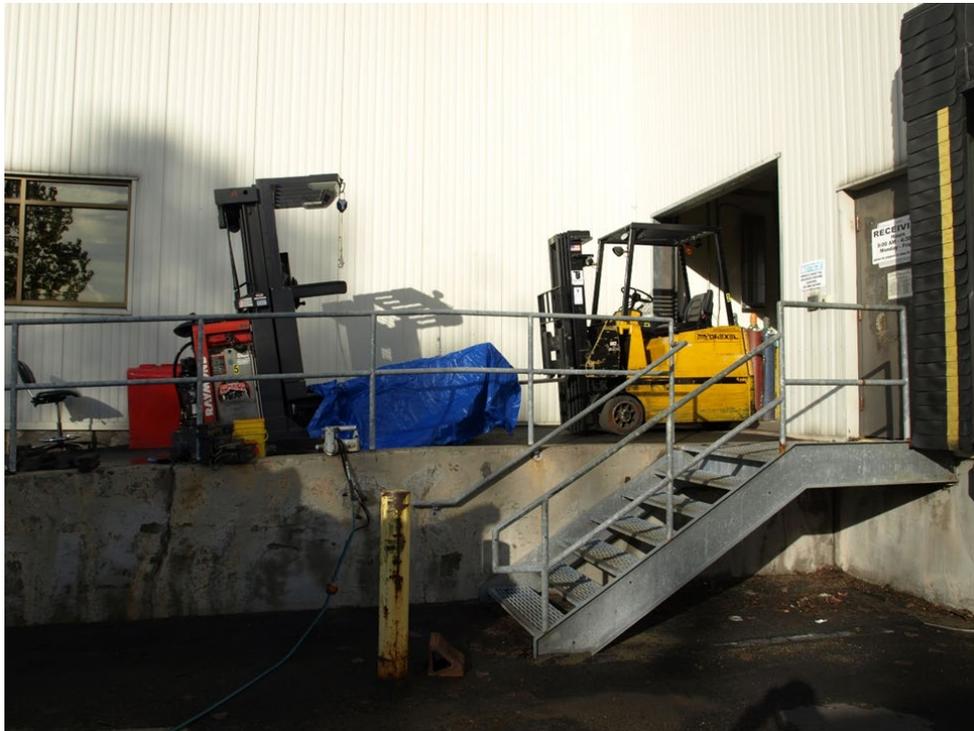
Photo 2. Post incident scene: The order picker was parked on the inclined ramp outside the loading dock during the incident. The forklift on the right was used in the rescue to lift the platform off the victim (Photo courtesy of city police department).
