REPORT#: 20NY030

REPORT DATE: 6/01/22

Town highway department mechanic crushed when truck fell off jack stand —New York

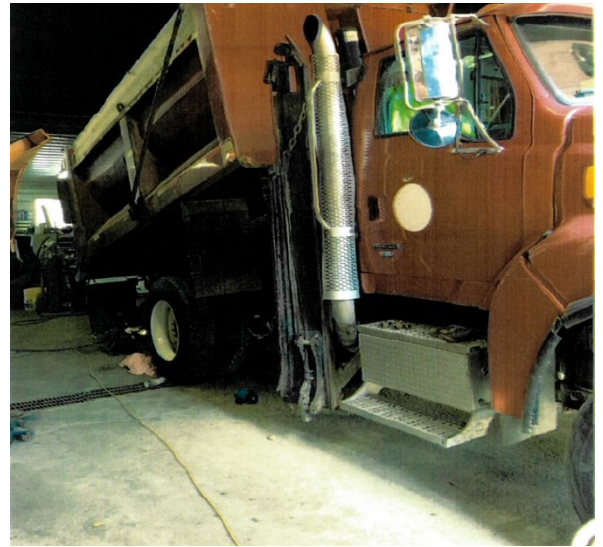
Photo 1: Truck involved in incident with right rear wheel missing (photo courtesy of PESH).

On October 21, 2020, a mechanic for a town highway department was fatally injured around 8:30 AM while he was in the process of changing air brakes on a truck in the town highway department garage (Photo 1). The New York State Fatality Assessment and Control Evaluation (NY FACE) staff learned of the incident from news media reports and contacted the employer to initiate an investigation. Additionally, NY FACE contacted the Public Employee Safety and Health Bureau (PESH) in the New York State Department of Labor (NYS DOL) to request information regarding the investigation. PESH is the regulatory body for NYS public employee safety, and initially investigated the case after the incident. NY FACE staff discussed the case with PESH to gather specific details of the incident.

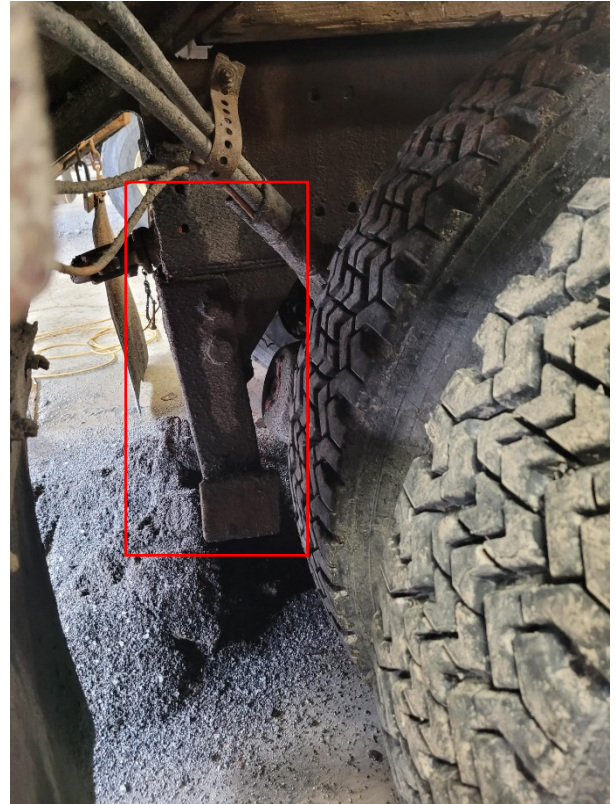
Photo 2: Chipper bar behind right rear tires of truck

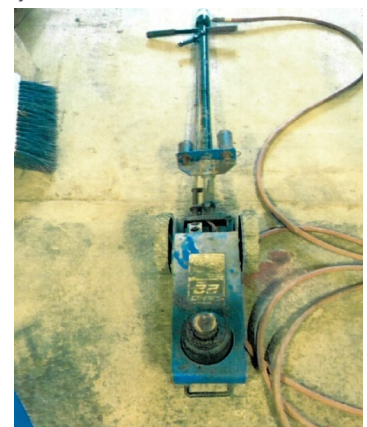
Photo 4: 22-ton pneumatic jack typically used to support truck during air brake maintenance (photo courtesy of PESH)
