FATALITY INVESTIGATION REPORT

REPORT #: 52-48-2021

Operator Falls from Boom Lift while Tree Trimming

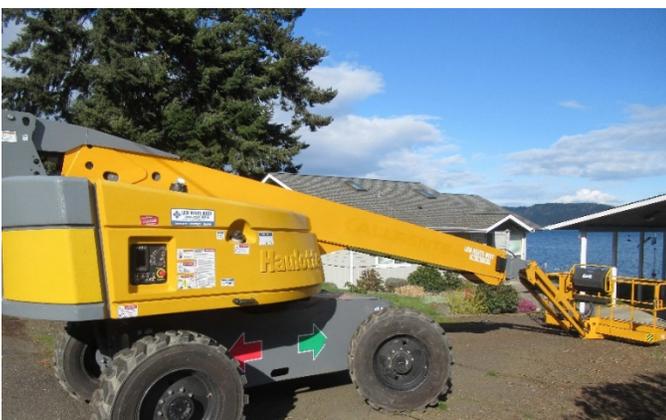
Photo 1: Incident scene driveway of residence with boom lift that workers were using to limb trees.

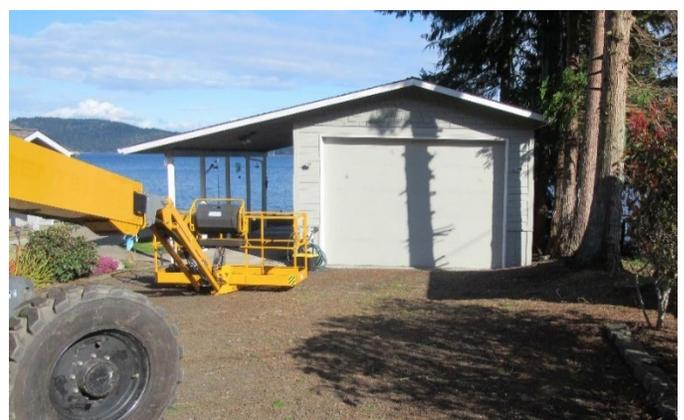
Photo 2: Incident scene driveway and garage of residence. Workers were in the boom lift basket limbing trees on the right side of the garage.

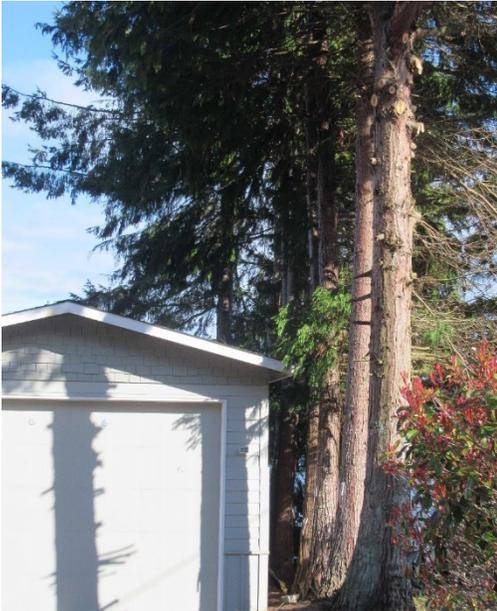
On the morning of the incident, the three-person crew arrived at the worksite at approximately 8:30 a.m. The worksite was a residential home (see photos 1 and 2). The trees next to the homeowner's garage needed to be taken down because they were damaging the foundation of the garage (see photo 3).

Photo 3: Incident scene garage of residence that hired the employer to remove the trees. Workers were in the process of limbing the tree on the right side of the garage in preparation to remove the tree when the operator fell from the basket.

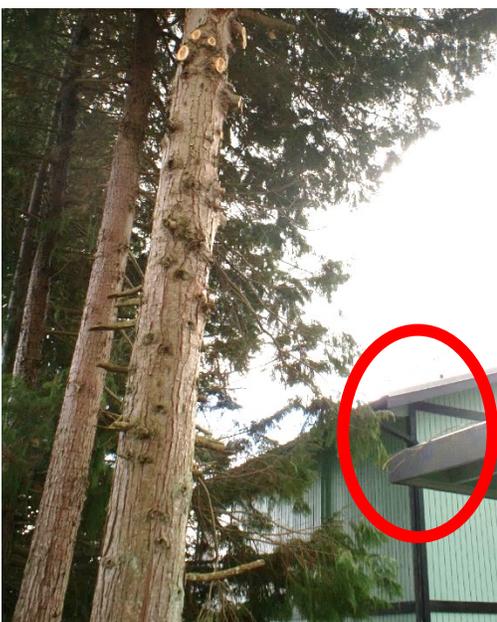
Photo 4: Tree that workers were in the process of limbing. The building on the right side of the tree is the adjacent residence. The roof of a small shed can be seen in the foreground (circled). The limb scars indicate that some of the limbs were several inches in diameter. Note the amount of space between the tree and the structures that would have allowed the crew to rig and lower cut branches to the ground.

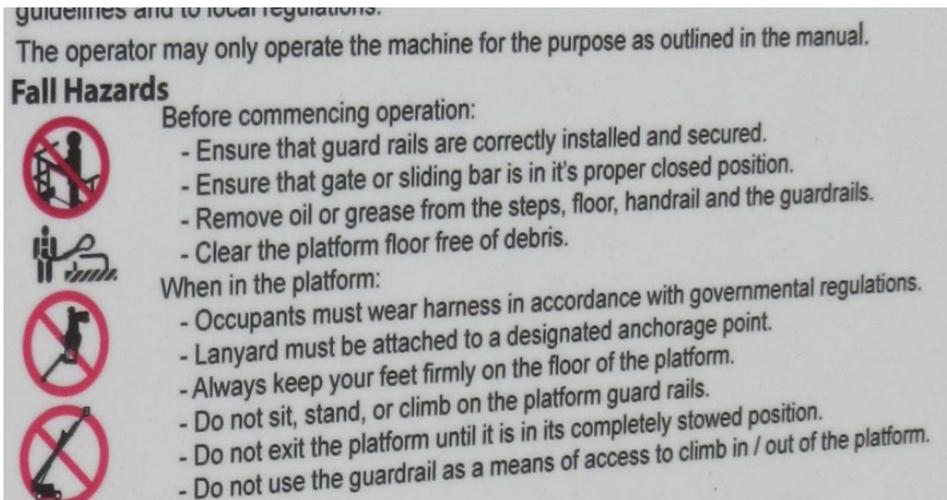
Photo 5: Photo of “Fall Hazards” section of the warning sign affixed next to the control panel in the boom lift basket. The sign explicitly states that when in the platform, occupants must wear a harness and its lanyard must be attached to a designated anchor point.

There is an explicit WAC¹⁰ and OSHA standard¹¹ that requires fall protection for workers in boom lift baskets. The requirement is not specific to the tree-care industry but applies to all workers on boom-supported elevating work platforms. It states that employers must make sure workers wear a full body harness and lanyard fixed to manufacturer provided and approved anchorage points.

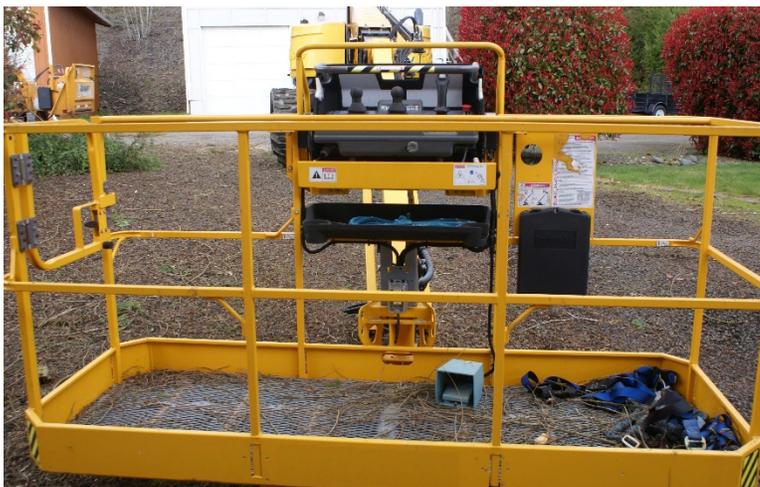
Shortly after arriving on site, the operator and his coworker entered the basket (see photo 6). The operator controlled the boom lift from the basket and elevated it to approximately 20 feet above the ground where they could reach the lower limbs of the tree. The bottom of the basket was approximately 12 feet above the roof of the shed. They decided they needed to pull the cut branches into the basket to keep them from falling and damaging the roof of the garage and the shed. The company owner remained on the ground to operate the chipper.

Photo 6: View of front of boom lift basket. The basket had a capacity rating for two workers or a maximum of 500 lbs.

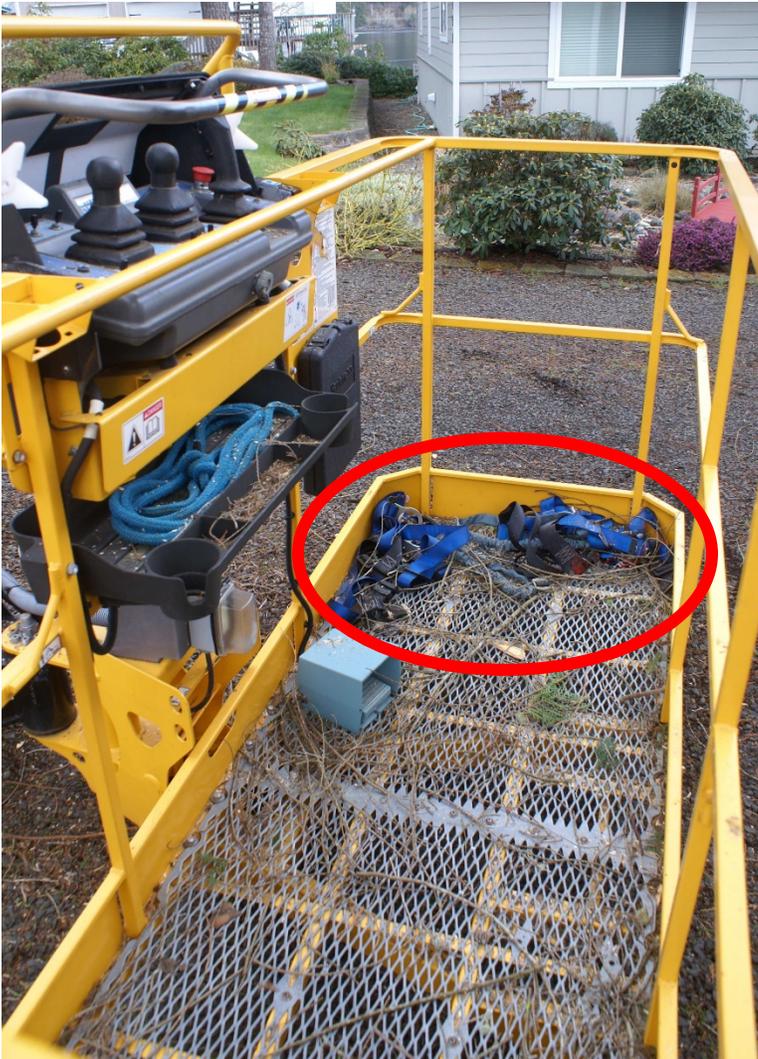
They were wearing hard hats, safety glasses, and safety boots so there was an awareness of and attention to safety hazards. It is unknown if they were using any other safety equipment at the time of the incident. They were not wearing their fall protection harnesses even though they were in the basket (see photo 7).

Photo 7: The two rented fall protection harnesses in the boom lift basket (circled). Also pictured are the control panel and the foot pedal that was required to be depressed in order to operate the basket.

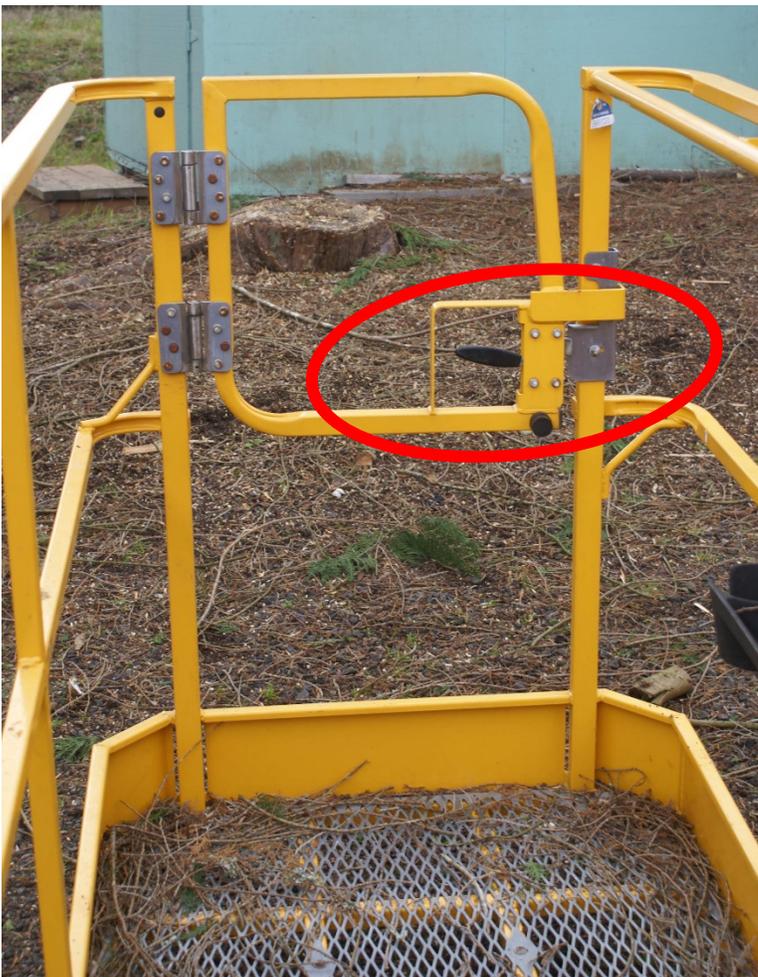
The coworker was cutting branches with his chainsaw while the operator was pulling the branches into the basket. They were doing this for approximately an hour. The operator opened the side access gate of the basket (see photo 8) in an attempt to get some branches into the basket. The coworker said he was reaching down to pick up his chainsaw when he saw the operator fall from the basket onto the roof of the shed 12 feet below (see photo 9). It is unknown if the operator was leaning outside of the basket and lost his balance while trying to maneuver limbs into the basket or tripped over branches in the basket or the toe board.

Photo 8: View of side access gate of boom lift basket. The gate had a mechanical latch (circled) and swung into the basket when opened. Note that the toe board is in place.

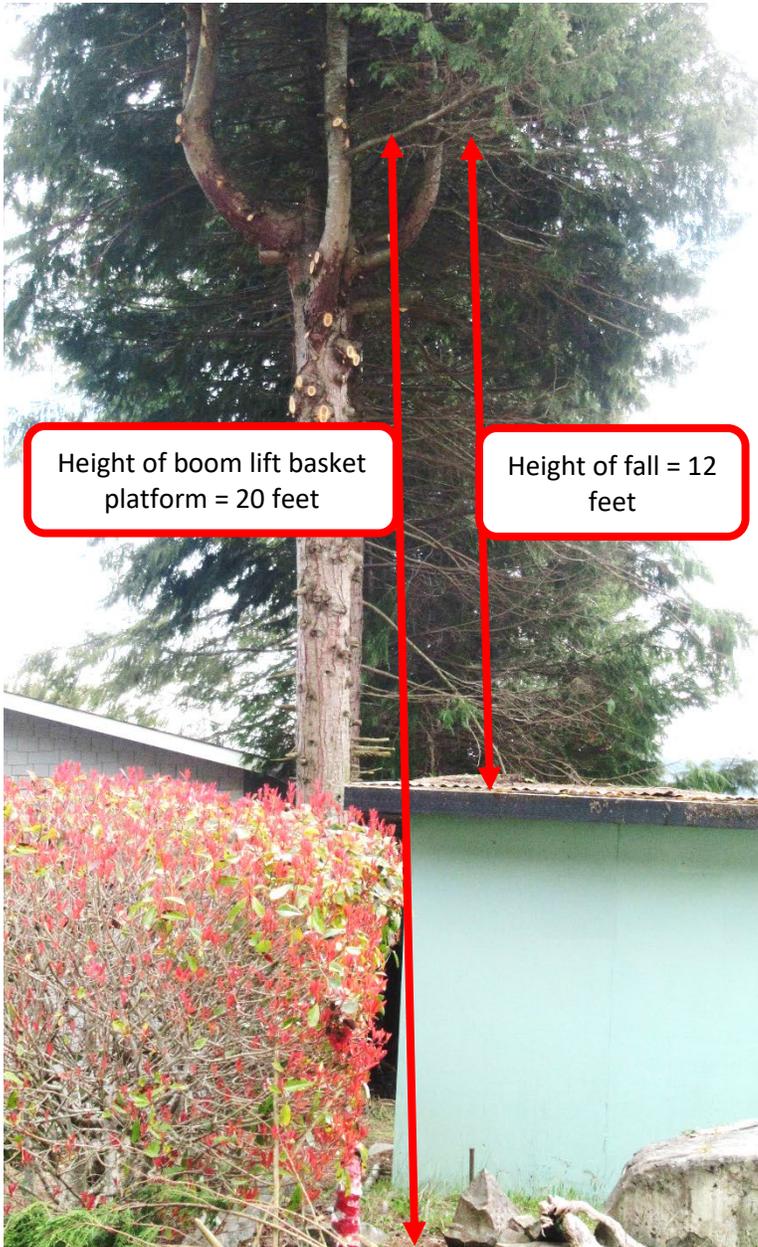
Photo 9: Incident scene tree that workers were limbing and shed that operator fell onto. Red arrows show approximate location and height of boom lift basket and operator's operator fall.

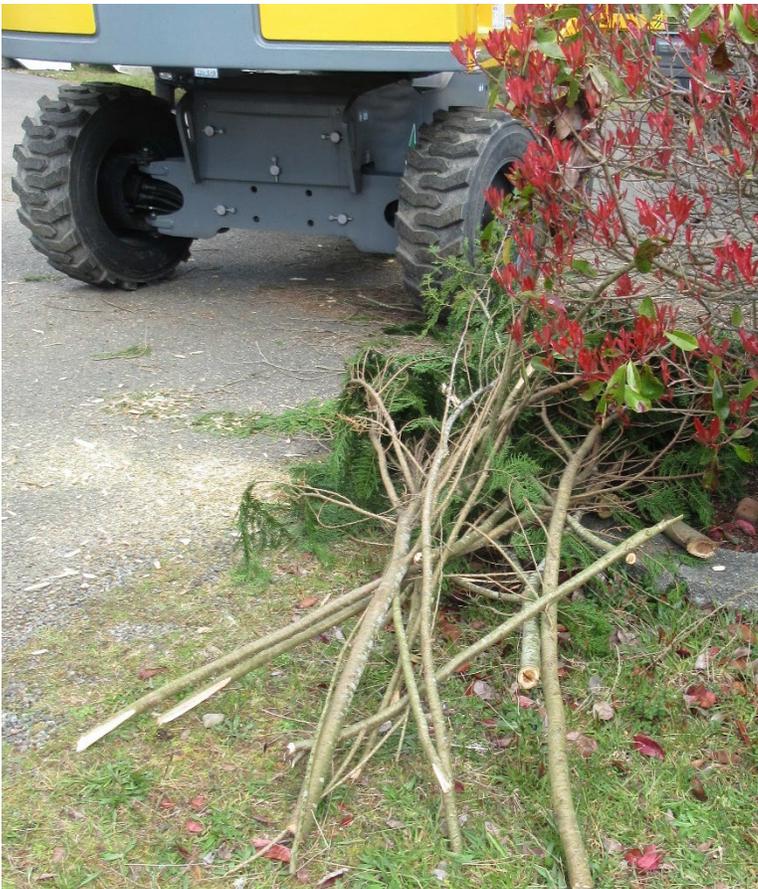
The remains of the cut limbs on the tree indicate that some of the limbs they had cut may have been several inches in diameter. This may have made the limbs difficult to bring into the basket. Some of the smaller limbs can be seen in photo 10. There is no evidence that the boom lift basket moved or shifted prior to the operator falling.

Photo 10: Some of the smaller limbs that the workers collected into the boom lift basket.

In addition, employers should train workers to limit the amount of items brought into the basket and to keep the basket clear of trip hazards. By gathering cut branches into the basket, the workers may have created cramped conditions or trip hazards. ANSI Z133-2017 specifically states that aerial devices shall not be used as cranes or hoists to lift, support, or lower tree parts unless where designed by the manufacturer to do so.
