**REPORT#:** 22CA001

**REPORT DATE:** March 24, 2023

## Forklift Operator Dies After Falling Into a Recycling Baler — California

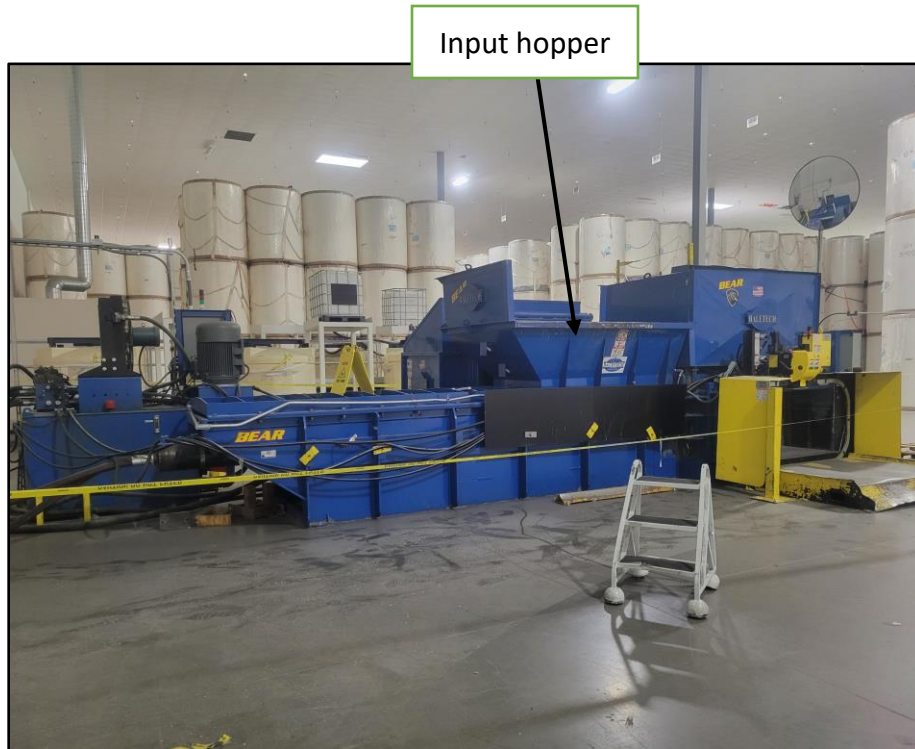
The equipment involved in this incident was a horizontal type, closed door, two-ram industrial recycling baler. This particular machine was purchased as a prototype under development from the manufacturer. It was an automatic baler that did not require an operator for compacting and baling material. After the forklift dumps bulk material into the baler input hopper (Exhibit 1), a photo-eye sensor automatically triggers the compression ram when the baler input area is full. The hydraulic ram engages to compress the material until the 'bale full' light is illuminated, and the bale is tied off and ejected. The material is then automatically bound using wire, and a single ram pushes the finished bale out of the machine (Exhibit 2 & 3).

**Exhibit 1. The recycling baler with input hopper. Photo by CA/FACE program.**

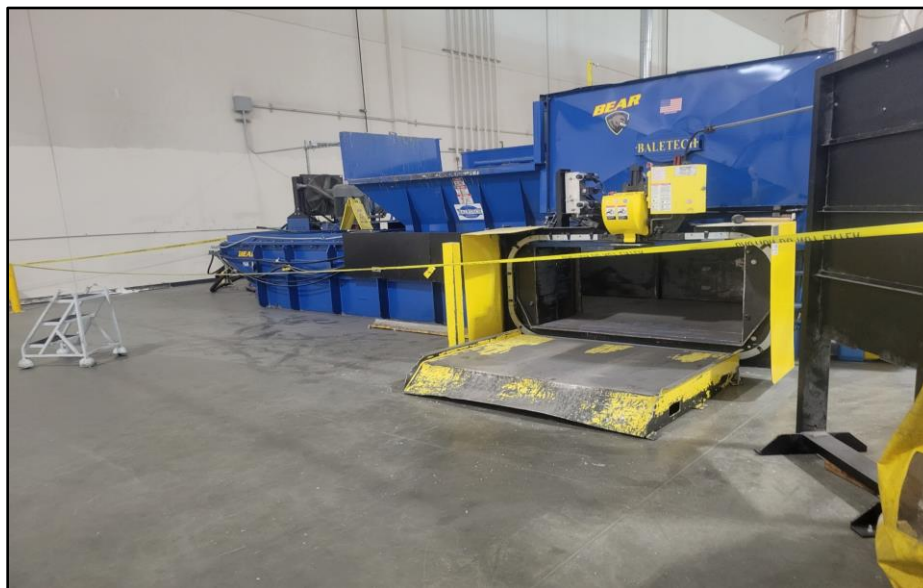
**Exhibit 2. The location where the finished bale is expelled.  
Photo by CA/FACE program.**

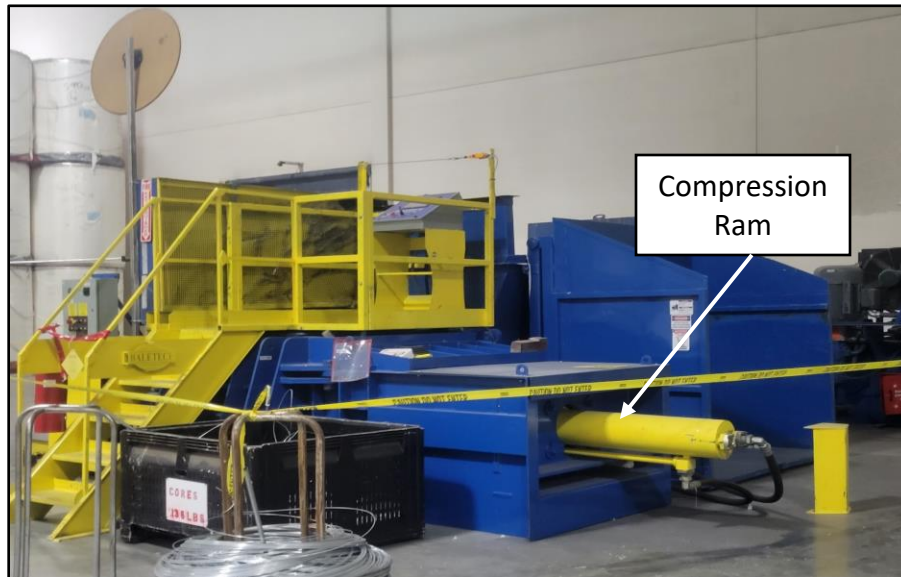
**Exhibit 3. The single hydraulic compression ram that pushes the finished bale out of the machine. Photo by CA/FACE program.**

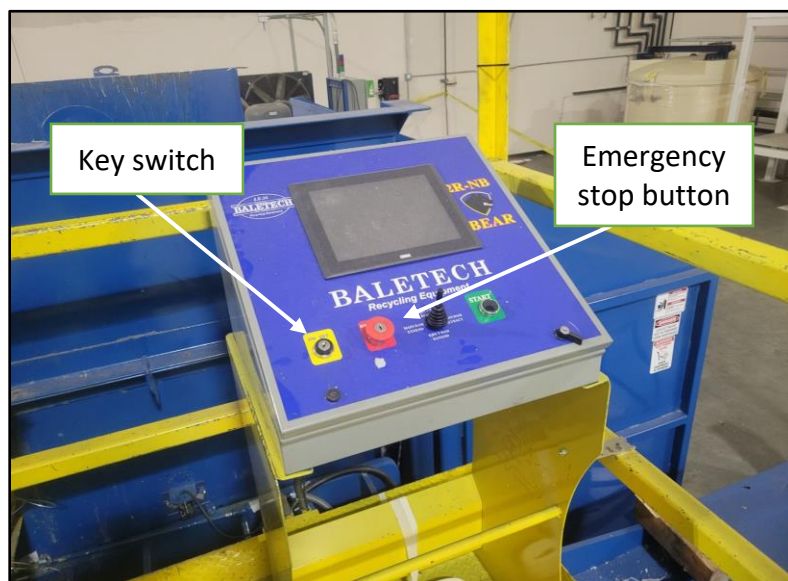
When material becomes jammed in the baler input, either in the compression or output areas, the operator should turn the key switch on the control panel to the off position and push the emergency stop button (Exhibit 4). The operator should then notify the supervisor using the company issued radio which is carried by all operators. A lockout/tagout procedure is then implemented prior to entering the baler areas.

**Exhibit 4. The recycling baler control panel with emergency stop button. Photo by CA/FACE program.**

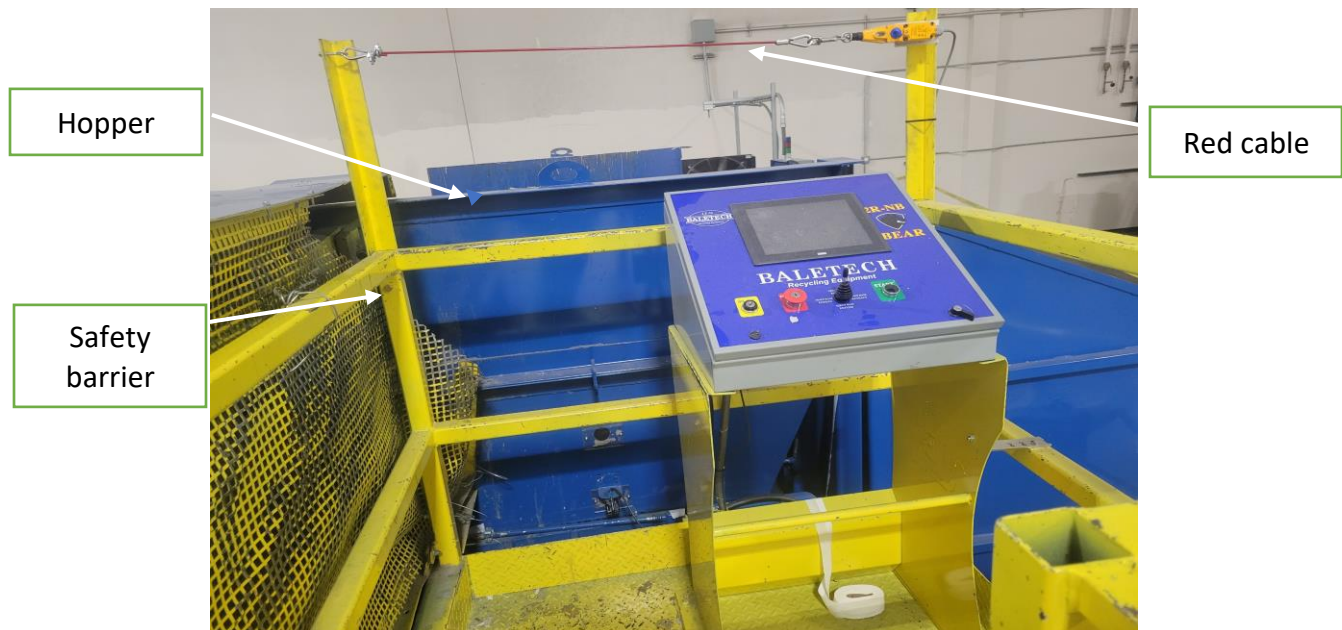
Discussion: In this incident, the victim was able to gain access to moving parts of the recycling baler while it was in operation. The design of the bale hopper had physical barriers (yellow), but they did not prevent access to moving parts (Exhibit 6). Collaboration between employers and machine manufacturers may result in additional safety devices that could be added to the machine to ensure worker safety when working in close proximity to moving parts.

**Exhibit 6. The yellow barrier around the control panel to prevent access to the hopper. The red cable was added after the incident occurred. Photo by CA/FACE program.**

***Recommendation #2: Design and install safety features to keep workers away from moving parts.***
