**REPORT#:** 23KY00901

## Project Manager Dies after Falling through Skylight

### SUMMARY

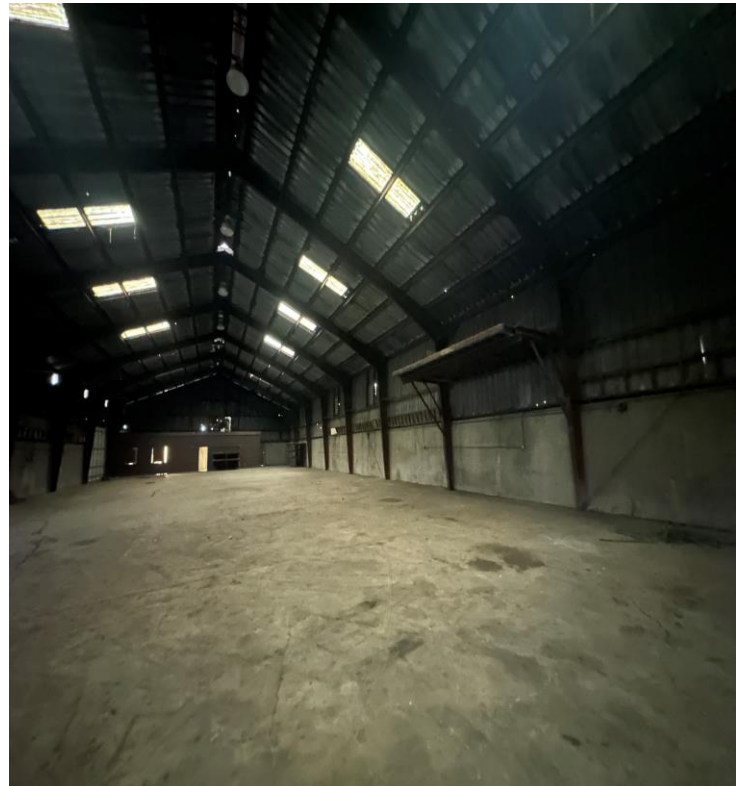
Photo 2. Photo showing interior and surface of the building where the incident occurred.

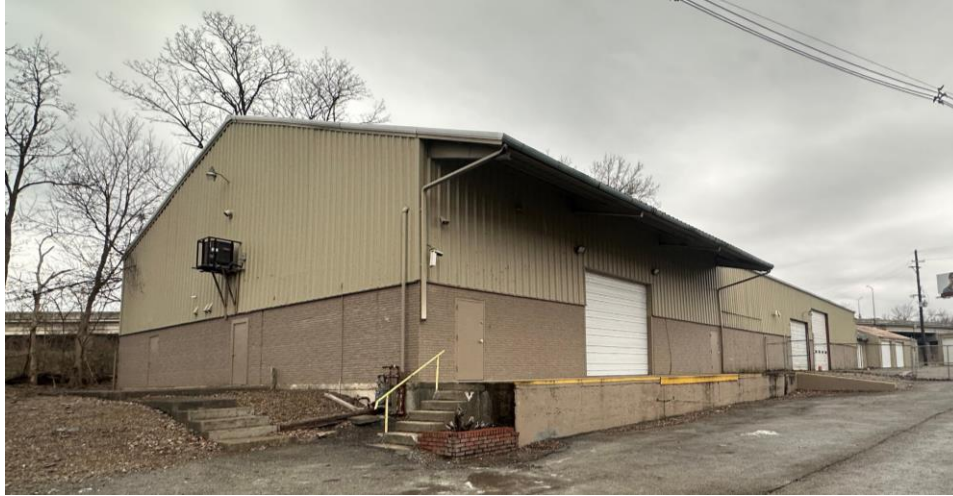
Photo 3. Exterior photo of the building where the incident occurred.

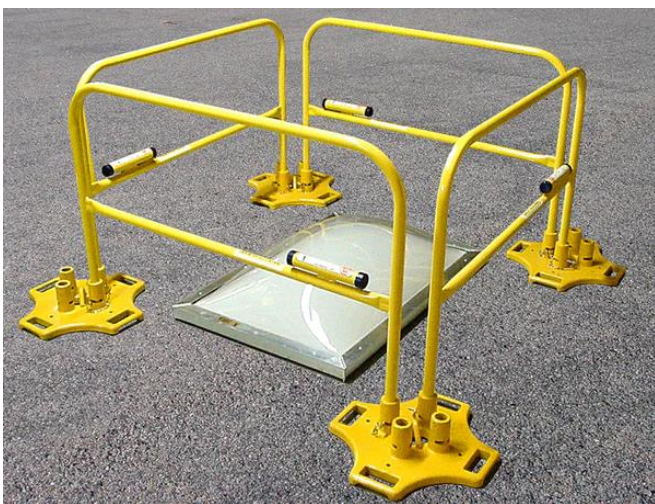
Photo 6. Photo depicting a skylight rail guarding system.<sup>5</sup>

***Recommendation #2: Employers should guard skylights with railings or a skylight screen.***

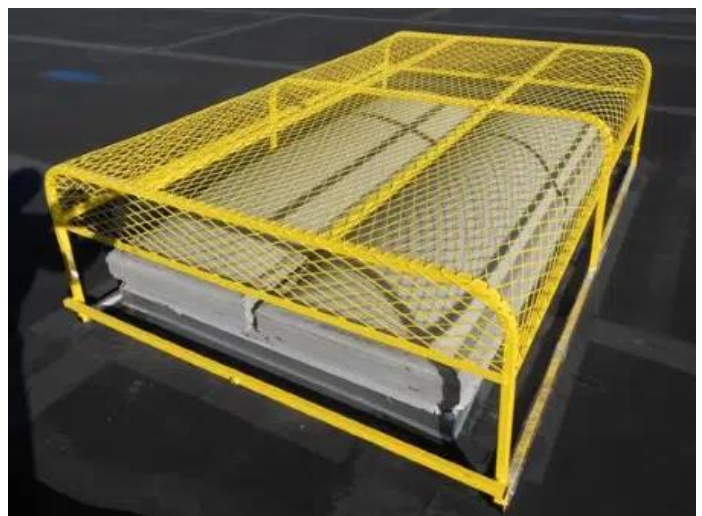
Photo 7. Photo depicting a skylight screen.<sup>6</sup>
