Hispanic Lumberyard Worker Dies When Struck By a Forklift – North Carolina

SUMMARY

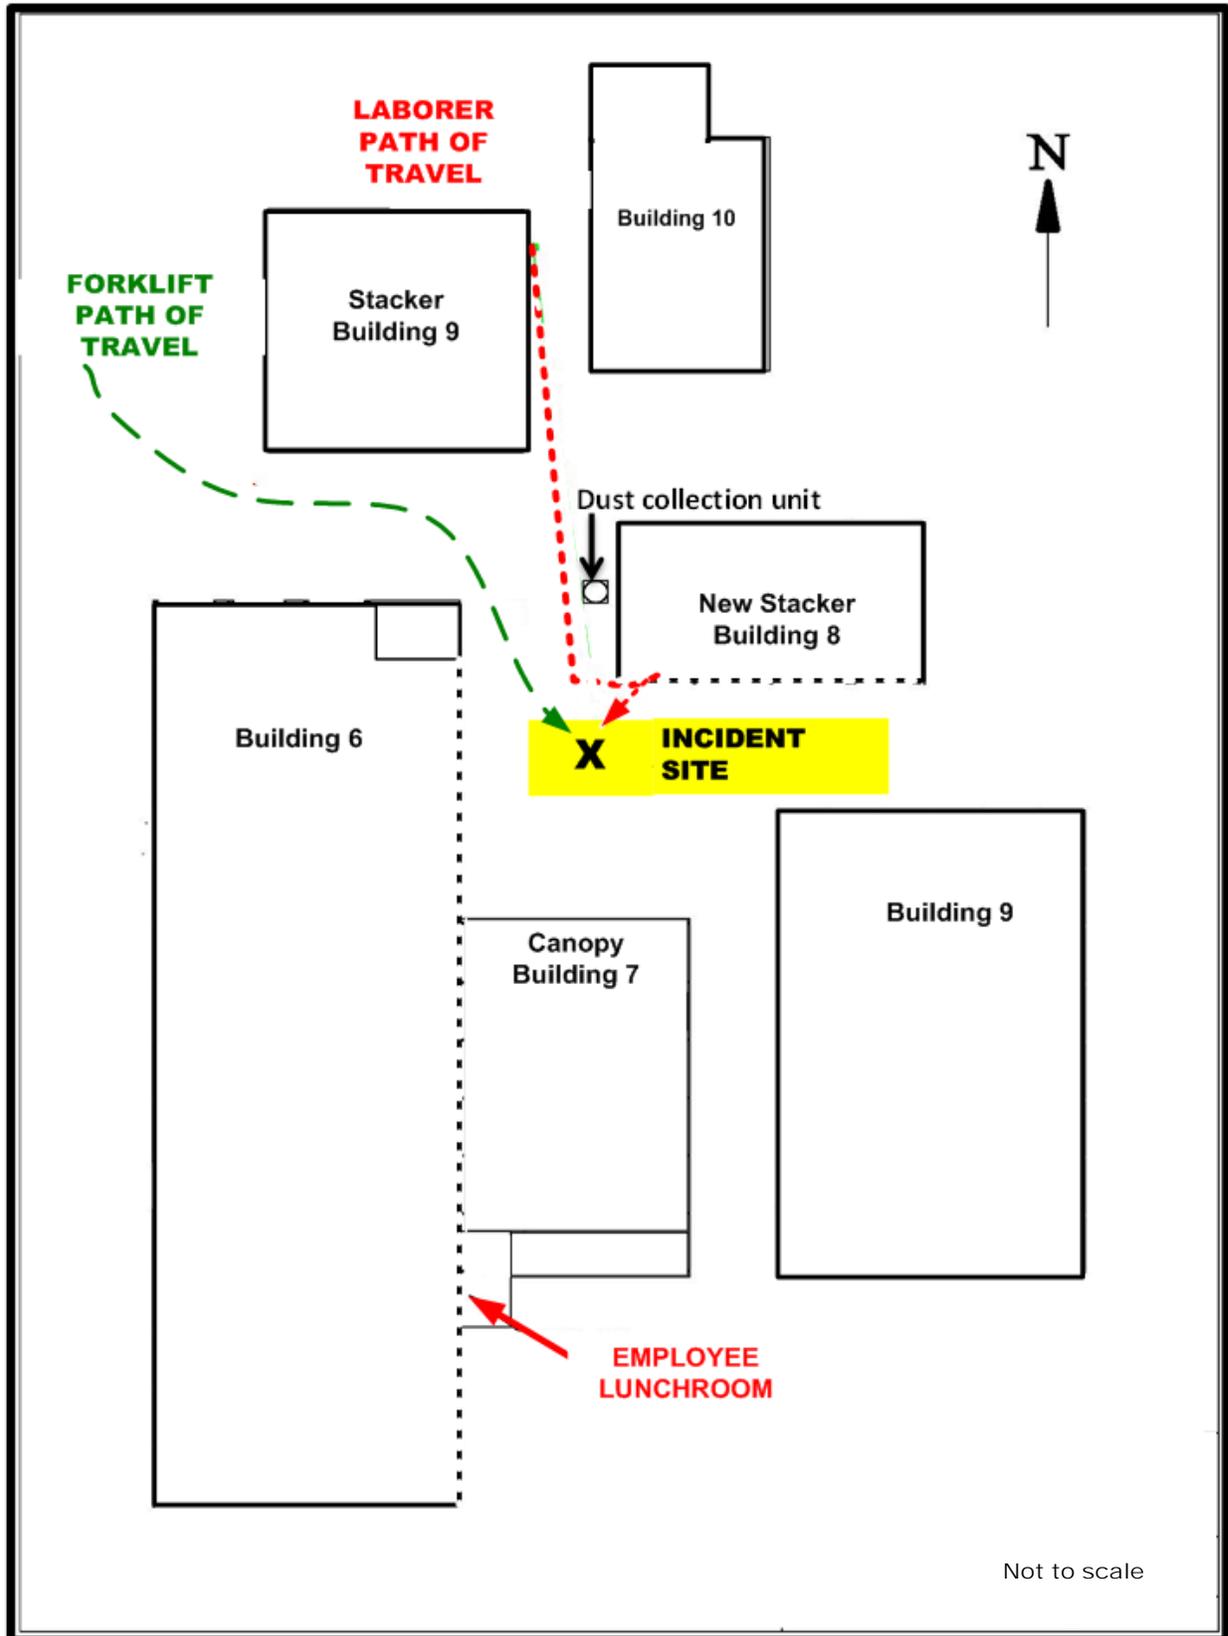
Diagram. Aerial depiction of forklift and Laborer's travel path.

The incident occurred in an open area between buildings that was approximately 35 feet across with a concrete surface (Diagram). There was an area of concrete deterioration toward the west side of the forklift travel lane. The lumberyard laborer was walking from B9 to B8, a distance of between 600 to 900 feet. He had about 200 feet to go to reach his destination, the lunchroom.

On March 30, 2012, at approximately 7:00 a.m. the lumberyard laborer began his workday at the lumberyard where he was employed through a staffing agency as a temporary lumberyard laborer. He had been assigned to two separate work areas that morning, first to B8 and later to B9 (Diagram). His duties were to place spacers between stacks of lumber to facilitate the drying process. At approximately 11:45 a.m., he stopped work to eat lunch. The employer had provided a lunch/break area for workers located in B7. It is believed that the laborer's path of travel to get to the lunch area would have taken him from B9 to B8 and then to B7 (Diagram).

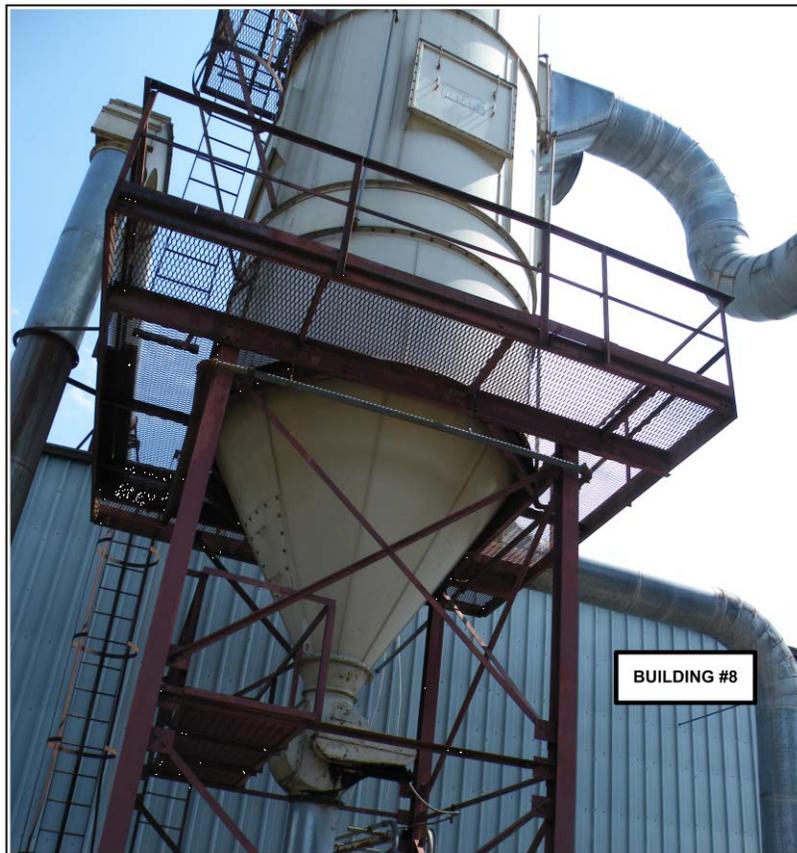
A dust collection unit was located approximately 15 feet from where the laborer was struck (Photo 1). The unit was activated only when needed and was in operation when the incident occurred. According to NCDOL/OSH, the noise level readings taken while the system was operating registered between 85.1 and 86.9 decibels adjusted (dBA). These levels are in compliance with Occupational Safety and Health Administration (OSHA) regulations; however depending on proximity to the dust collection unit, the noise may have been loud enough to interfere with a pedestrian's ability to hear an approaching forklift. Forklifts have an average decibel level of 89.4dBA¹.

Photo 1. Dust collection unit. (Photo courtesy of NCDOL/OSH)

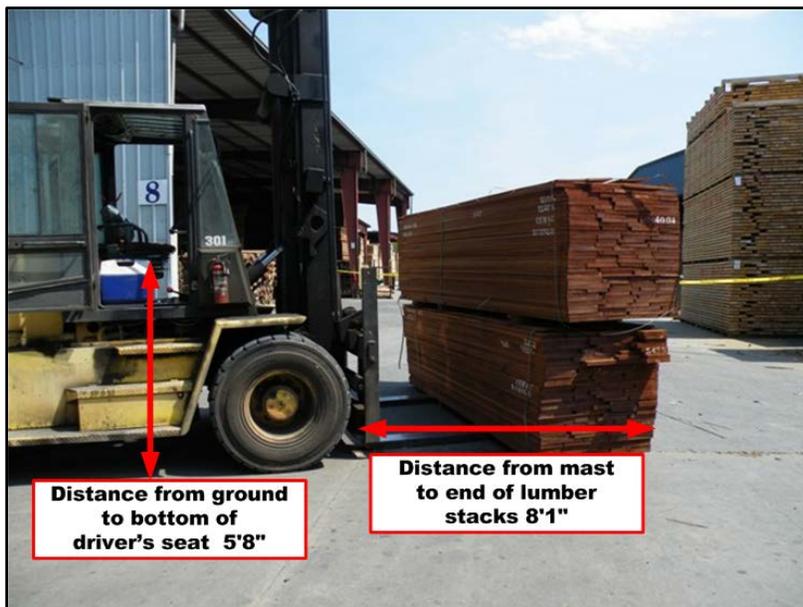
The laborer was struck by a 33,000 pound capacity forklift which was manufactured in 1990 with one forward-facing driver's seat. The cab was enclosed with glass doors on each side of the driver's seat and equipped with an operational horn, back-up alarm, and flashing light affixed to the top rear of the cab enclosure. The distance from the ground to the bottom of the driver's seat was 5 feet 8 inches and the distance from the mast to the end of the stacks of wood measured 8 feet 1 inch (Photo 2).

At the time of the incident, the forklift was traveling forward at an estimated speed of one mile per hour (MPH). It was transporting two stacks of lumber measuring 7 feet, 2 inches high, 4 feet, 1 inch wide, and 12 feet 2 inches long. The forks were raised six inches off the ground, which would place the top of the load at 7 feet 8 inches (Photo 3). All powered industrial trucks at the facility receive a bi-monthly preventative maintenance inspection. The forklift involved in this incident had been last inspected on February 9, 2012.

Photo 2. Photo showing a side view of the forklift and load of lumber.
(Photo courtesy of NCDOL)

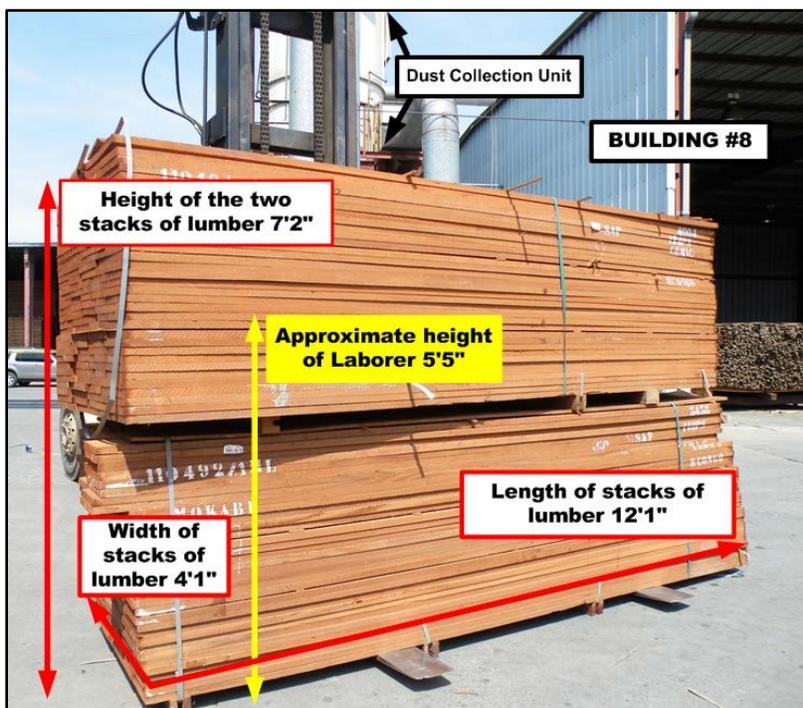
Photo 3. Area where incident occurred and pertinent measurements.
(Photo courtesy of NCDOL/OSH)

Near the area where the laborer was struck, the concrete road surface had begun to deteriorate along the west side of the forklift travel lane. It was common for operators to steer to the left to avoid the uneven road surface when they were transporting lumber from B9 to B8, which was the forklift operator's intended path of travel. This maneuver would have placed the forklift close to the dust collection unit. Therefore, the routes that the laborer and the forklift operator took would have placed both of them in proximity to the dust collection unit at the same time (Diagram). It is possible that the forklift operator could not see the laborer due the height of the load of lumber (Photo 4.) The laborer may not have seen the forklift because he was facing the opposite direction heading to B7, and may not have heard it due to the noise from the dust collection system.

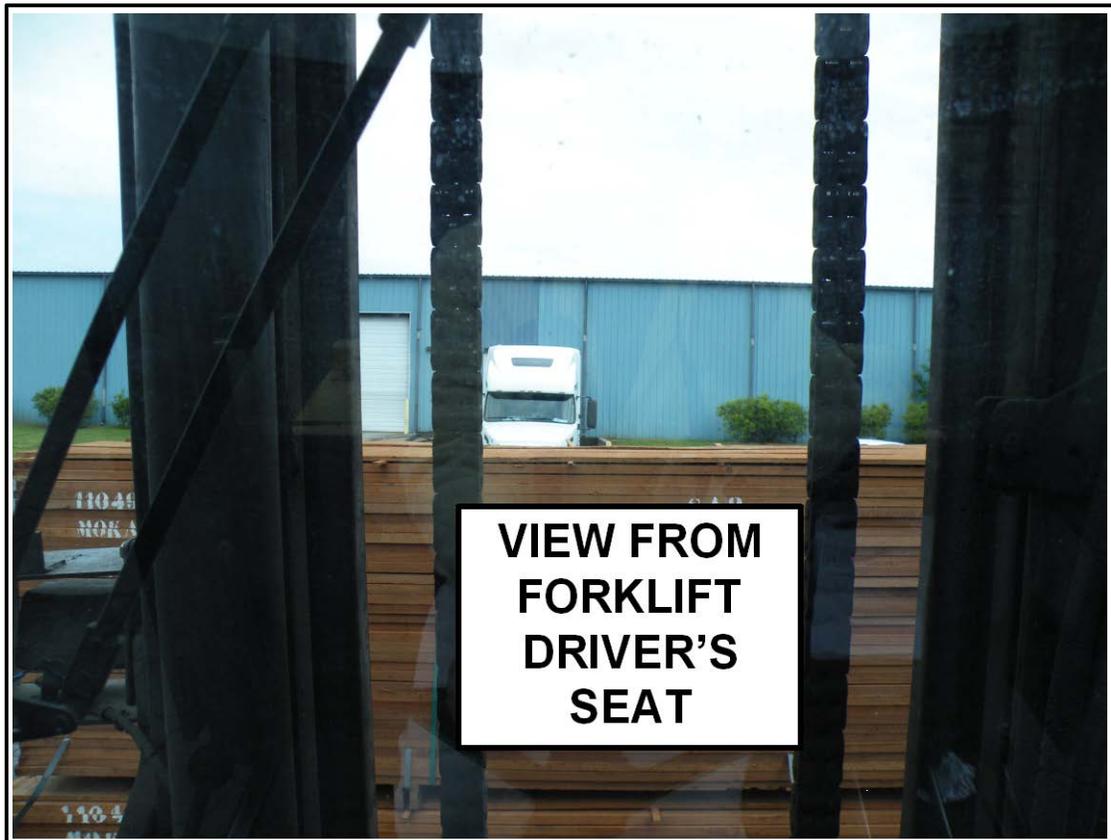
Photo 4. Photo taken from the forklift driver's seat showing obstructed forward facing view. *(Photo courtesy of NCDOL/OSH)*

Recommendation #1: Employers should develop, train on, implement, and enforce safe forklift operating procedures.

The employer in this incident had conducted forklift training in accordance with OSHA guidelines and timeframes and it was against company policy to operate a forklift with the view obstructed; company policy was to travel in reverse with the load trailing. The operator also deviated from the regular path to avoid the deteriorating concrete. Following the incident, the concrete was repaired, all workers were retrained and reminded of the company's progressive discipline policy which includes termination of employment for violations of safety policies, and supervisory personnel were charged with strict enforcement of all safety rules.
