## ***Hispanic worker falls from residential roof – North Carolina***

### **SUMMARY**

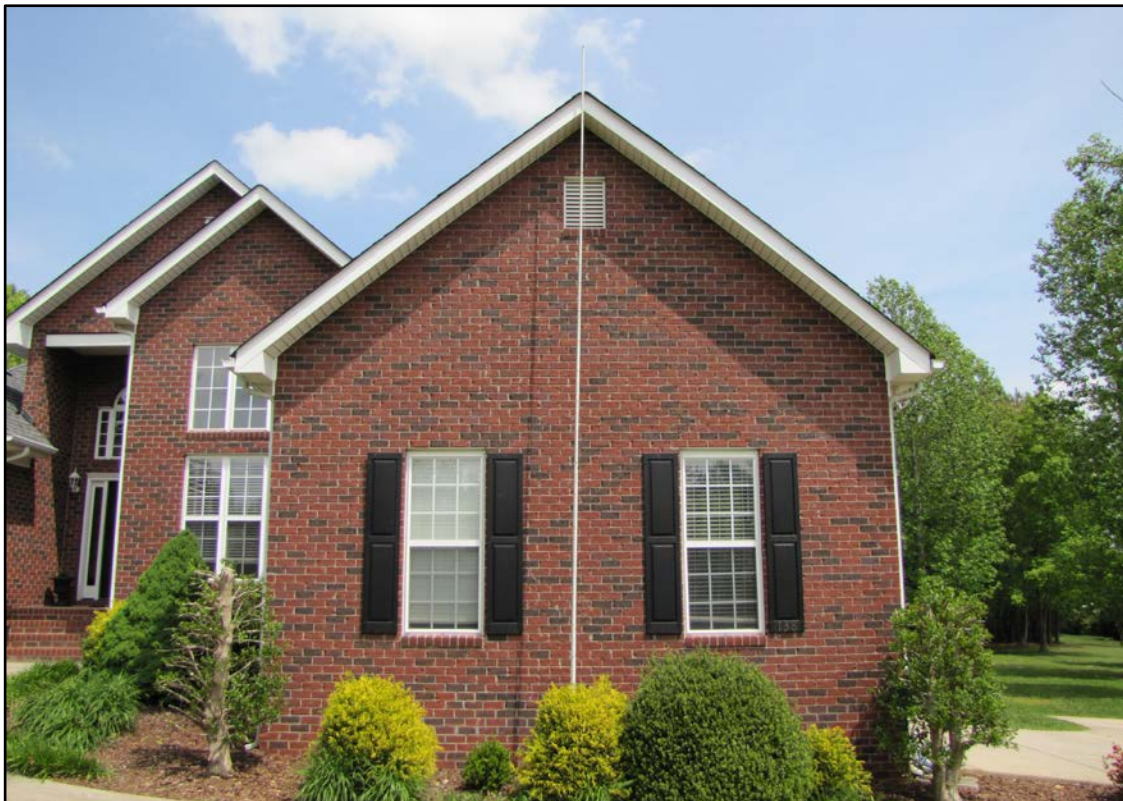
**Photo 1. Roof pitch of the garage was determined to be 10/12**  
*(Photo courtesy of NCDOL/OSH)*

He was working alone on the garage roof at the time of the incident. The garage roof had a 10/12 pitch roof with a height of 23.1 feet at the peak and 13.5 feet at the eave (Photos 1 & 2). The other employees were working on other portions of the roof and on the ground. It is believed the laborer lost his footing then slipped and slid down the roof, falling more than 13.5 feet to the

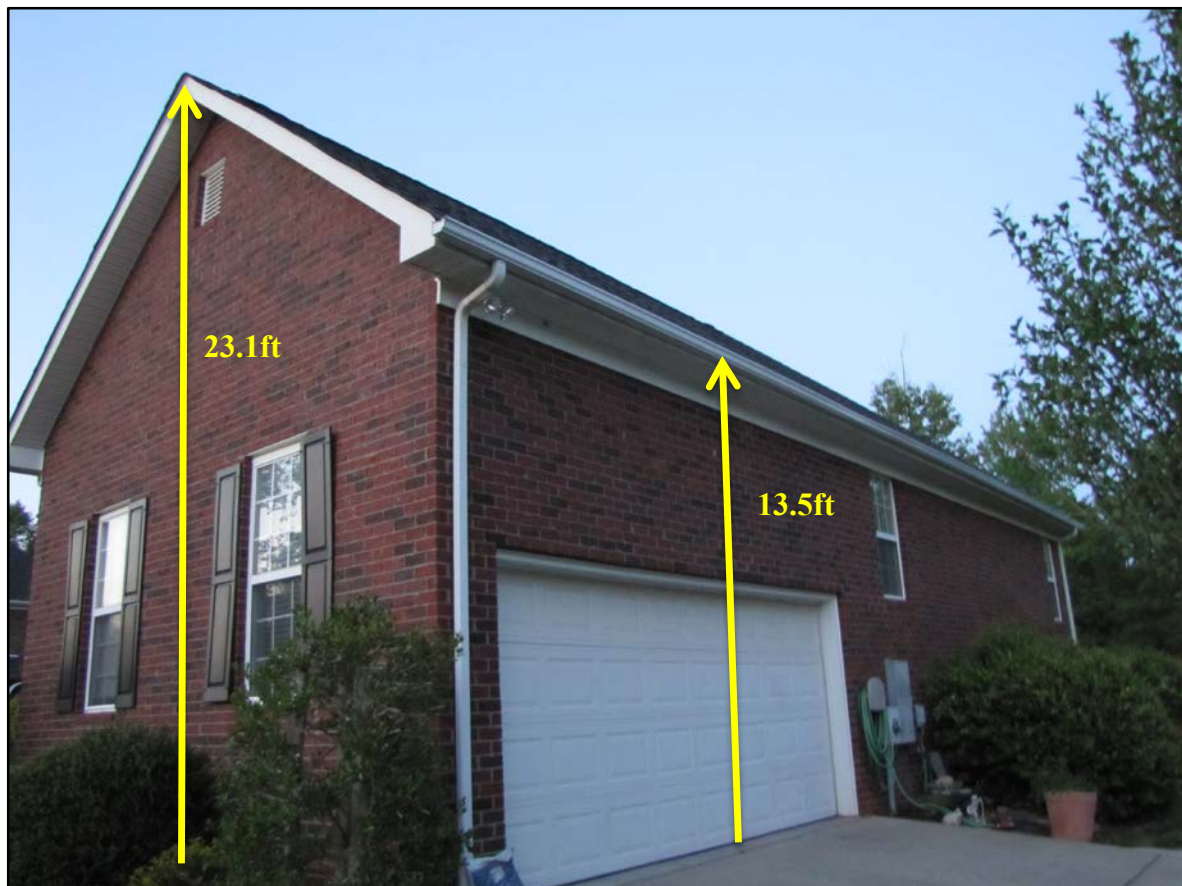
**Photo 2. Garage where laborer was working (Photo courtesy of NCDOL/OSH)**

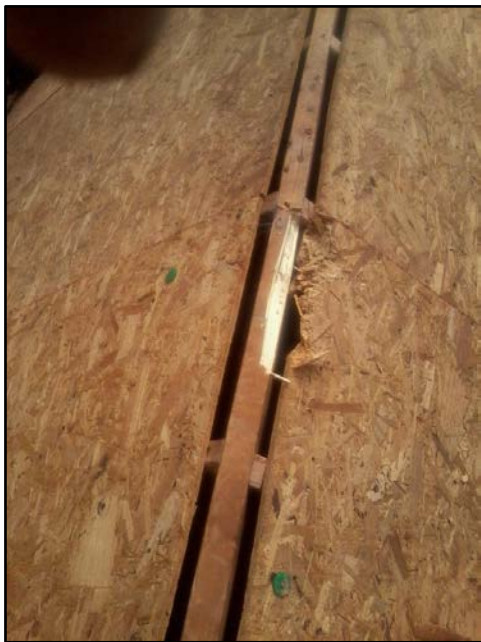
Based on photos retrieved from the scene, the anchor for the laborer's PFAS had pulled from the peak (Photo 3). Further investigation of the anchor suggests that it had been installed laterally along the ridge of the roof with two or three nails of unknown size. The lifeline was found coiled near the laborer's hand. The rope grab was attached to the right leg webbing of his harness rather than the D-ring anchor, and the energy-absorbing lanyard was attached to the roof anchor. The harness, lanyard, rope grab, and connectors appeared to be in good condition and were within the 5-year recommended service life. There were damaged fibers at the 25-foot mark on the 50-foot lifeline (Photo 4).

**Photo 3.** PFAS anchor location after incident (*Photo courtesy of NCDOL/OSH*)

According to 29 CFR 1926.502(d)(15)<sup>6</sup> the anchorage points used for attachment of personal fall arrest equipment shall be independent of any anchorage being used to support or suspend platforms and capable of supporting at least 5,000 pounds (22.2 kN) per employee attached, or shall be designed, installed, and used as part of a complete personal fall arrest system which maintains a safety factor of at least two under the supervision of a qualified person. The anchor for the PFAS used in this incident is believed to have been installed horizontally along the ridgeline of the roof, secured with 3 roofing nails into the sheathing (Photo 3). To meet the 5,000 pounds per employee support requirement, the manufacturer recommends installing the anchor over the ridgeline, with a minimum of 10 to 12, 3-inch, 16d nails through the holes, into the truss (Photo 7).

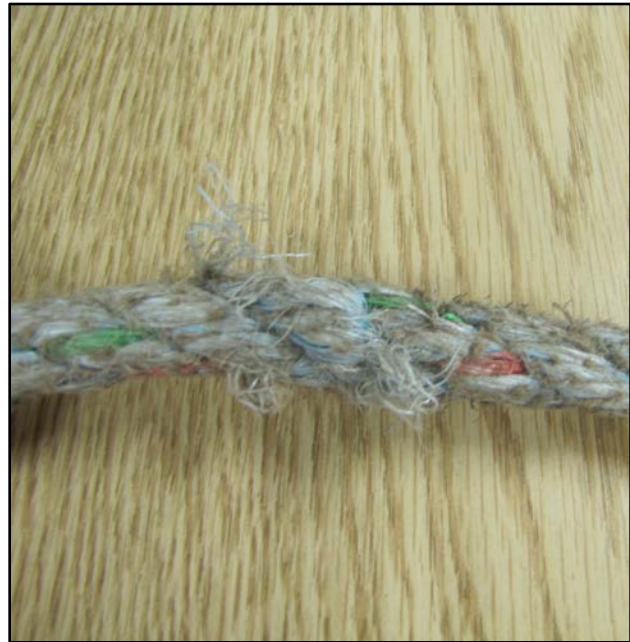
**Photo 4.** Damaged fibers in laborer's 50-foot lifeline (*Photo courtesy of NCDOL/OSH*)

According to 29 CFR 1926.502(d)(21)<sup>6</sup> personal fall arrest systems shall be inspected prior to each use for wear, damage and other deterioration, and defective components shall be removed from service. In this case, the 50-foot lifeline was damaged at the 25-foot mark and should have been removed from service.

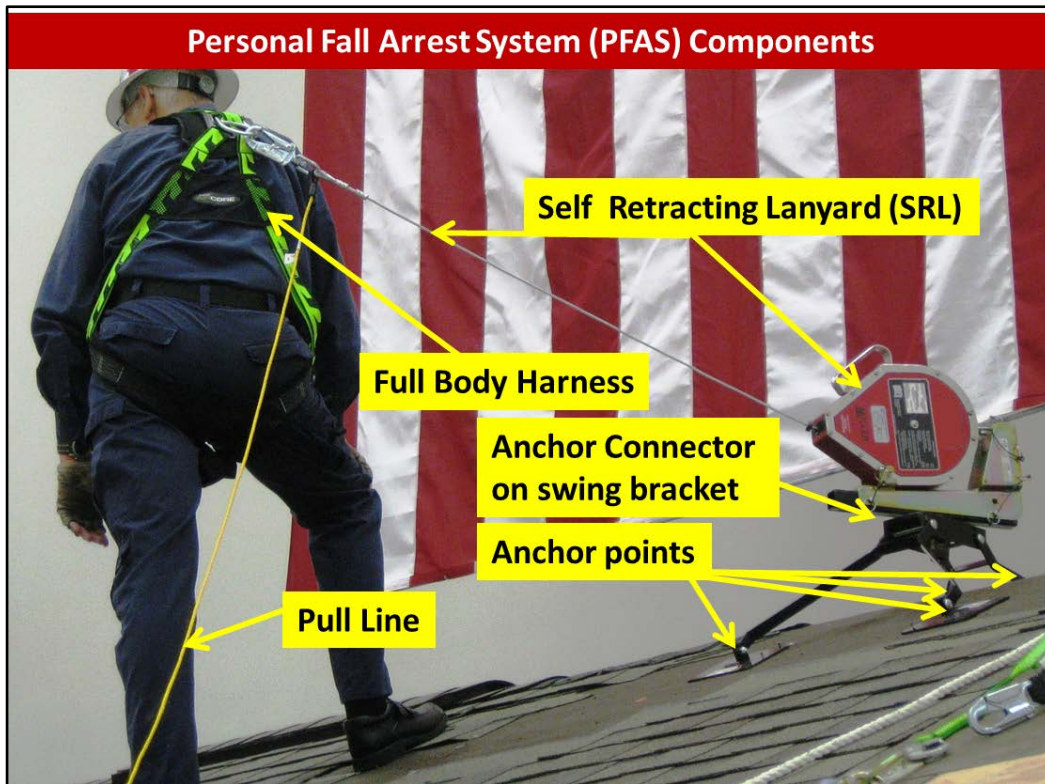
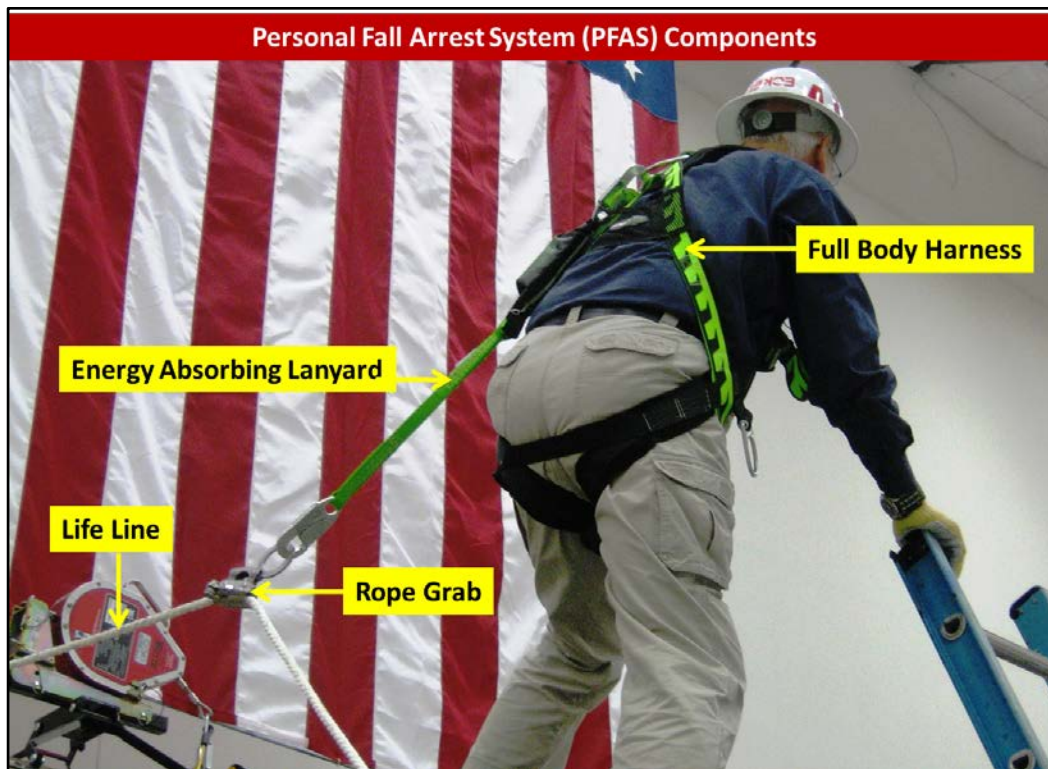
Photo 5. Proper components of a PFAS (Photos courtesy of John Eckel, Honeywell)

Photo 6. Proper components of a PFAS (Photos courtesy of John Eckel, Honeywell)

Discussion: Employers in residential construction, including subcontractors, are required to provide employees with a fall protection system (e.g. guardrail systems, safety net systems, or personal fall arrest systems) when employees are walking/working on a surface, horizontal and vertical, with an unprotected side or edge which is 6 feet or more above a lower level. A Personal Fall Arrest System (PFAS) is designed to stop a worker's fall before they strike a lower level

(Photo 5 & Photo 6). According to OSHA regulations the general contractor who has control of the work site has a responsibility to ensure workers on the site are in compliance with OSHA standards found in 29 CFR 1926.501<sup>5</sup>. This fall protection system must be in accordance with the fall protection criteria, requirements for fall protection systems, criteria, and practices that are found in 29 CFR 1926.502<sup>6</sup>.

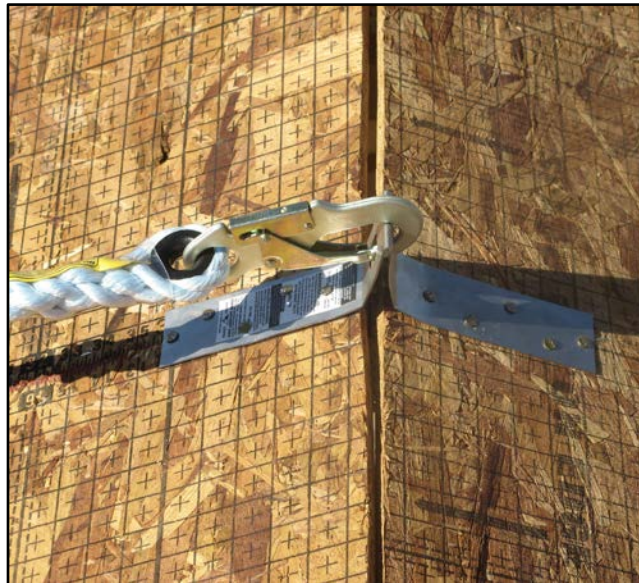
**Photo 7. Proper installation of PFAS anchor**  
*(Photo courtesy of NAHB)<sup>2</sup>*
