FACE Report Number 2013-05

June 22, 2017

Worker Killed When a Section of Pipeline Crashed Through Excavator Cab and Struck Him in the Chest During a Tandem Lift—West Virginia

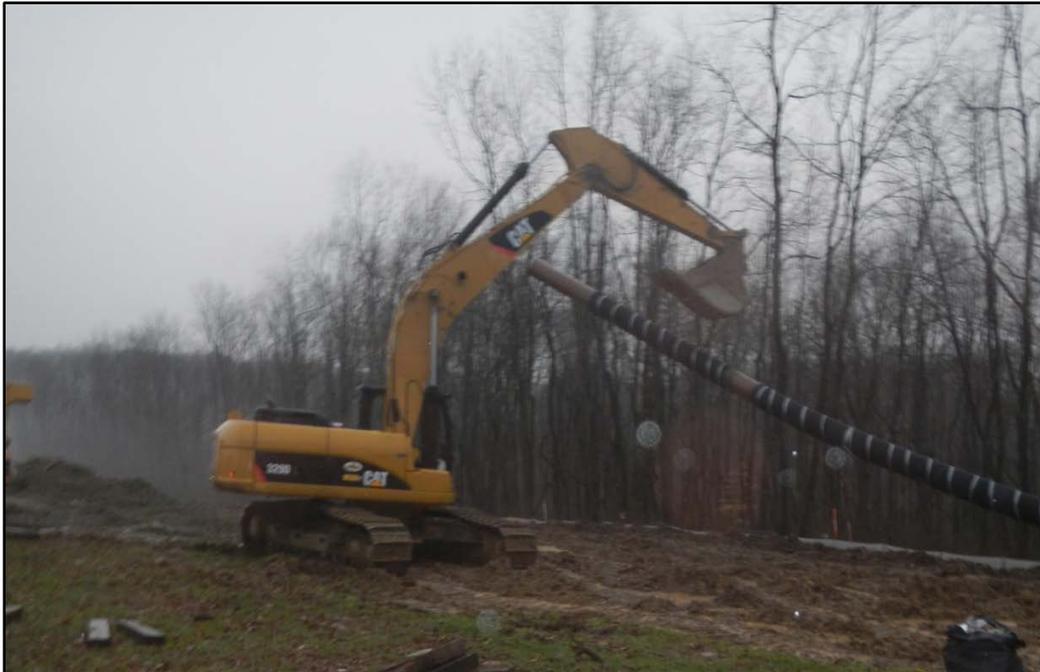
The lead excavator was a Caterpillar 329D ([Photo 1](#)). The rear excavator was a Caterpillar 336E [Caterpillar 2009] ([Photo 2](#)). Both excavators were attached to the pipe via a nylon continuous strap. The lead excavator was attached to the hook on the bucket of the excavator ([Photo 3](#)). The bucket of the rear excavator had been removed, and a Caterpillar 10-ton swivel mat hook with safety latch was installed to the end of the dipper stick using two shackles ([Photo 4](#)).

Photo 1. Lead excavator.
(Photo courtesy of WV OSHA.)

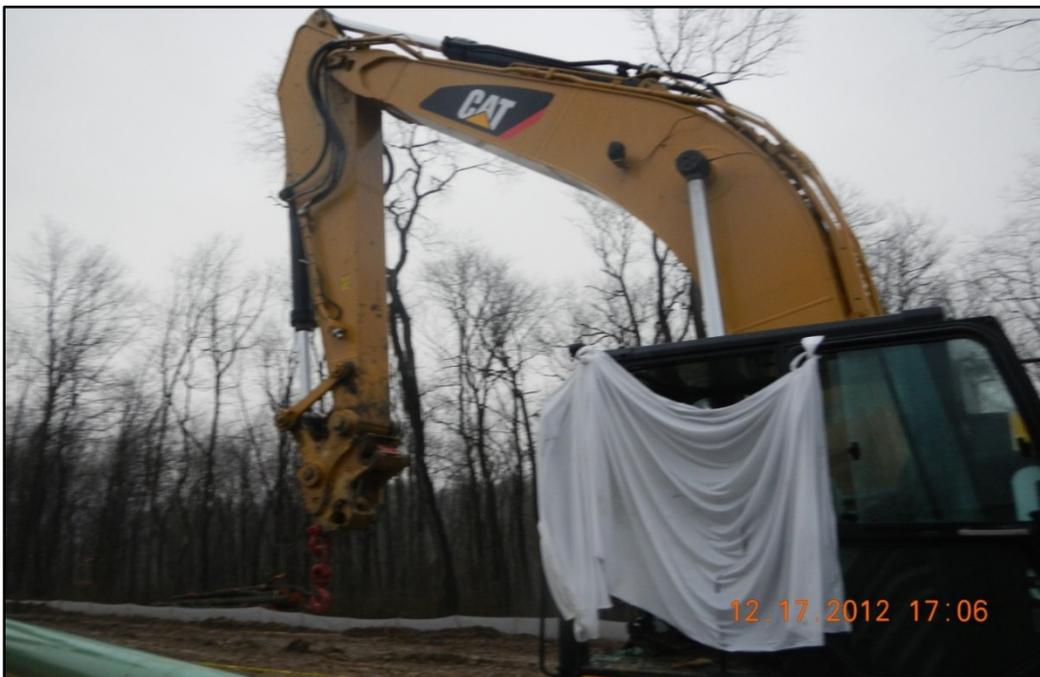
Photo 2. Rear excavator (victim).
(Photo courtesy of WV OSHA.)

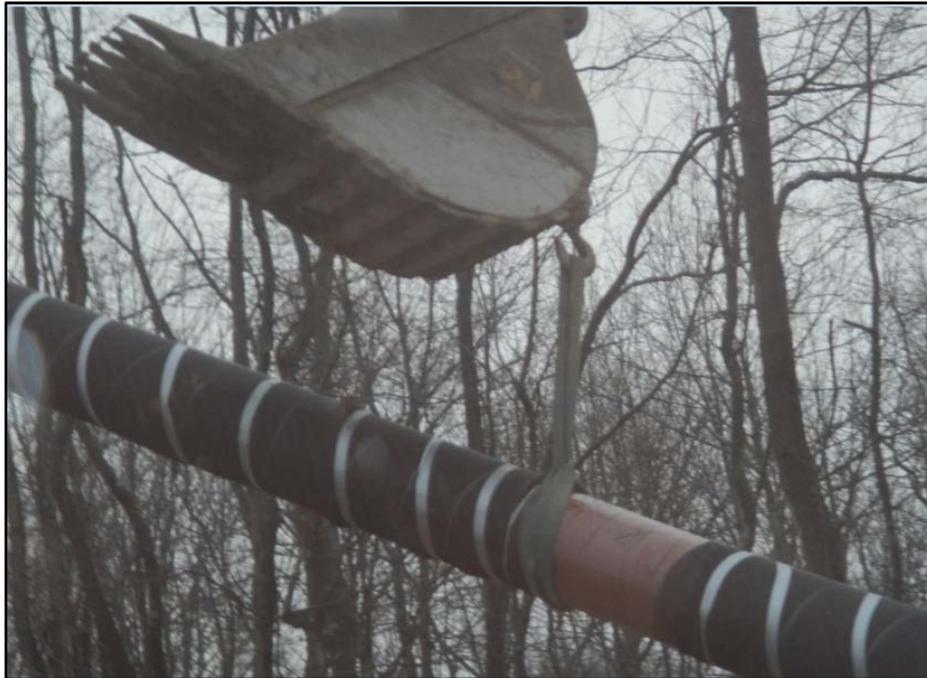
Photo 3. Lead excavator; pipe attached to the hook on the bucket of the excavator.
(Photo courtesy of WV OSHA.)

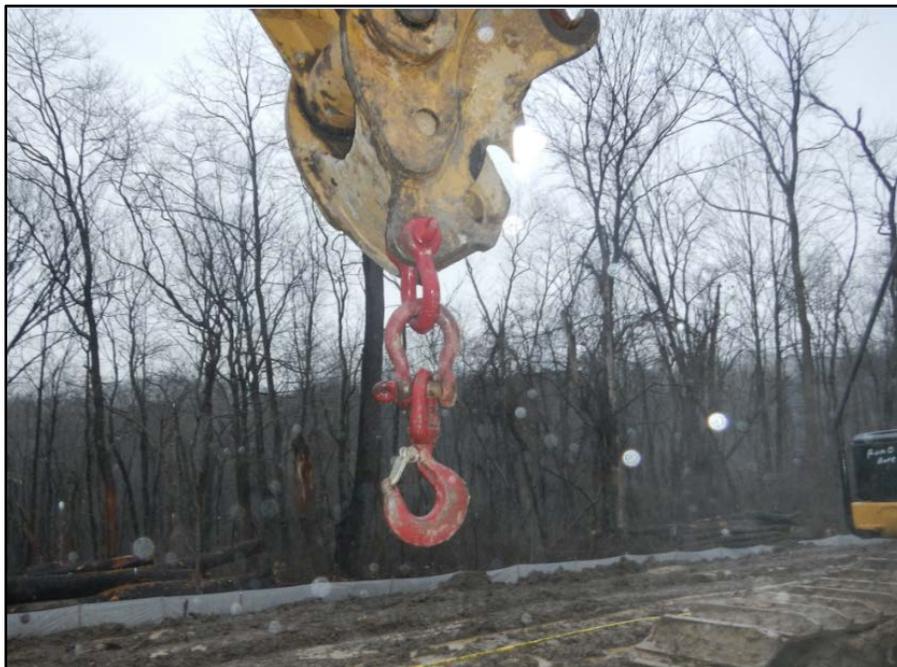
Photo 4. Rear excavator; Caterpillar 10-ton swivel mat hook with safety latch installed to the end of the dipper stick using two shackles.
(Photo courtesy of WV OSHA.)

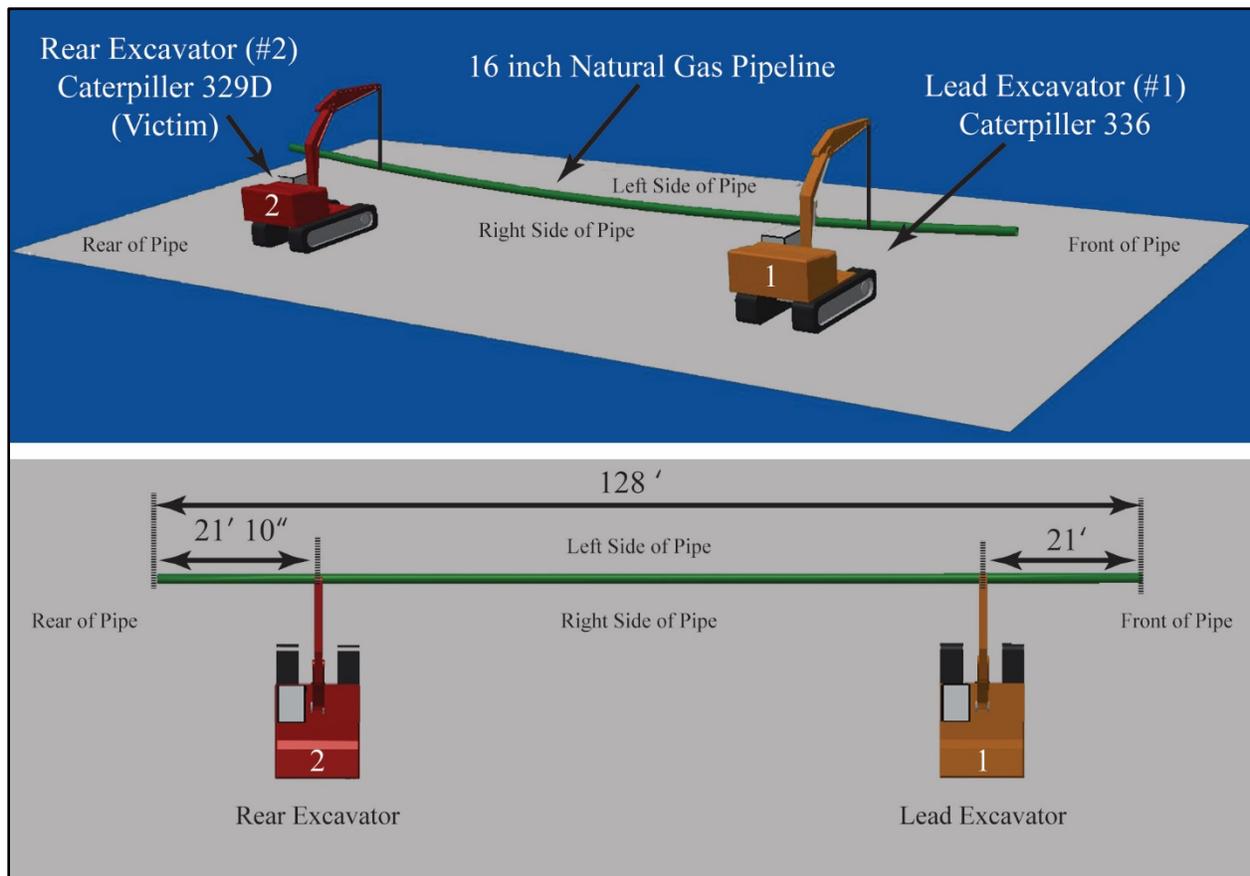
The 128-foot section of pipe was constructed and sitting on wooden skids and needed to be transferred from the working side of the right-of-way to the ditch side of the right-of-way. Both excavators were on the right side of the pipe when they first attached to it. The lead excavator was attached to the pipe approximately 21 feet from the end while the rear excavator (victim) was attached approximately 21 feet 10 inches at the opposite end ([Figure 1](#)).

Figure 1. Drawing of excavator position in reference to pipeline.

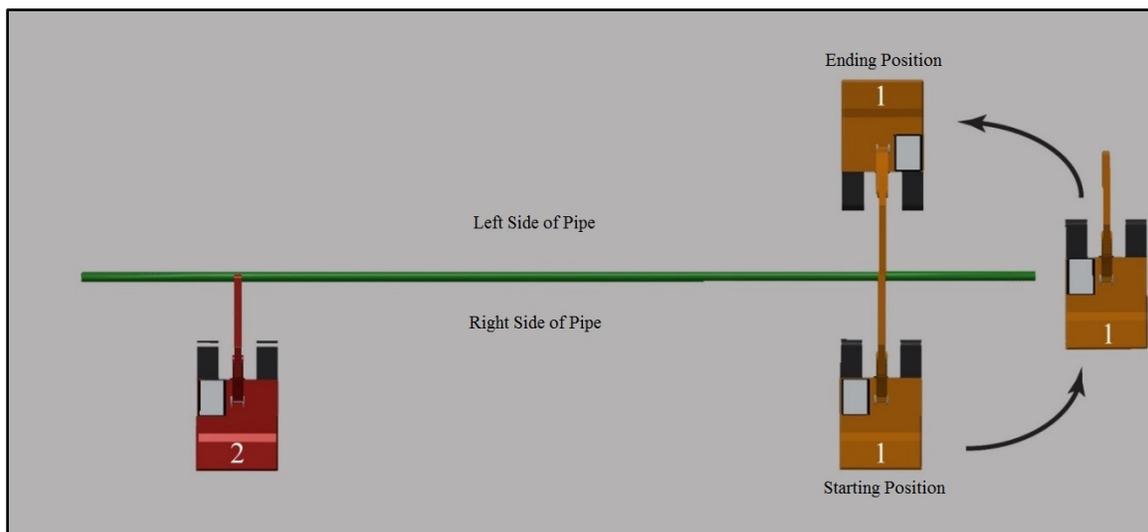
Both operators picked up the pipe at the same time. The lead excavator operator backed away from the skids and then lowered the pipe to the ground; the rear excavator operator kept his end of the pipe up in the air. A coworker unhooked the lead excavator from the pipe to allow the lead operator to move his excavator around to the opposite side of the pipe and re-attach ([Figure 2](#)). Once the lead excavator was in its new position, the coworker reattached it to the pipe and the lead excavator operator again raised the pipe.

Figure 2. Drawing showing movement of the lead excavator.

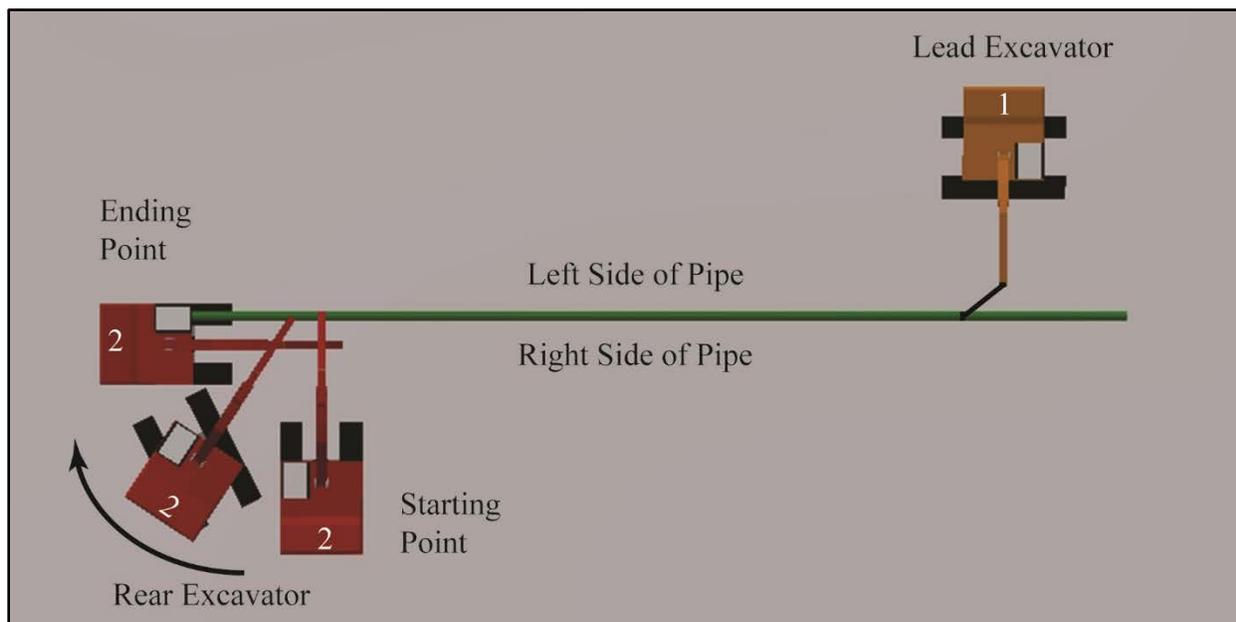
The lead excavator operator started swinging his boom to his left, taking the pipe away from the rear excavator. The rear excavator operator started swinging his end of the pipe to his right towards the lead excavator. The lead excavator operator said that he could tell that the rear excavator operator was swinging because he could see him at first and he could tell by the position of his choker (nylon strap). The chief inspector for the gas company observed that as the rear excavator was swinging the end of the pipe around, the pipe cleared the front of the rear excavator by approximately 3 feet. Once the rear excavator reached the end of the pipe, the operator turned his tracks from perpendicular to the pipe end to direct alignment with the pipe ([Figure 3](#)).

Figure 3. Drawing showing movement of rear excavator (victim) while attached to the pipe.

In this instance, the alignment of the rear excavator in direct alignment with the pipe created an unsafe condition because any longitudinal swinging of the pipe placed the operator at high risk of the pipe entering into the cab.

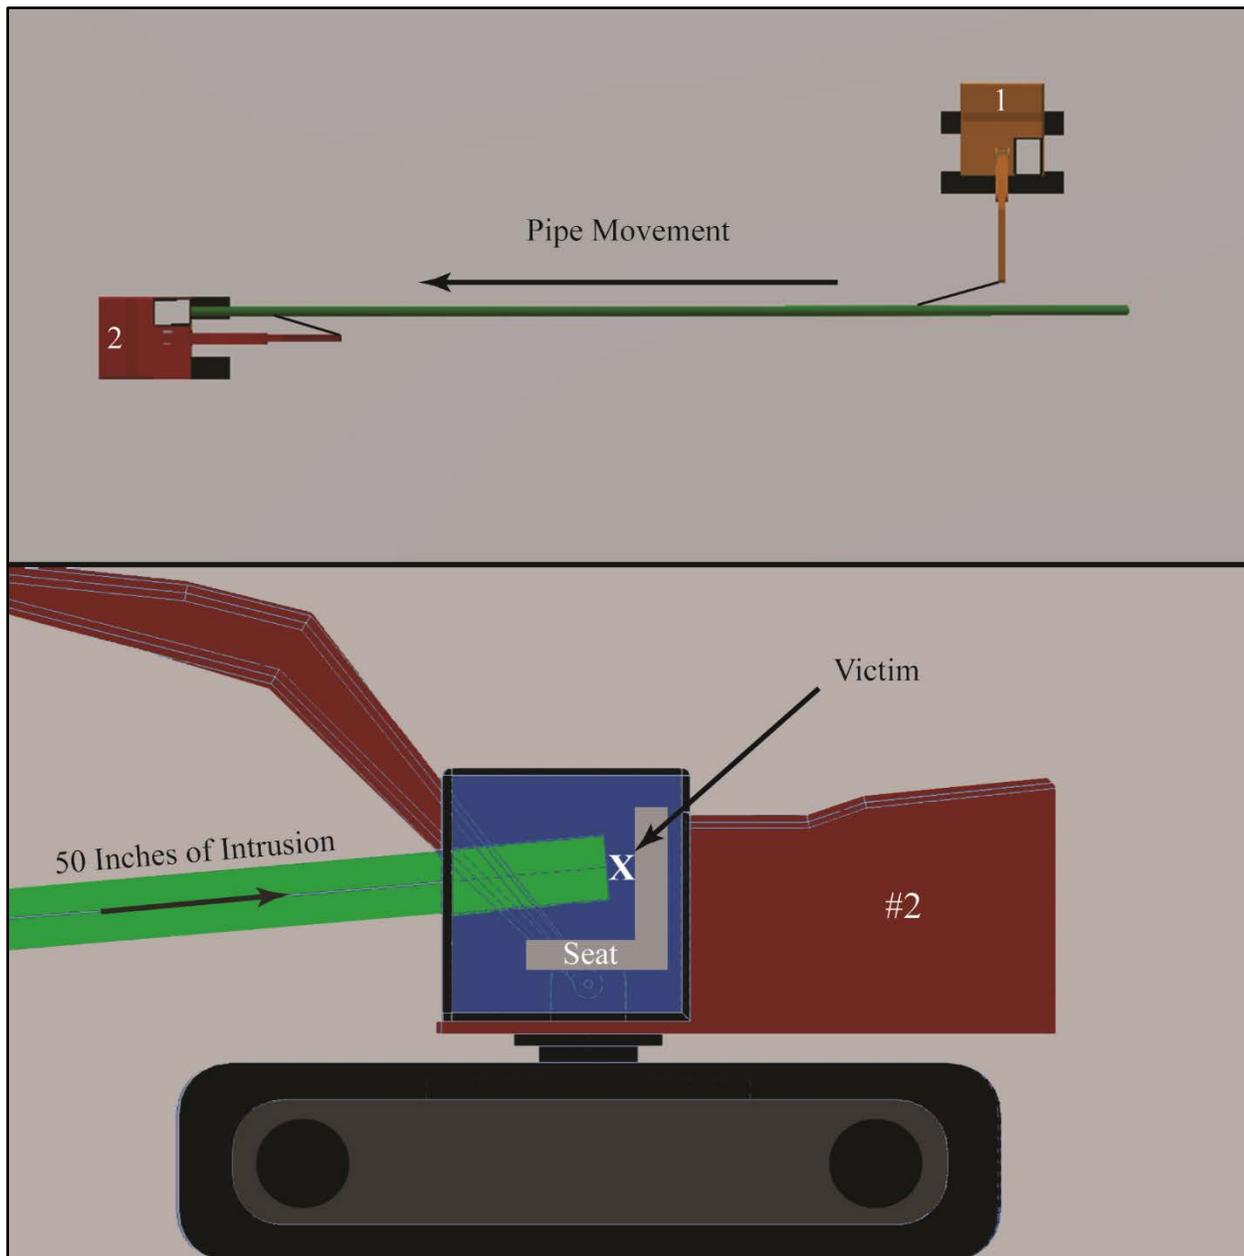
The lead excavator operator said that everything was going smoothly, then all of a sudden his excavator was jerked toward the rear excavator. The pipe pulled the lead excavator through the swing brake, and the operator reported that the lead excavator was pulled approximately 3 inches toward the rear excavator. The end of the pipe that was supported by the rear excavator was pulled through the front glass of the cab approximately 50 inches, striking the rear excavator operator in the chest ([Figure 4](#)). The travel control, which controlled the force to pull the bucket through the ground, was punched backward and bent to the side. The fuse box, which was located behind the operator's seat, was damaged and may have caused the machine to stop running.

After the situation was assessed, the lead excavator operator attempted to pull the pipe back out of the rear excavator cab, but the pipe would not move. It was noted that the rear excavator was not running but the key was still in the on position and that the strap supporting the pipe was running parallel to the pipe instead of hanging down at 90 degrees. The operator was found with his right hand up to his chest and his left hand down toward the controls. Coworkers attempted to knock the chokers back down the pipe to relieve pressure on the operator but were unsuccessful. Emergency medical services, who had been contacted and had arrived on site, instructed the employees to stop efforts to remove the pipe until the medical examiner arrived. Once the medical examiner arrived, employees removed the travel controls from the excavator to relieve the pressure from the stick and the pipe. The operator was pronounced dead at the scene and then transported to a local hospital.

Figure 4. Drawing showing pipe movement into the rear excavator cab.

OSHA’s inspection determined that the boom of the rear excavator had inadvertently pulled back and sent the end of the pipe into the operator’s cab striking him. The precise cause of the arm pulling the pipe back toward the cab could not be determined. However, the complexity of the task that was attempted, as described above, could be a contributing factor.

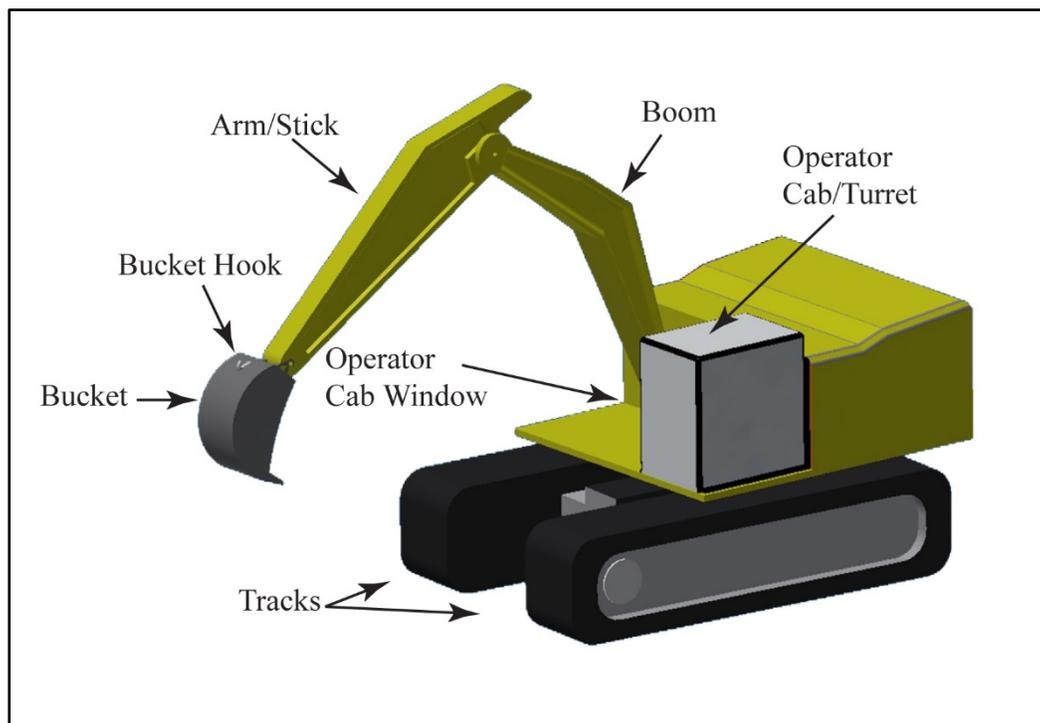
Figure 5. Excavator components.

The excavator has two main sections—the undercarriage and the house. The undercarriage includes the tracks, track frame, and the final drives, which have a hydraulic motor and gearing that provide the drive to the individual tracks. The house is attached to the undercarriage by way of a center pin that allows the machine to turn 360 degrees. The main boom of an excavator is attached to the house, and the stick or “dipper arm” is attached to the boom (Figure 5). In this incident, the final drive for the excavator tracks was positioned to the front of the excavator. With the final drive positioned to the front, the hand controls in the cab would be pulled back to move the machine forward. Because of this, when the pipe entered the cab and struck the drive control bars, it caused the excavator to move forward. Had the final drive been positioned to the rear of the excavator when the pipe entered the cab, the excavator would have traveled backward.
