## Maintenance Worker Struck by Forklift Carriage—Tennessee

### SUMMARY

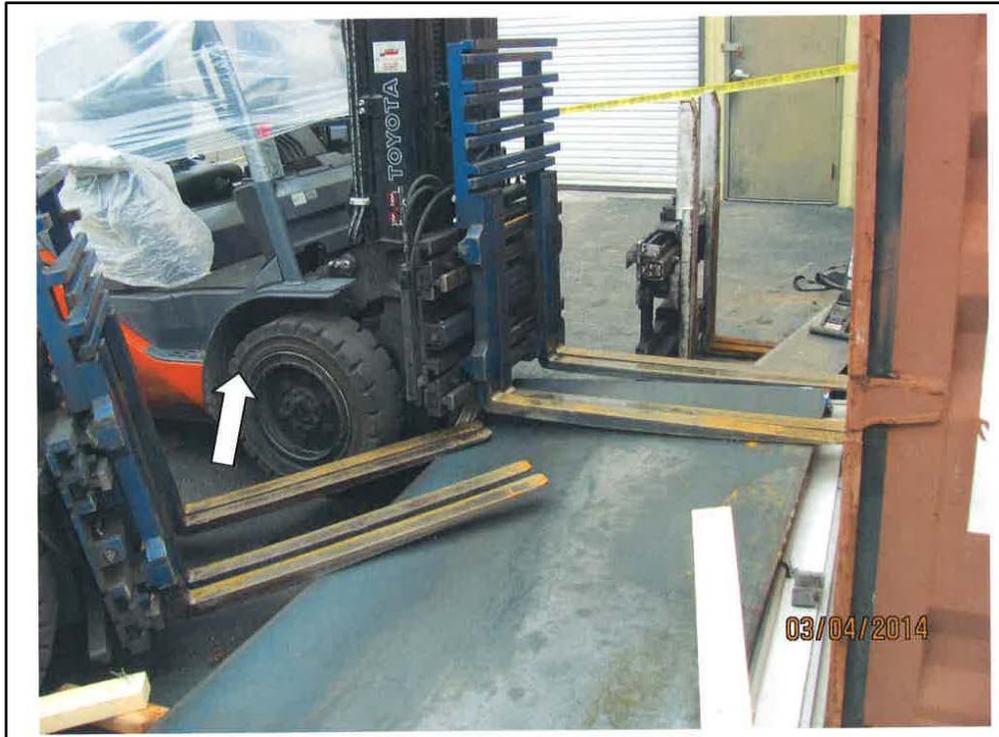
The forklift was being repaired outside near the maintenance shop in a concrete paved yard. A CONEX shipping container was also located outside with a pallet on the ground next to it. The pallet measured 48 inches wide and 12 inches tall. A steel plate and a tractor-trailer door were stacked on the pallet (Photo 1). The pallet with steel plate and tractor trailer door, which was on the ground next to the shipping container, was approximately 51 inches long, and the shipping container was 101 inches tall. The pallet was 7 inches from the mast of the forklift. The forks were 58 inches long (Diagram 1). This allowed only the tips of the forks to rest on the shipping container. After the incident, scratches were observed on the side of the shipping container approximately 1 inch from the top edge where the forks had rested (Photo 2).

**Photo 1. Incident scene, pallet with material on the ground; arrow indicates forklift involved.**  
*(Photo courtesy of TOSHA.)*

positioned as the maintenance worker wanted it, then set the emergency brake on the forklift, turned off the forklift, and exited the forklift. The pallet on the ground with the steel plate and tractor-trailer door on it prevented the forklift operator from moving closer to the shipping container and allowed only the tips to be placed on the top of the container side.

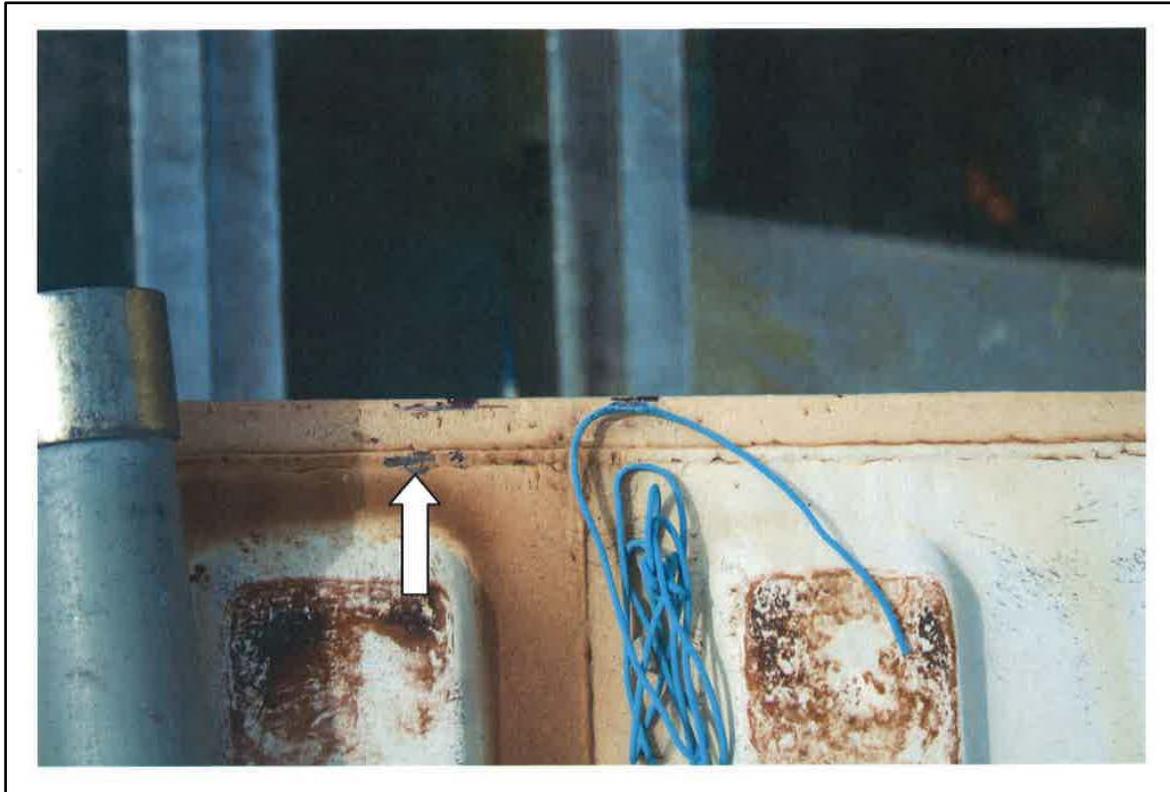
**Photo 2. Arrow indicates scratches on shipping container.**  
*(Photo courtesy of TOSHA.)*

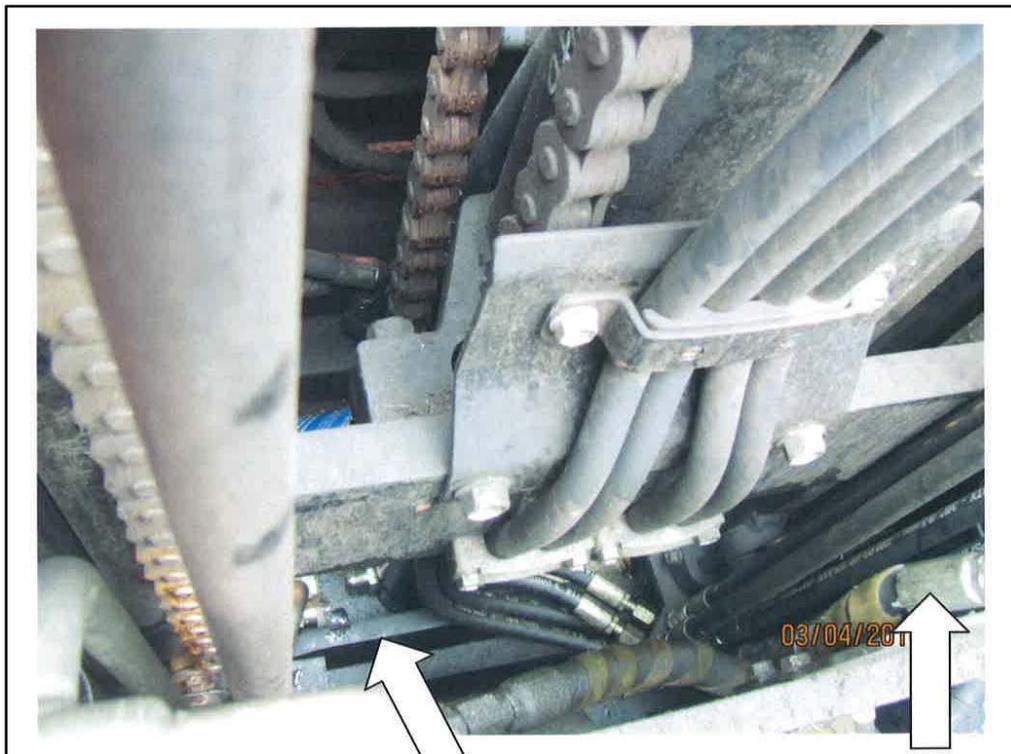
The maintenance worker walked under the elevated forks, kneeled down, and proceeded to examine the hydraulic cylinder. The maintenance worker determined the leak was coming from the hydraulic hose fitting into the hoist cylinder (Photo 3). The maintenance worker and operator went to retrieve a replacement O-ring from the maintenance shop. They returned with the O-ring, and the maintenance worker positioned himself under the forks and began to replace the O-ring. The maintenance worker asked the operator to step out of the way while he repaired the forklift. The maintenance worker sat down on a bucket under the elevated forks, drained the hydraulic fluid, removed the damaged O-ring, installed a new O-ring and began to replace the hose fitting. When the maintenance worker turned the wrench to tighten the fitting, the forks of the forklift were dislodged and slipped off the shipping container. The carriage on the forklift mast fell and struck the maintenance worker in the back of the head, pinning him between the tractor trailer door on the pallet, which was under his feet, and the carriage of the forklift. The operator radioed for 911 and emergency medical services dispatched to the incident. The maintenance worker was then transferred to the hospital where he succumbed to his injuries.

**Photo 3. Right arrow indicates repair location on mast; left arrow indicates where the carriage hit the worker.**

employer developed a lockout/tagout procedure that included training on removing the fork attachment and using jack stands to support the carriage before relieving hydraulic pressure from the mast lift cylinder.
