Fatality
Assessment
and Control
Evaluation
Program

REPORT#: 2015-01

REPORT DATE: April 18, 2018

Oil and Gas Delivery Driver Crushed Between a Dozer and a Semi-truck While Connecting Towline—West Virginia

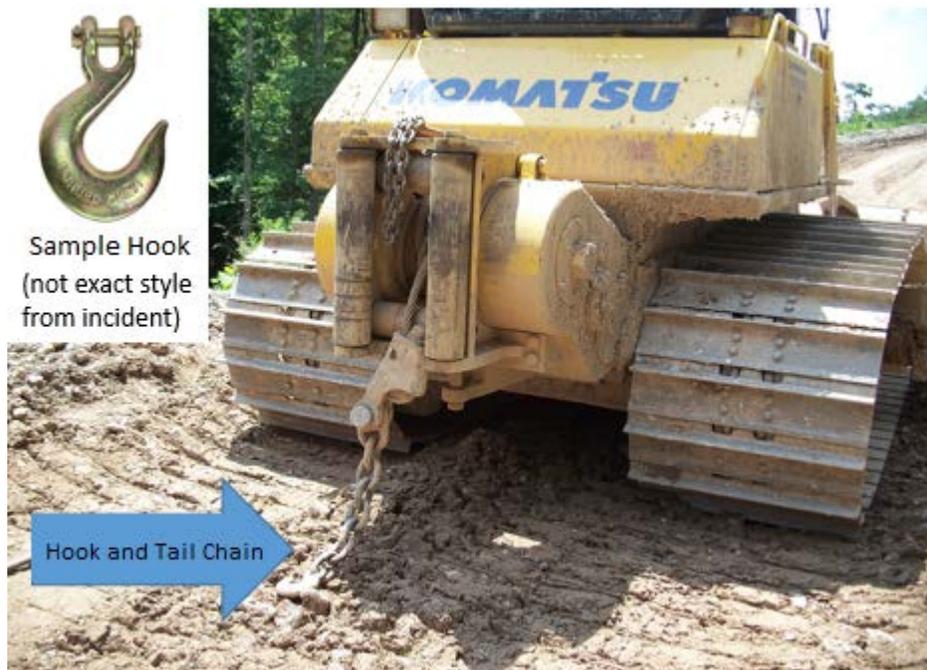
Photo 1. Tow hook and tail chain, showing length of towline at time of incident.
(Photo courtesy of WV OSHA.)

- *Lack of safety training or standard operating procedure for towing vehicles*
- *Lack of appropriate safeguards for equipment*
- *Lack of spotter or designated hookup personnel*
- *Steep terrain*
- *Short length of chain being used; winch cable and chain not spooled out*
- *Truck not properly equipped ahead of time for towing (i.e., no D-ring pre-mounted on hitch pin)*

Recommendation #4: Ensure vehicles are properly equipped for towing prior to initiating the towing connection procedures (either have a D-ring pre-mounted on the truck's hitch pin or have a D-ring in the truck).

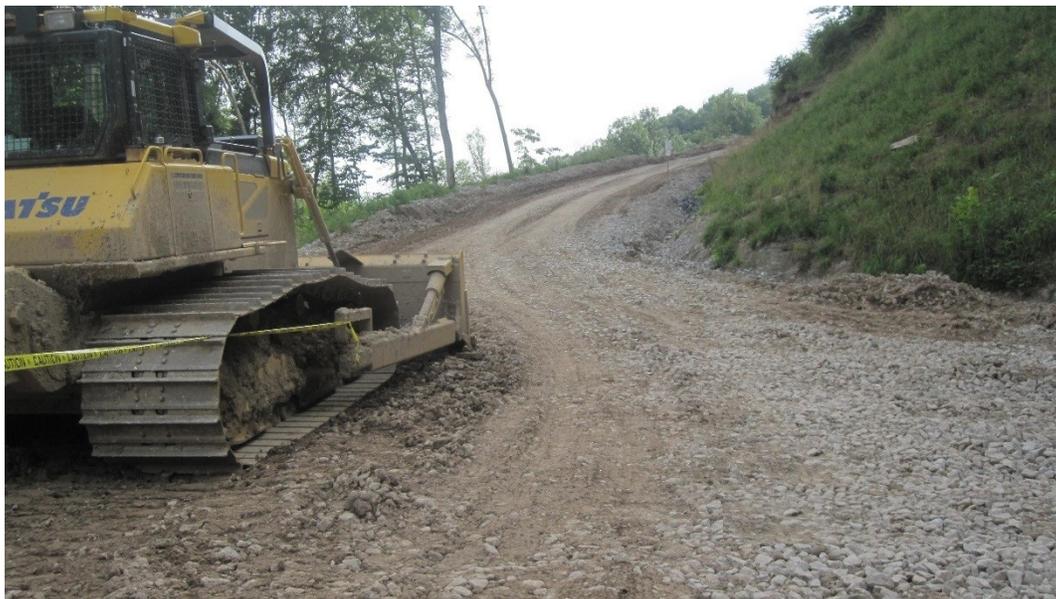
The incident occurred on an access road to a well site while the delivery truck driver was hooking up his semi-truck to a dozer. The section of access road was graded dirt and gravel surface with an approximately 10 percent grade (Photo 2). The dozer operator backed his dozer to within 3 feet of the driver's truck for hookup.

Photo 2. Incident scene, showing terrain and hill accessing the well site.
(Photo courtesy of WV OSHA.)

Recommendation #5: When possible, ensure a designated area is flat prior to making towing connections.

Towing connections should be conducted on level ground where possible. In this incident, an attempt to hook up was performed on a slope of approximately 10 degrees. Steep terrain increases the chance of machinery moving unintentionally during operations. Designating a level area for hookup operations may reduce the risk of involuntary movement. If level ground isn't available, the machines should be staggered/offset so that if the potential to roll backward exists, the machine would not roll into the unit being towed.

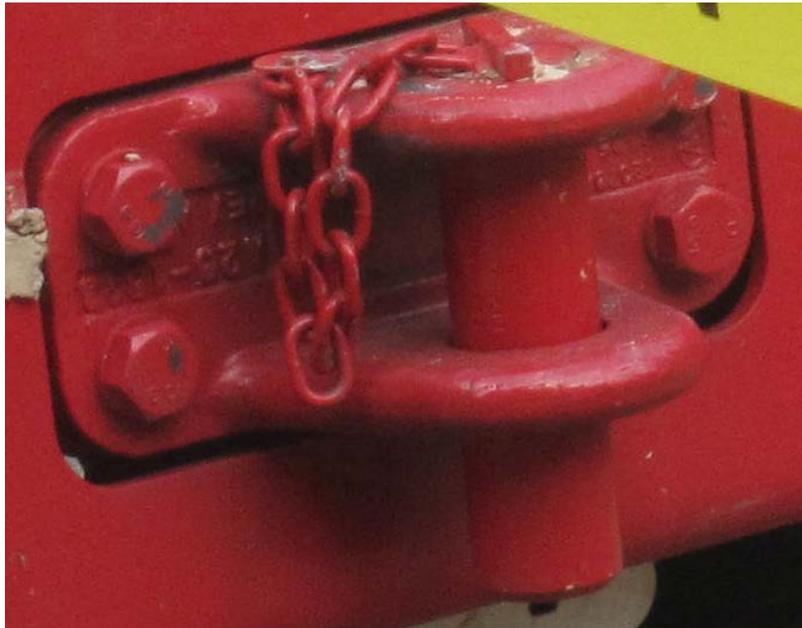
The delivery driver was driving a Kenworth model 660 semi-truck and bulk cement trailer. He was struck by a Komatsu dozer that rolled backward and made contact with the Kenworth truck. The truck was equipped with a pin-type tow hitch on the front bumper that required the use of a D-ring to connect the hitch pin with the dozer's winch line hook (Photos 3 and 4). The truck did not have a D-ring (Photo 4) connected to the hitch prior to the truck pulling onto the access road. However, D-rings were kept on the dozers for trucks that came on-site without them.

Photo 3. Pin-type tow hitch on front of the truck involved in this incident.
(Photo courtesy of WV OSHA.)

In this case, the dozer operator was exiting the dozer to give the truck driver a D-ring for connection. Vehicles being towed should be properly equipped for towing with all necessary hookup equipment prior to engaging in the hookup procedures. For example, the D-ring can either be equipped on the truck or placed on the truck before preparing to be towed. This is especially true where towing connection is an ongoing activity at the job site.

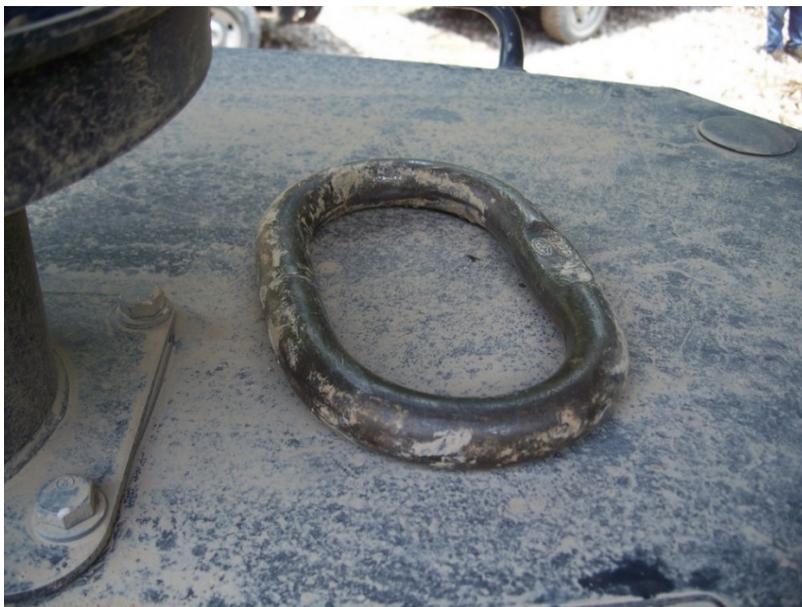
Photo 4. D-ring needed for connection between hook and hitch pin.
(Photo courtesy of WV OSHA.)

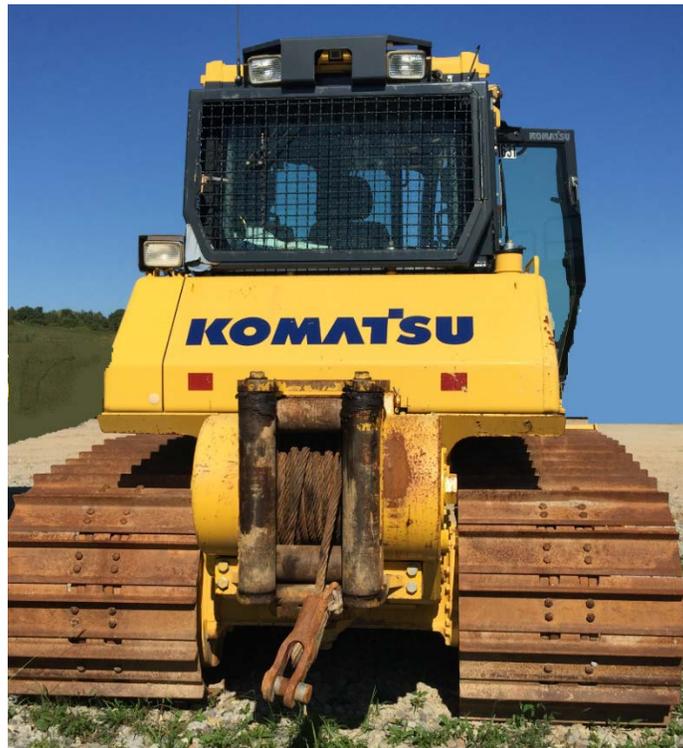
The Komatsu dozer model D65PX-15 weighed approximately 47,000 lbs (Photo 5). The dozer was equipped with a winch for towing. Specifications on the winch are unknown. Two levers lock different parts of the machine. The safety lock lever is a device that locks the work equipment, such as the blade, from being used. The parking lever stops the tram control from being used and the machine from moving. In this incident, it is believed that the operator inadvertently kicked the parking brake lever while exiting the machine, releasing it and causing the dozer to roll backward (Photo 6).

Photo 5. Dozer involved in the incident.
Note: The tow hook and tail chain have been removed.

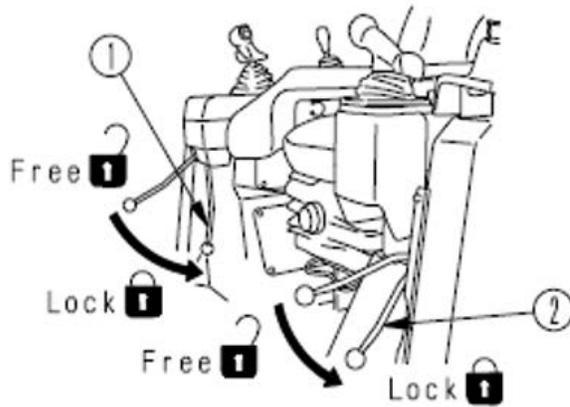
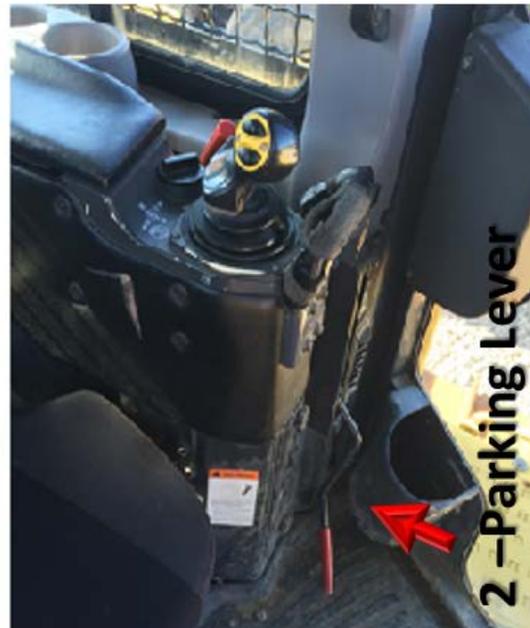
Photo 6. Safety lock lever (1) and parking lever (2).
(Illustration adapted from Komatsu [2004].)

In this incident, the victim was pinned between the dozer and semi-truck. It is believed that the dozer operator bumped the parking brake lever while dismounting the dozer, which disengaged the parking brake and caused the dozer to roll back and onto the victim.

In this case, the dozer operator left the cab to give the delivery driver a D-ring, and the parking brake lever was inadvertently disengaged, which caused the dozer to roll back. A separate safety lock lever on the right side of the seat controls the work equipment attachments, such as the blade, from moving up and down. It is believed that this safety lock lever may not have been engaged. The operator's manual warns that if the control lever (parking brake lever) is touched by accident, the machine may suddenly move and cause serious personal injury.

Recommendation #6: Dozer equipment manufacturers should consider providing an engineering control, such as an interlock or other safe guards, to prevent parking brake levers from disengaging.

Control guards are safety features designed to prevent the inadvertent operation of equipment. Larger controls, such as levers, may require bars or specifically designed guards to limit access to the levers. Alternatively, mechanical stops, such as removable pins or blocks, can be used to limit movement of the lever until the operator is ready to safely activate the control.

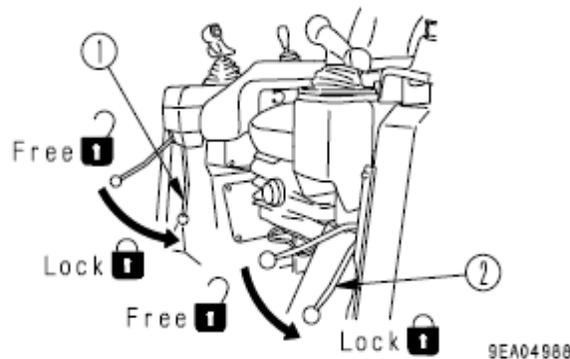
- Always apply the lock when leaving the operator's seat (Figure 1). Before standing up from the operator's seat (such as when adjusting the operator's seat), lower the work equipment completely to the ground, set the safety lock lever (1) and parking lever (2) securely to the LOCK position, then stop the engine. If you accidentally touch the levers when they are not locked, the machine may suddenly move and cause serious injury or property damage [Komatsu 2004].

Figure 1. Safety lock lever (1) and parking lever (2).
(Adapted from Komatsu [2004].)

Recommendation #1: Employers should ensure employees follow safe operating procedures as written in the equipment's operations manual.

- When leaving the machine, always lower the work equipment completely to the ground, set the safety lock lever (1) and parking lever (2) securely to the LOCK position, then stop the engine. Use the key to lock all the equipment. Always remove the key, take it with you, and keep it in a specified place [Komatsu 2004].

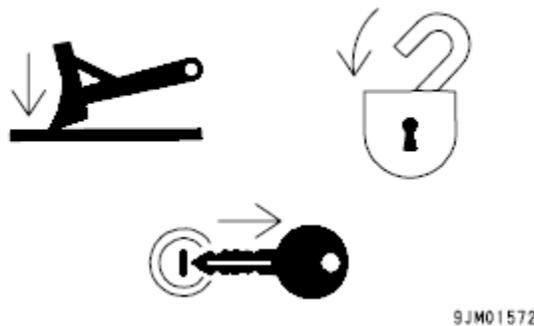
- Park the machine on firm, level ground. Select a place where there is no hazard of falling rocks or landslides, or of flooding if the land is low. Lower the work equipment completely to the ground. When leaving the machine, set the steering, directional, and gearshift levers in the NEUTRAL position and set the blade lever in the HOLD position; then apply the safety lock lever (1) and the parking lever (2) and stop the engine. Always close the operator's cab door and use the key to lock all the equipment in order to prevent any unauthorized person from moving the machine. Always remove the key, take it with you, and leave it in a specified place (Figure 2) [Komatsu 2004].

Figure 2. Warning label from the Komatsu operations manual.
(Adapted from Komatsu [2004].)
