Fatality
Assessment
and Control
Evaluation
Program

REPORT#: 2019-01 **REPORT DATE:** July 29, 2021

City Electric Maintenance Worker Electrocuted While Installing Lines for Security Cameras – Ohio

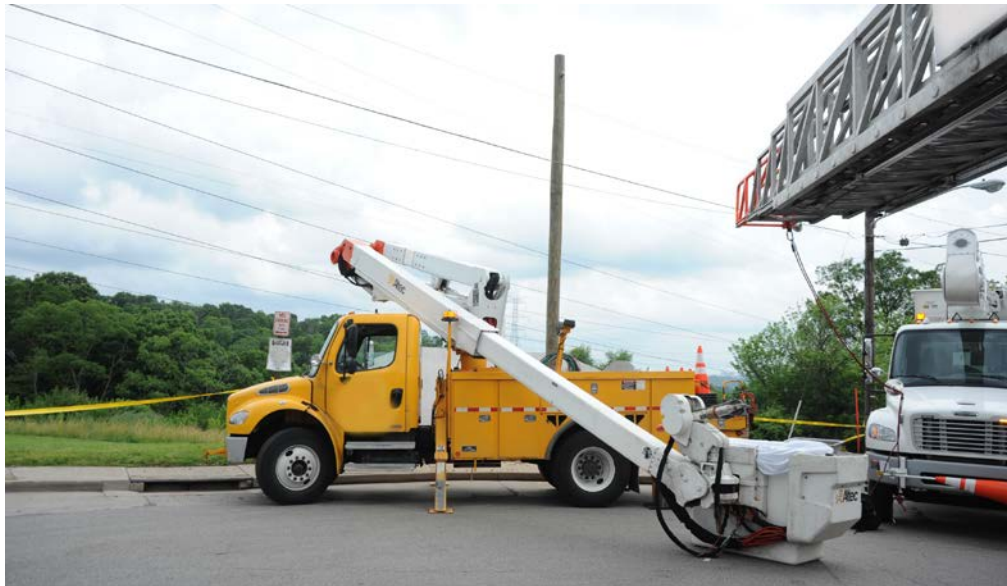
Photo 1. Freightliner M2 Aerial Lift Boom Truck *Courtesy of the City*

The equipment on-site on the day of the incident was a 2008 Freightliner M2 utility truck mounted with an Altec aerial articulating lift truck and basket rated for 46kV and below with dielectric usage category C (Photo 1). The employer conducted regular routine maintenance of the utility truck and maintained service records. The vehicle mounted lift was inspected on July 7, 2018 and passed an annual dielectric test but failed the annual visual inspection of equipment test including vehicle body, outriggers, controls, boom and bucket. The employer removed the equipment from service, completed the necessary repairs and placed it back in service. At the time of the incident the lift truck was compliant with all annual testing requirements.

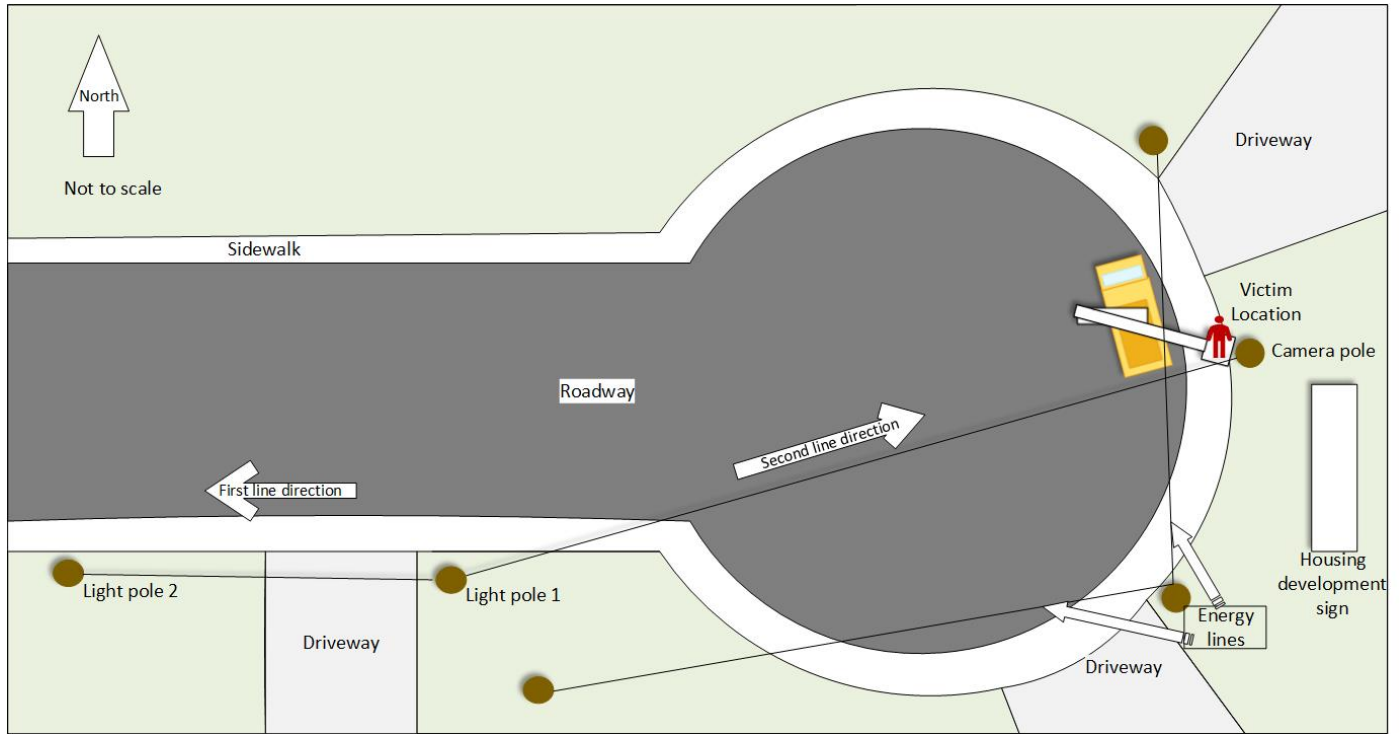
Diagram. Incident scene

The incident occurred in a residential area at the end of a cul-de-sac (Diagram). The city was in the process of installing surveillance cameras along the cul-de-sac. The cameras were to be attached to the light poles along the street (Photo 2). The light poles were on the South side of the street running East/West. At the end of the cul-de-sac was a housing

the basket, starting at light pole #1 and working his way up the road to the other light poles that ran from the cul-de-sac area to the main roadway (from East to West) (See Diagram).

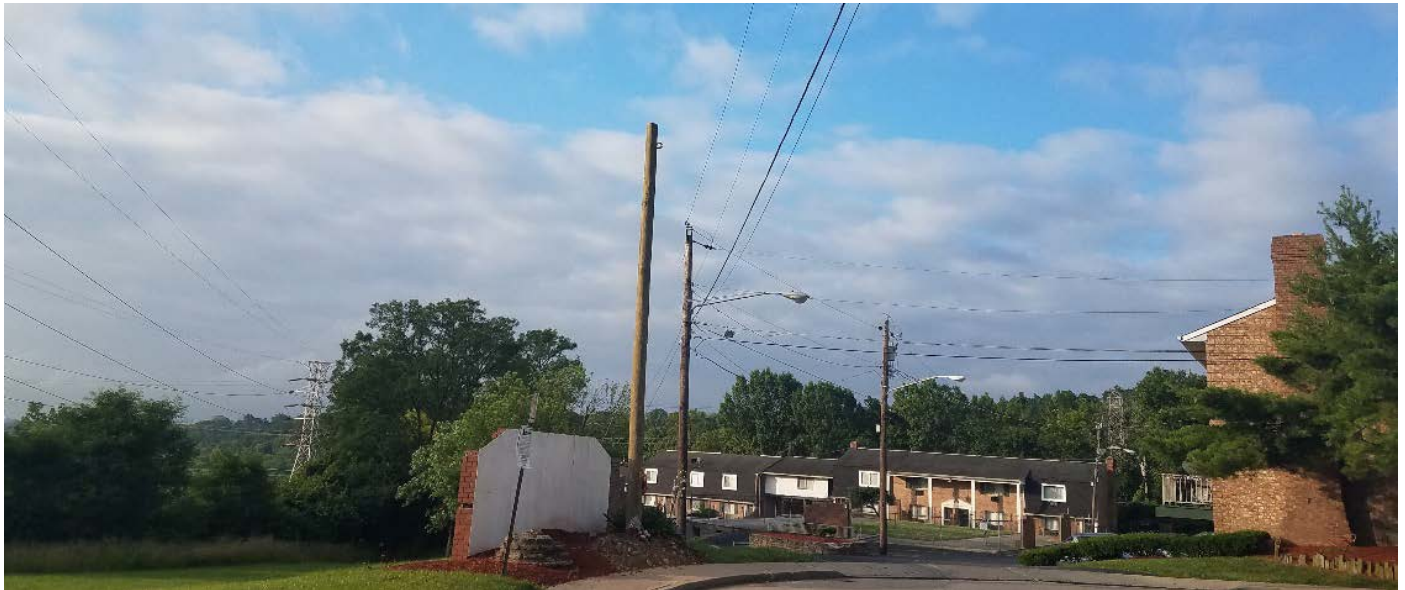
Photo 3. Photo of new camera pole at end of cul-de-sac *Courtesy of the Public Employment Risk Reduction Program*

development sign with the housing development driveways on each side of the sign. Above the sign were a series of power lines, cable lines, and phone lines attached to light poles mounted near the development driveways. These utility lines supplied the nearby housing developments. Next to the development sign was a newly placed camera pole where one of the future surveillance cameras would be placed (Photo 3). The electric power lines running to the housing development were 1,300 volt lines, beyond these lines were 3-phase 7,200 volt power lines. The electric maintenance worker was found by firefighters in the raised basket of the bucket truck, which was parked near the new pole under the series of power, cable, and phone lines (Photos 3 and 4).

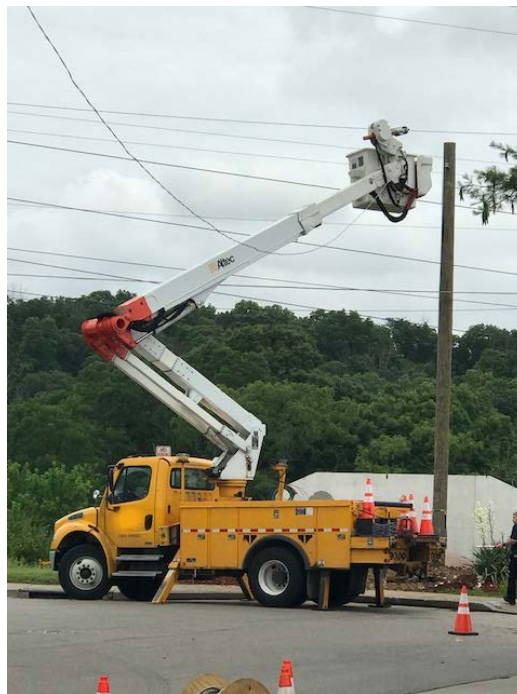
Photo 4. Position of bucket truck in cul-de-sac at the time of the incident *Courtesy of the City*

According to a GPS tracker in the elevated bucket truck, the electric maintenance worker left light pole #1, turned the elevated bucket truck around and drove up the street to position the truck in front of the newly placed security pole. A 1,300 volt power line was located in close proximity to the camera pole. The electric maintenance worker got in the basket and raised it approximately 28 feet. He began pulling some triplex service wire and installing it on the security pole. It is believed he did not realize his proximity to the power lines while performing this task and contacted his right shoulder with the energized power line.

Recommendation #1: Prior to assigning work, employers should determine appropriate safety distances while working near electrical power line hazards.
