Motor-Vehicle Incident Claims the Life of a Volunteer Fire Fighter and Injures a Volunteer Chief - Virginia

SUMMARY

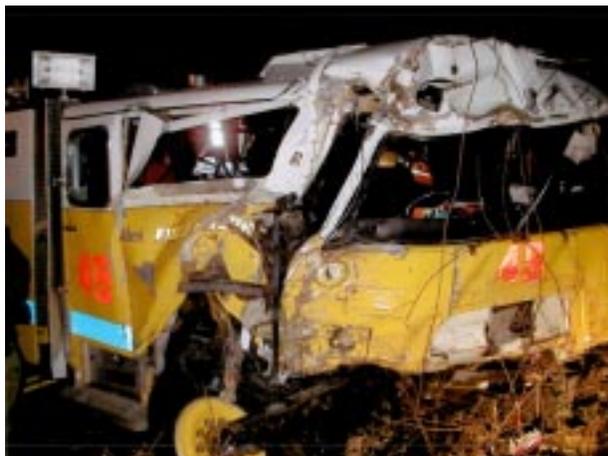
Rescue Truck Involved in This Incident

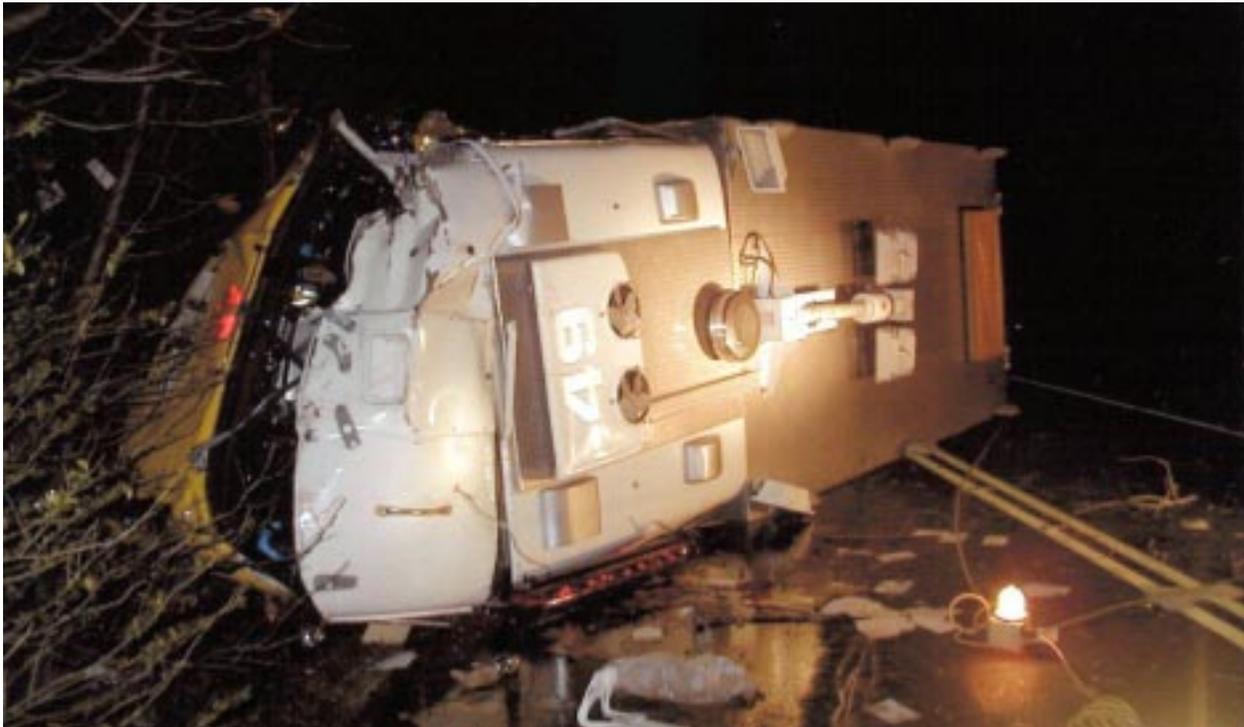
On December 18, 1999, a 22-year-old male volunteer fire fighter (the victim) died and a 30-year-old volunteer District Chief was injured after the rescue truck he was driving veered off the road, struck an oncoming car and then a tree. The incident occurred while they were responding to a reported gas leak at a private residence. The volunteer District Chief (driver) and a fire fighter (the victim) responded in Rescue 49. While en route, the driver looked down at the dashboard to lower his response priority by shutting off his lights and siren. While doing so, the truck's right side tires dropped off the road surface into a ditch. During the driver's efforts to bring the truck back onto the roadway, he overcompensated, causing the truck to cross the oncoming lane of traffic and strike an oncoming car. Just prior to striking the car, the driver started steering the truck back to the right to avoid a second collision. Due to the momentum of the truck, it struck a tree and flipped onto the driver's side (see Photo 1). Seconds after the wreck, the driver crawled out of his loose seat belt and out of the truck. Several

Photo 1. Rescue 1 After Impact With the Tree.

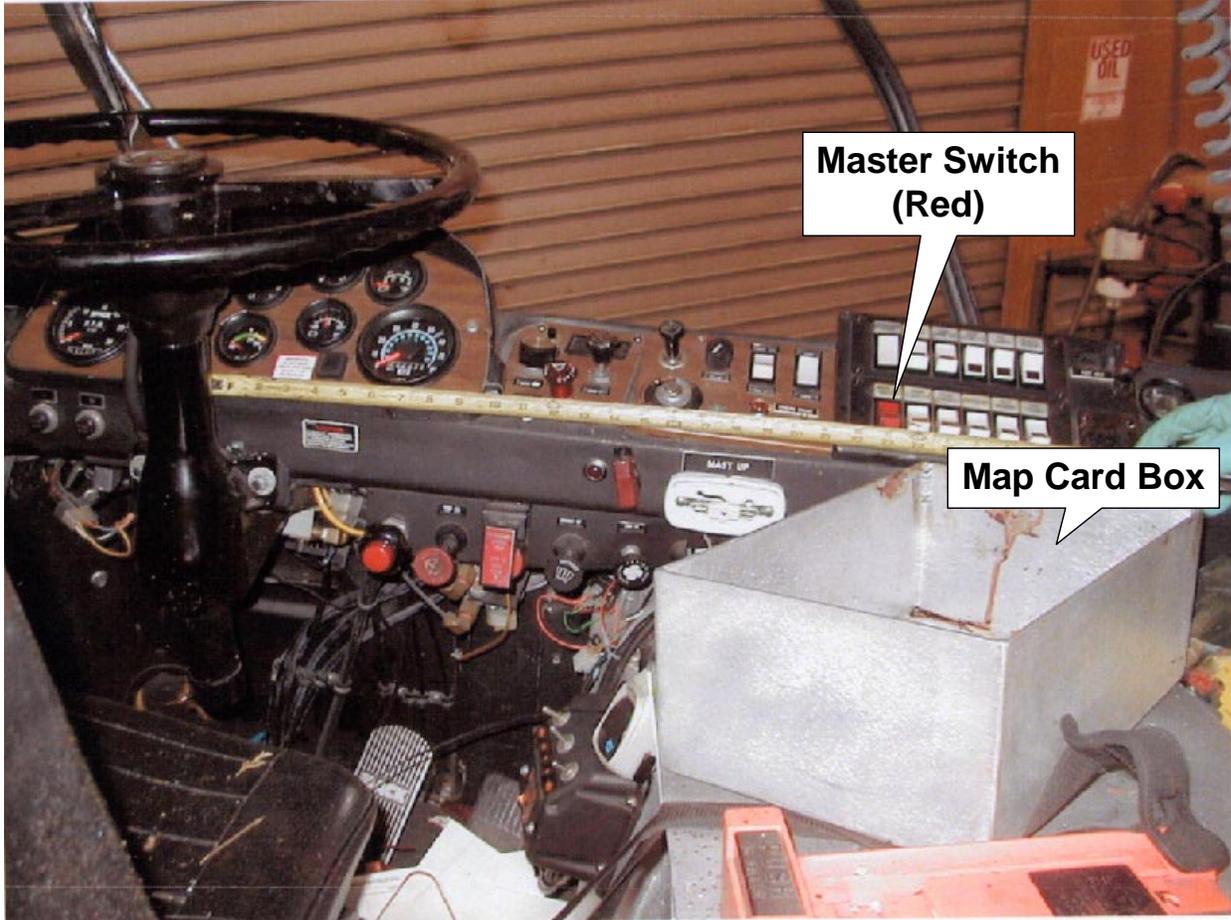
All units, except Rescue 49, were on the scene. The driver noticed there was very little radio traffic. To reduce his priority, the driver looked down at the dashboard and reached over to cut the lights off, via the master switch. *Note: The master switch, located on the dashboard between the driver's and officer's seat, is 23 inches from the center of the steering column. The driver had to reach up and over a metal 8-inch by 12-inch map card box (see Photo 2).* As the driver looked down at the dashboard area to find the master switch, he reached over to the right, with his left hand still on the steering wheel. *Note: The driver's arm length was insufficient to reach the controls without leaning while in the seated position. It is undetermined whether the driver inadvertently pulled the steering wheel to the right while he was reaching for the master switch or if the rescue truck followed a straight path instead of following the slight curve of the road.* The rescue truck's right front and rear dual tires dropped off the road surface, into a ditch and concrete culvert pipe (see Photo 4). The rescue truck traveled across an asphalt driveway and back into the ditch. The driver put both hands on the steering wheel and let off the accelerator. The police department analyzed the arc of the tire marks, determining a radius and the critical speed scuffs. They determined that the rescue truck lost control after leaving the driveway (see Photo 4). After the vehicle lost control it was determined that it was traveling approximately 51 mph at the time it came out of the ditch line and back onto the roadway. The driver tried to bring the truck back onto the roadway, however, he overcompensated, crossed into the oncoming lane of traffic, and struck a vehicle heading eastbound (Vehicle #1). Before impact with the oncoming vehicle (Vehicle #1), the driver steered the rescue truck to the right, attempting to avoid a second collision (Vehicle #2). It is estimated that the rescue truck was traveling approximately 45 mph

Discussion: When departments add additional equipment to an apparatus, they should consider if it will obstruct any controls the driver must operate. The department installed a metal 8-inch by 12-inch map card box in the center console of the rescue truck (see Photo 2). The driver had trouble reaching up and over the box to operate the master switch.

Photo 2. The Map Card Box and the Master Light Switch Inside the Cab.

Recommendation #3: Fire departments should ensure that the placement of additional equipment (e.g. radios and map card boxes) added to an apparatus does not interfere with the driver’s ability to operate controls.¹

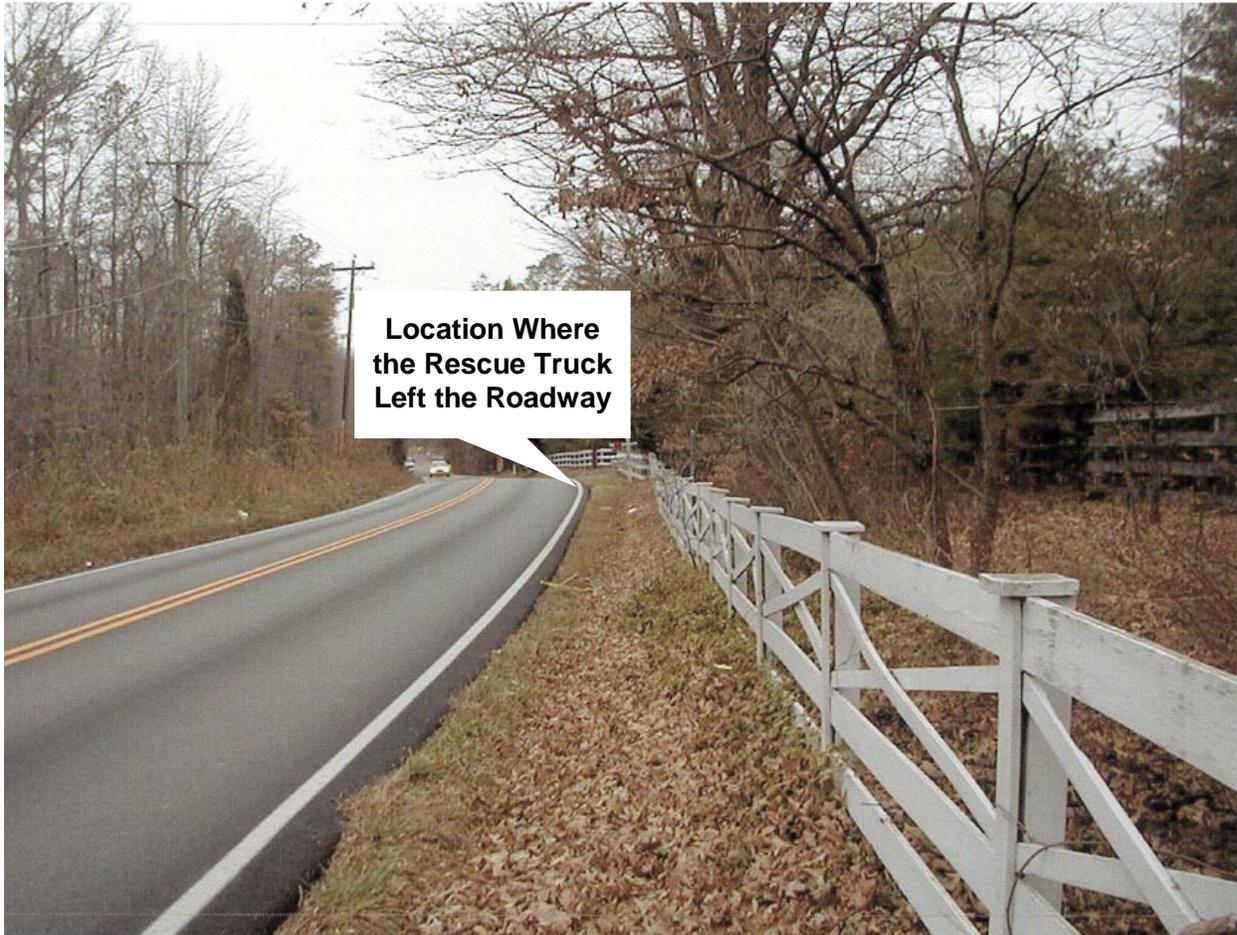
Photo 3. Incident Site.

The rescue truck was traveling on a two-lane residential road in the westbound direction; the lane measured 9 feet 9 inches wide. The eastbound lane measured 9 feet 8 inches wide. The pavement markings consisted of solid double-center yellow lines and white fog lines. The road was asphalt and at the time of the incident was in good condition. It had no drivable shoulder and dropped into a moderate ditch (see Photos 3 and 4). The posted speed limit was 35 mph with an advisory safe speed of 30 mph due to an approaching curve. This road had been identified by the fire department as a dangerous road due to the

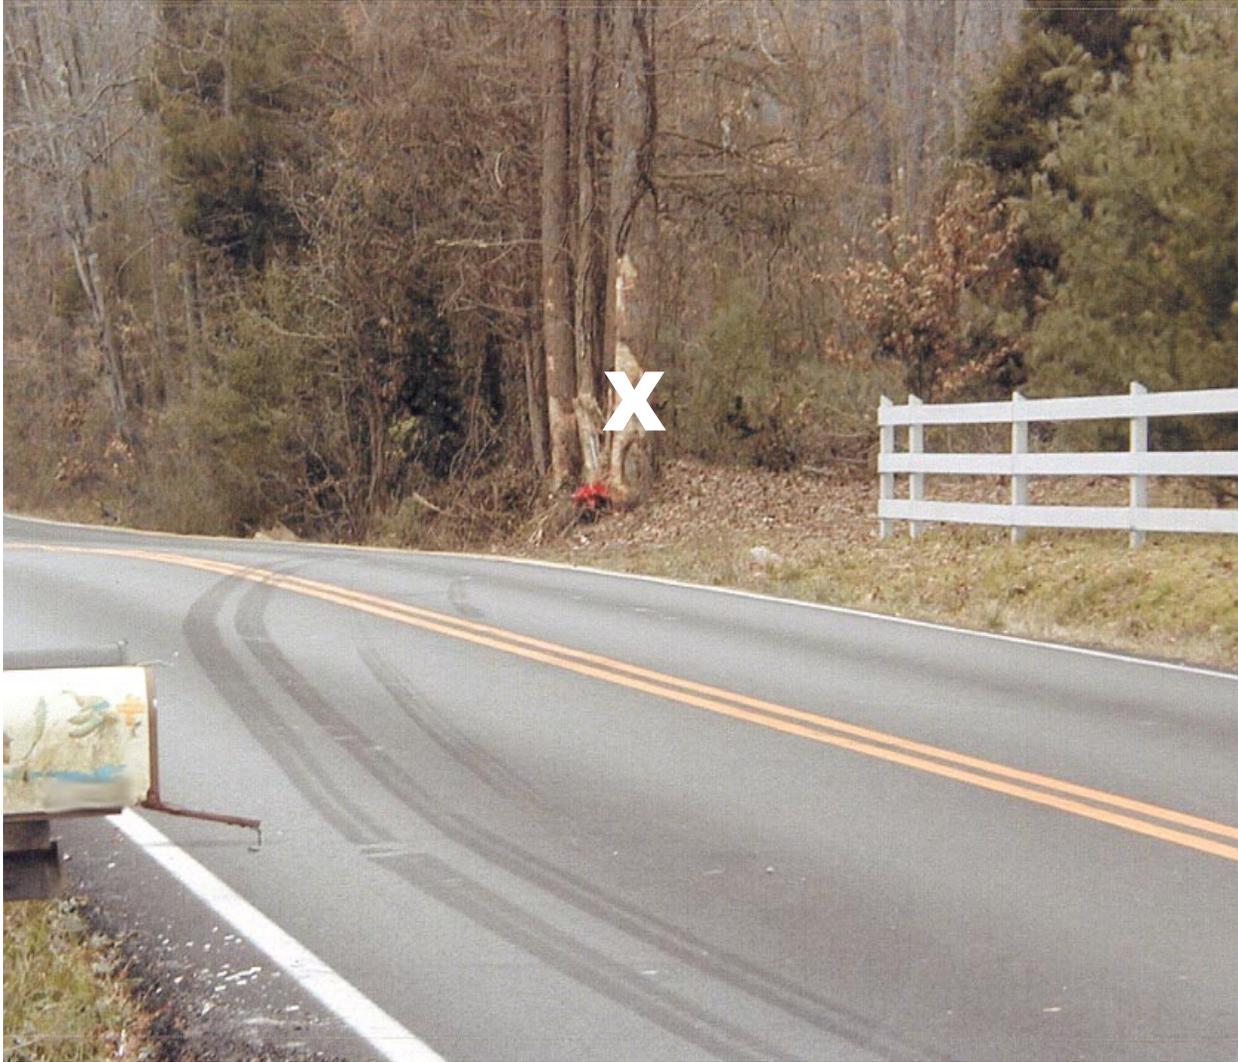
at this point. After impact with Vehicle #1, the truck crossed back into the westbound lane, went off the road surface and hit a large tree (see Photo 5). *Note: The police department determined that the truck's weight shifted to the driver's side as the truck struck the tree. This weight shift caused the truck to overturn onto the driver's side. The speedometer of the rescue truck was analyzed and it was determined that the rescue truck was traveling approximately 55 mph at the time of impact with the tree.* Vehicle #2, traveling eastbound behind Vehicle #1, ran off the road to avoid hitting the rescue truck. Both Vehicles #1 and #2 ran off the road and into the eastbound ditch; however, none of the occupants were injured. Several residents who heard and saw the collision of the rescue truck, called 911 to report the motor-vehicle incident. Immediately after the collision, the driver crawled out of his loose seat belt and out of the cab through the shattered windshield. The victim was suspended by his seat belt, and was hanging over the center console. Between 1944 and 1951 hours, the following units were dispatched to the motor-vehicle incident involving the rescue truck: Engine 43, Engine 44, Engine 53, Engine 54, Engine 93, Truck 97, Ambulance 422, Ambulance 731, Ambulance 736, BC 1, BC 2 and BC 4. An off duty fire fighter/paramedic was several cars behind the wreck in a privately owned vehicle when he approached Rescue 49 and saw it overturned on its side. The fire fighter/paramedic ran to Rescue 49 and saw the driver by the front of the truck. He asked the driver who else was on the apparatus and the driver replied that the victim was inside the vehicle. The fire fighter/paramedic climbed on the passenger side of the truck and saw a civilian holding the victim's head. The fire fighter/paramedic did a quick assessment of the victim and noticed that he had a very weak pulse and agonal respiration. He noticed the victim had extensive head trauma and his legs were pinned

Photo 5. The X Indicates the Point of Impact of the Rescue Truck With the Tree.
