## **Tanker Rollover Results in the Death of One Volunteer Fire Fighter - Texas**

### **SUMMARY**

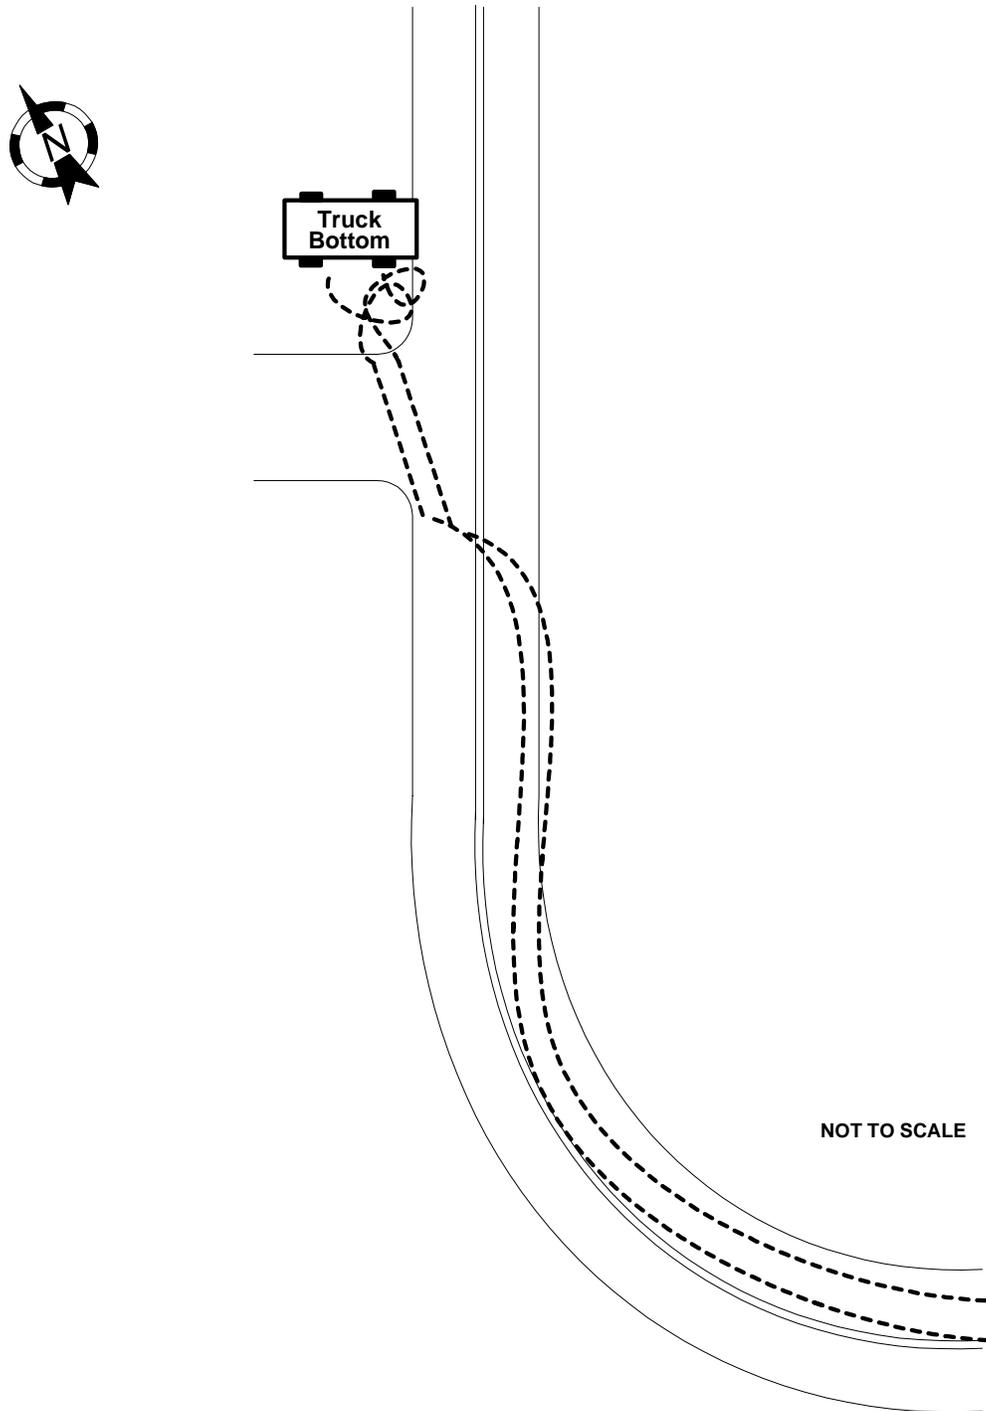
**Diagram 1.** Path of Tanker Truck

On November 14, 1999, a 46-year-old male volunteer fire fighter died while responding to a mutual-aid call received at 1633 hours from a neighboring career department. The career department was battling fire in approximately 200 hay bales and requested an additional supply of water. The victim responded in a tanker truck with a full tank of water. The truck was top-heavy and had a short wheelbase (approximately 136 inches). The victim's vehicle was traveling northbound on a two-lane road with a posted speed limit of 55 mph.

Witnesses have described the truck entering a curve near the center line and then veering back toward the right shoulder. As the truck went through the curve, the right front and rear wheels dropped off the road surface onto the gravel shoulder. The victim attempted to steer the truck back onto the road surface when it is believed that the weight of the truck shifted, causing the victim to lose control. The truck went into a sideways skid, crossing over the center lines and traveling toward the gravel shoulder in the opposing southbound lane. The tires dug into the gravel, and the truck flipped and rolled (see Diagram 1). The victim was partially ejected from the cab through the rear window. He was not wearing his seat belt. After rolling 1½ times, the truck came to rest upside down, trapping the victim between the cab and the ground. Civilians who witnessed the incident rushed over to the truck to assess the victim's condition. One civilian stated that the victim was semiconscious but had several apparent injuries. The police department that investigated the incident estimated the truck was traveling at a speed under the posted speed limit.

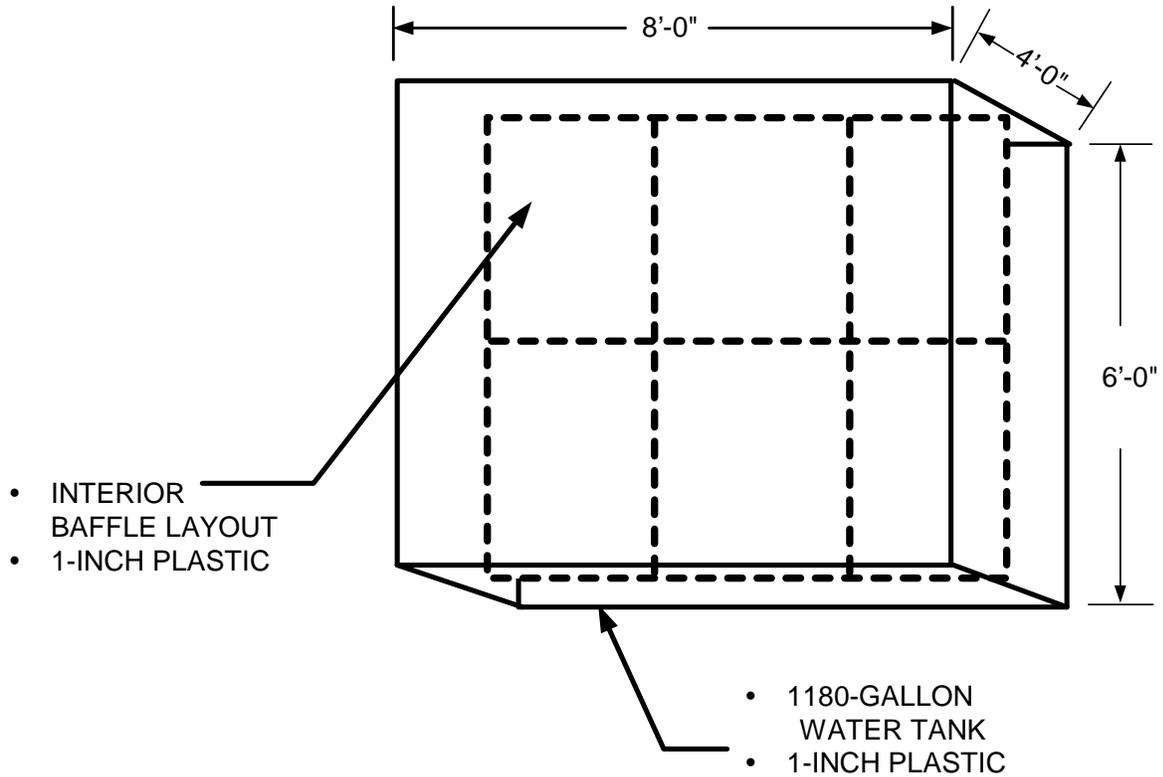
**Diagram 2.** Tank Baffle Diagram

The vehicle involved in this incident was a two-door, 1982 Ford F700 flat bed truck. The vehicle's gross weight was 23,100 lbs., and it had a short wheelbase of approximately 136 inches. The vehicle was equipped with an air brake system and a three-point restraint system (lap/shoulder). Originally used as a utility truck for a power company, the vehicle was donated to the volunteer fire department and then modified to be used as a tanker truck for water supply. The rectangular water tank attached to the truck bed held 1,180 gallons of water and was full at the time of the incident. The total weight of the tank with water was 9829 lbs. Measuring 8 feet long by 6 feet wide by 4 feet high, the tank was constructed of plastic approximately 1 inch thick. The tank was located directly in the center of the truck bed. The tank was equipped with baffles which were made of the same material as the tank (see Diagram 2).

consisted of removing the power company's equipment, redesigning the truck's bed to hold a 6-foot by 8-foot water tank, and painting the truck. The truck had a short wheelbase, approximately 136 inches. The truck was top-heavy due to the short wheelbase and the additional weight of the added tank and water. A truck of this design could be subject to weight transfer problems. The effects of weight transfer must be considered in the safe operation of emergency vehicles/apparatus. Whenever a vehicle undergoes a change in velocity or direction, weight transfer takes place relative to the severity of the change. When the victim attempted to steer the vehicle back onto the road surface, the weight of the truck shifted, causing the victim to lose control.

***Recommendation #1: Fire departments should ensure that all operators of emergency vehicles be familiar with the vehicle and its design.<sup>1</sup>***
