Volunteer Fire Fighter Dies Fighting a Structure Fire at a Local Residence - Texas

Fatality Assessment and Control Evaluation Investigative Report #F2000-09

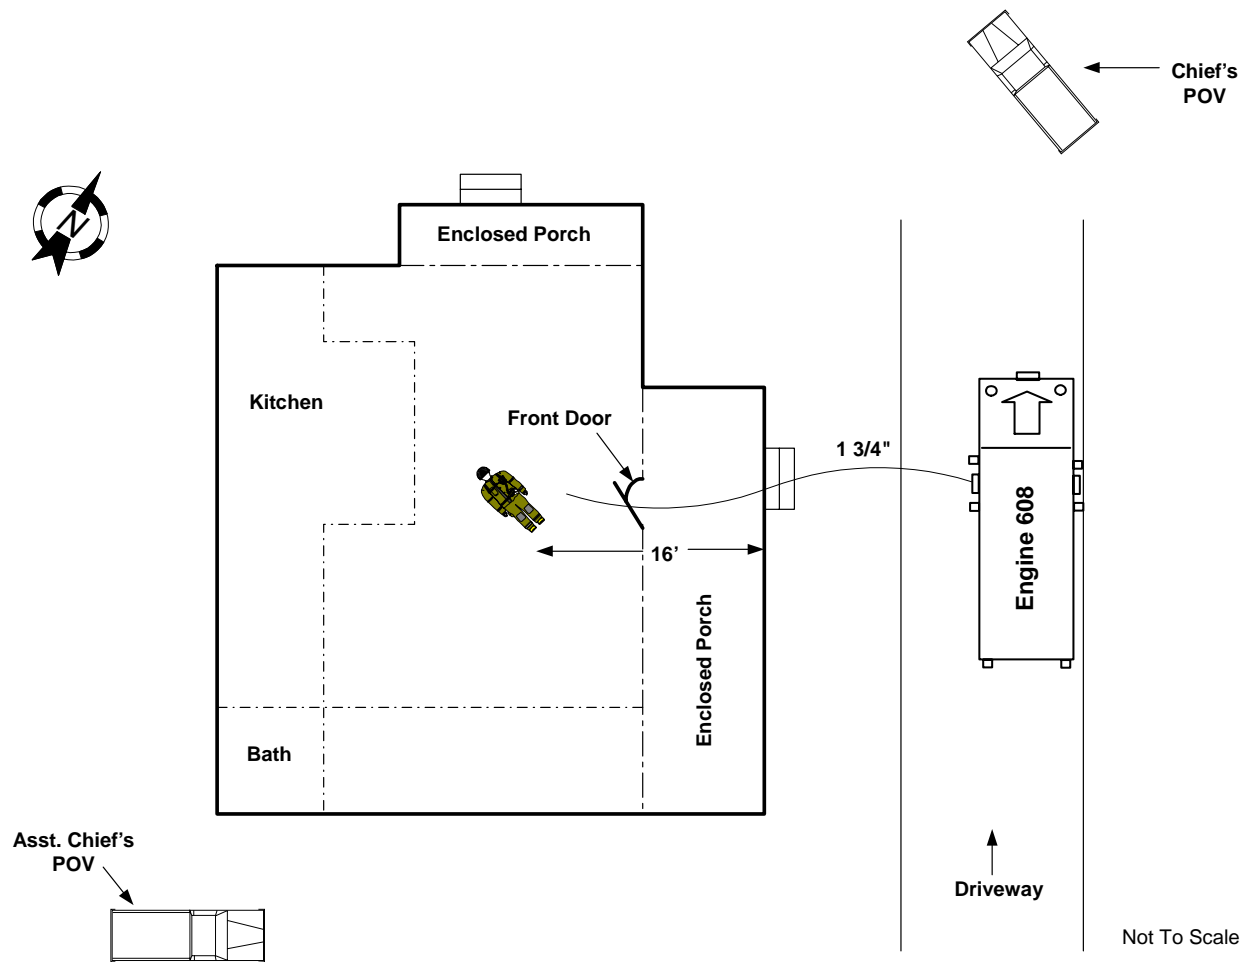
Figure. Overview of Incident Site

The crew from Engine 608 pulled 200 feet of 1 3/4-inch cross lay hoseline and proceeded through the door of the enclosed porch and then into the front door of the main structure (see Figure). The victim took the nozzle, and Fire Fighters #1 and #2 followed as backup. The chauffeur/engine operator of Engine 608 called for a supply line to be laid, and one of the mutual-aid companies laid the line. As the crew from Engine 608 entered the structure, the victim called for more hose line. Fire Fighters #1 and #2 went to the doorway of the main structure to pull more hose line into the structure. As Fire Fighters #1 and #2 were feeding hose line to the victim, they felt the hose line drop. *Note: At approximately this time, it is believed that a thermal heat column occurred, causing the hose line to drop as if they were feeding the line directly into the ground.* Fire Fighters #1 and #2 exited the structure and reported to the Chief to notify him of the situation. The Chief
