NIOSH
Fire Fighter Fatality Investigation
and Prevention Program

February 7, 2001

Restaurant Fire Claims the Life of Two Career Fire Fighters - Texas

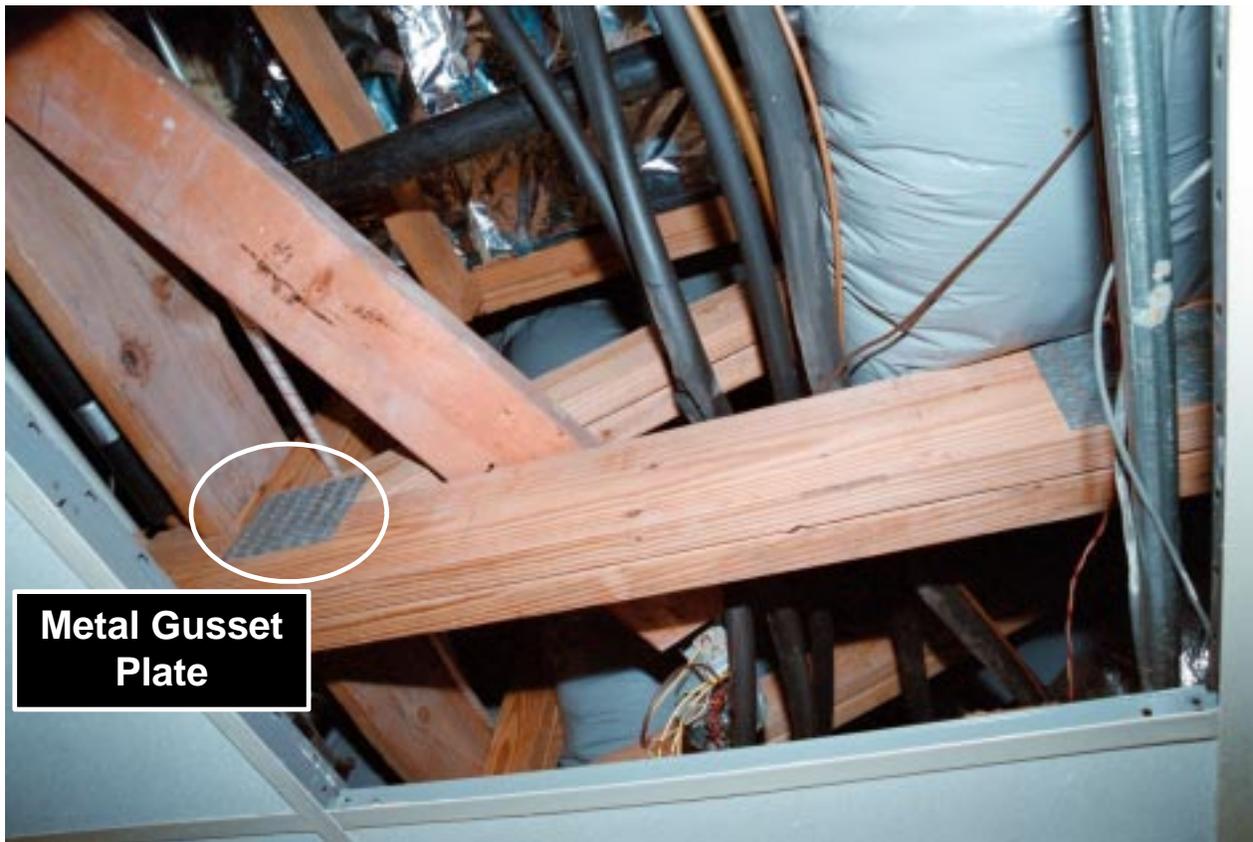
Photo 1. *Metal Gusset Plate Used on Roof System of Restaurant* Note: Photo was taken of a restaurant similar to the one involved in this incident.

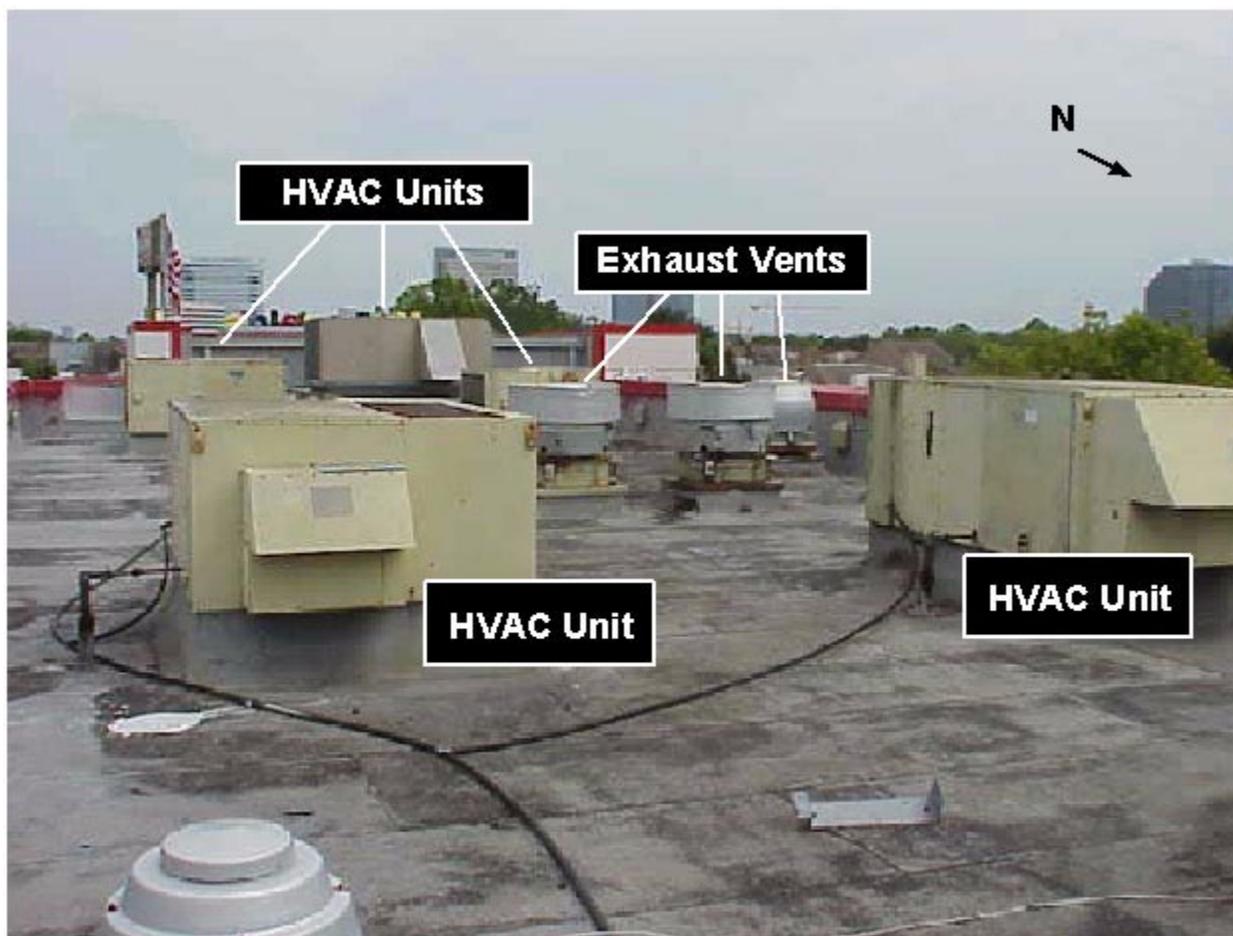
Photo 2. HVAC Units and Cooking Vents Positioned on the Roof of the Restaurant

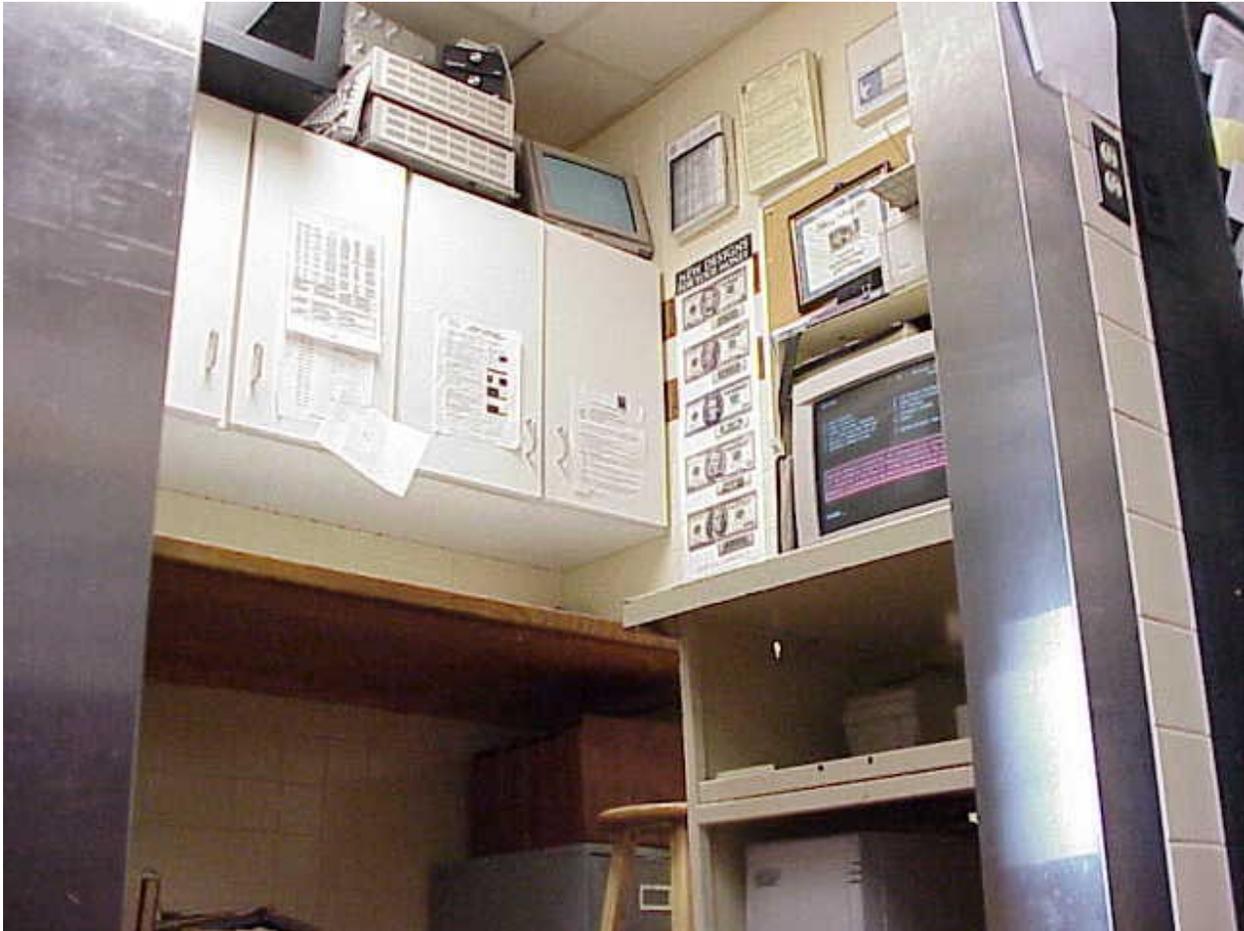
The City Fire and Arson Bureau declared the cause of this incident as arson. The origin of the fire was determined to be in the office, which extended into the void space above the suspended ceiling.

Photo 3. Fire's Point of Origin Was Determined to Have Occurred in the Office of the Restaurant Note: Photo was taken of an office in a restaurant similar to the one involved in this incident.

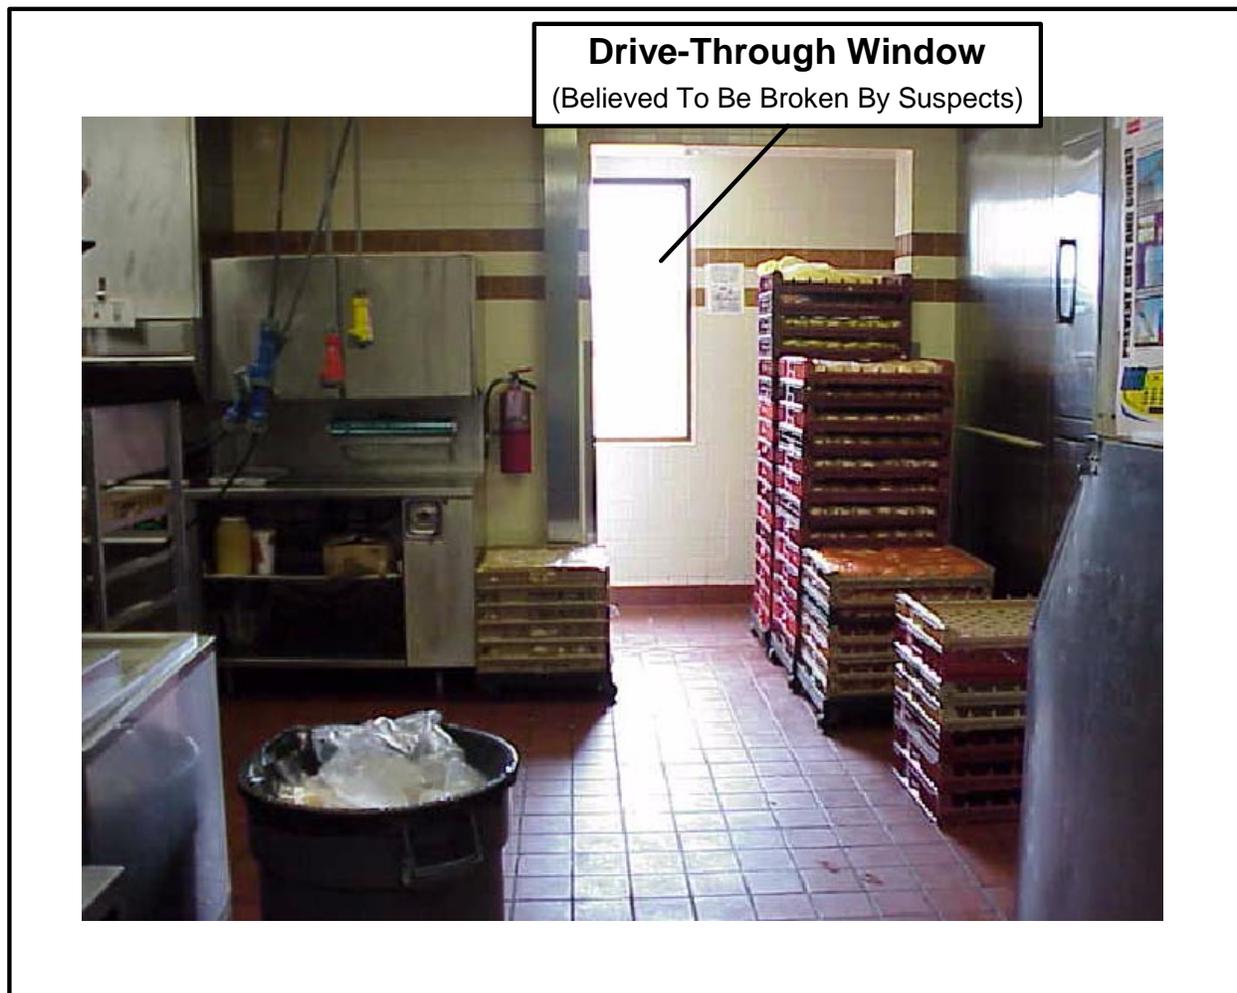
Photo 4. Drive-Through Window of Restaurant, Located Across From the Office Door
Note: Photo was taken in a restaurant similar to the one involved in this incident.

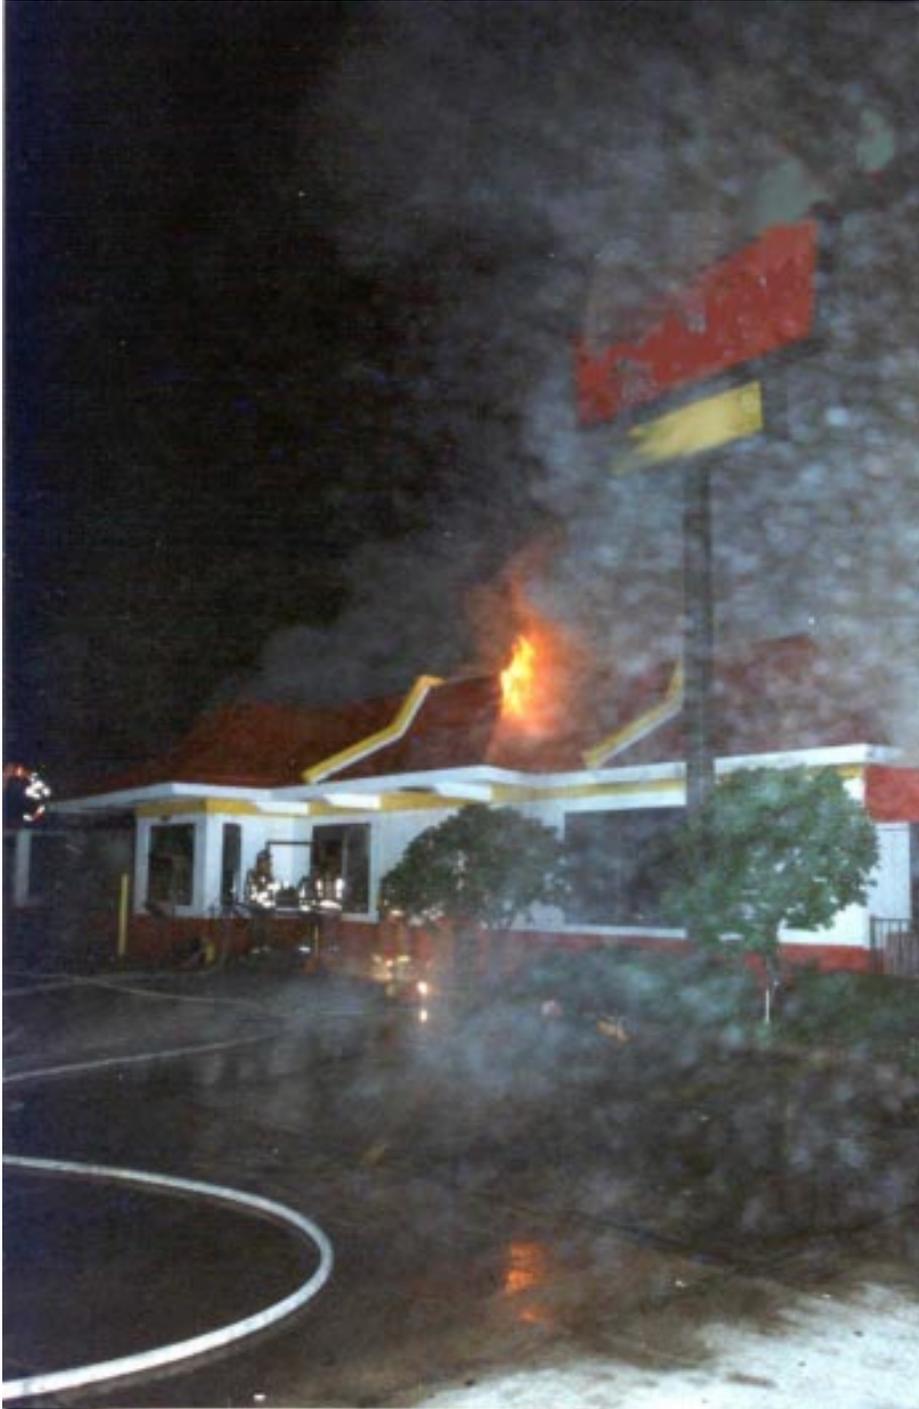
Photo 5. Early Stages of the Restaurant Fire

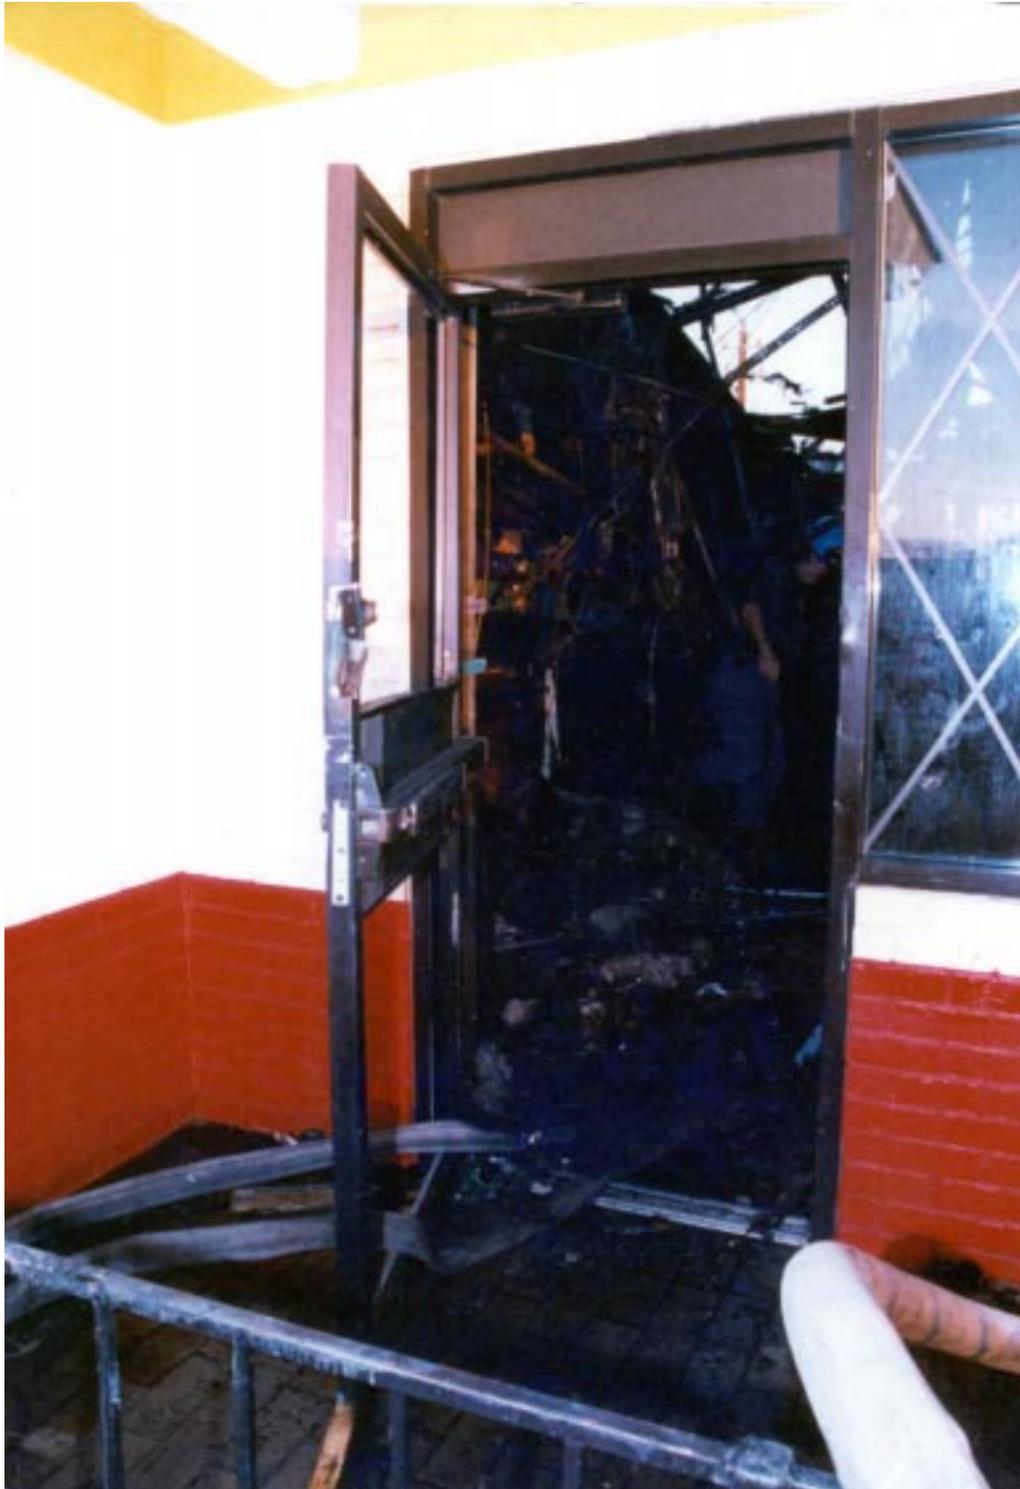
Photo 6. West Side Door, Entered and Exited by the Fire Fighters

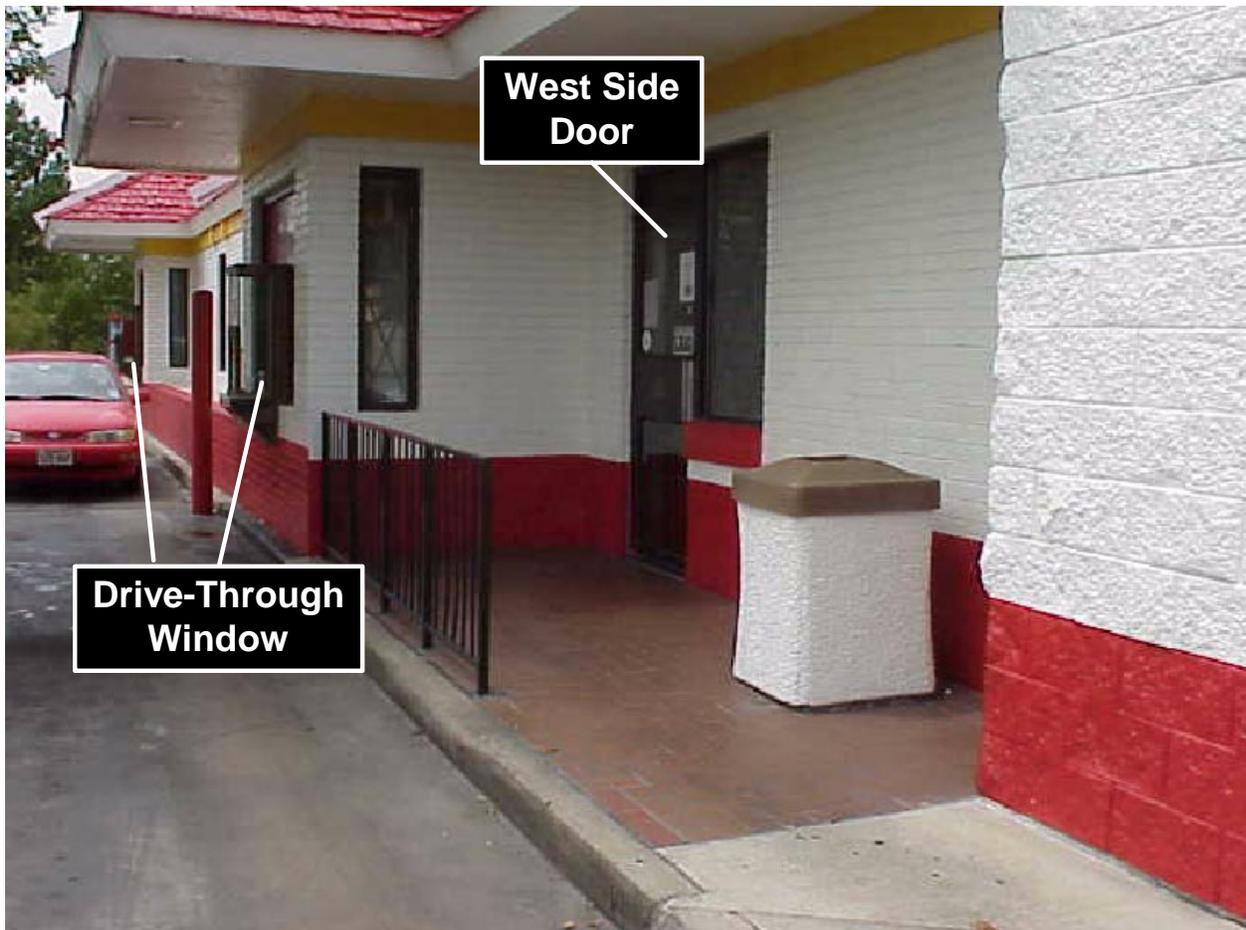
Photo 7. West Side of Restaurant Note: Photo was taken of a restaurant similar to the one involved in this incident.

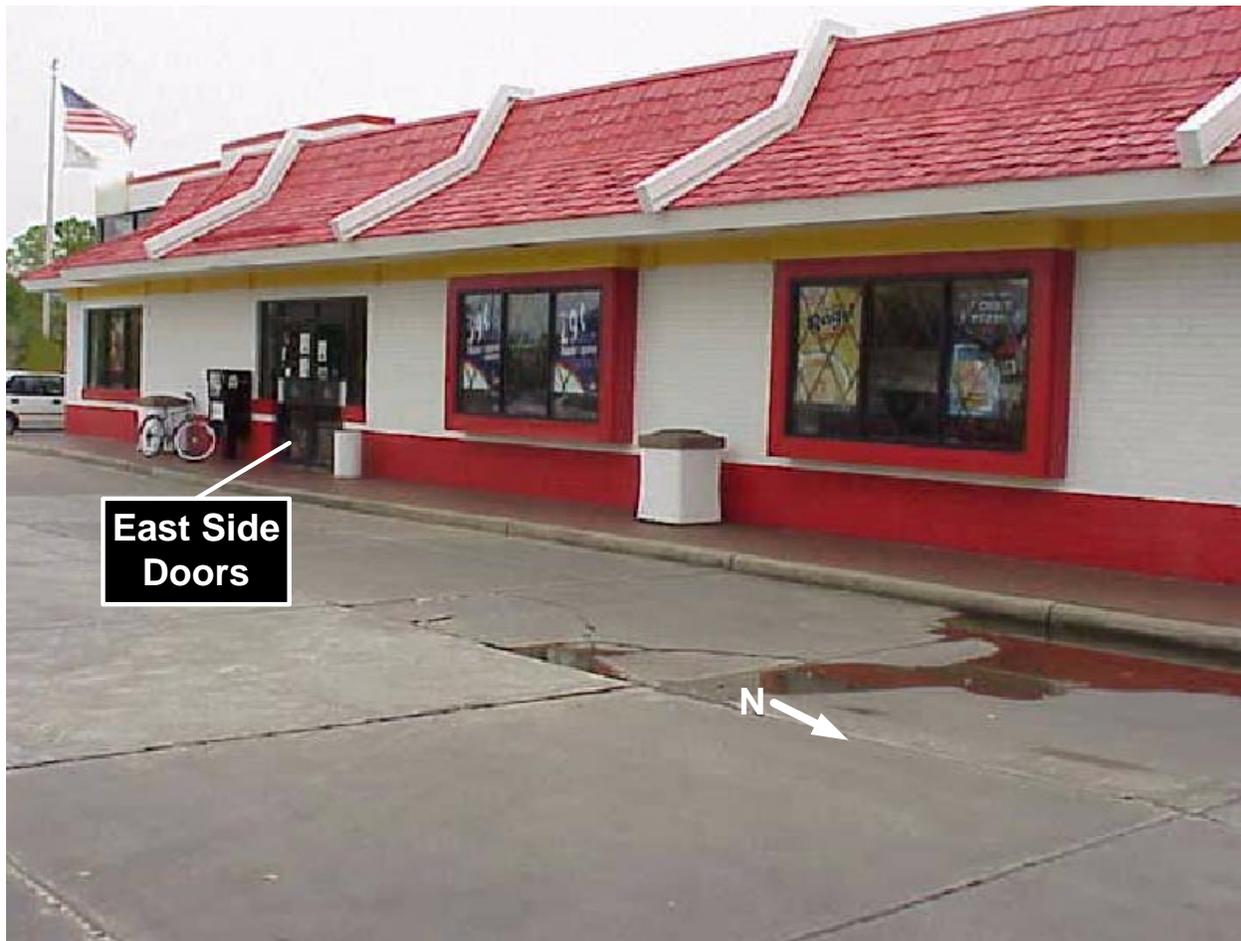
Photo 8. *East Side of Restaurant* Note: Photo was taken of a restaurant similar to the one involved in this incident.

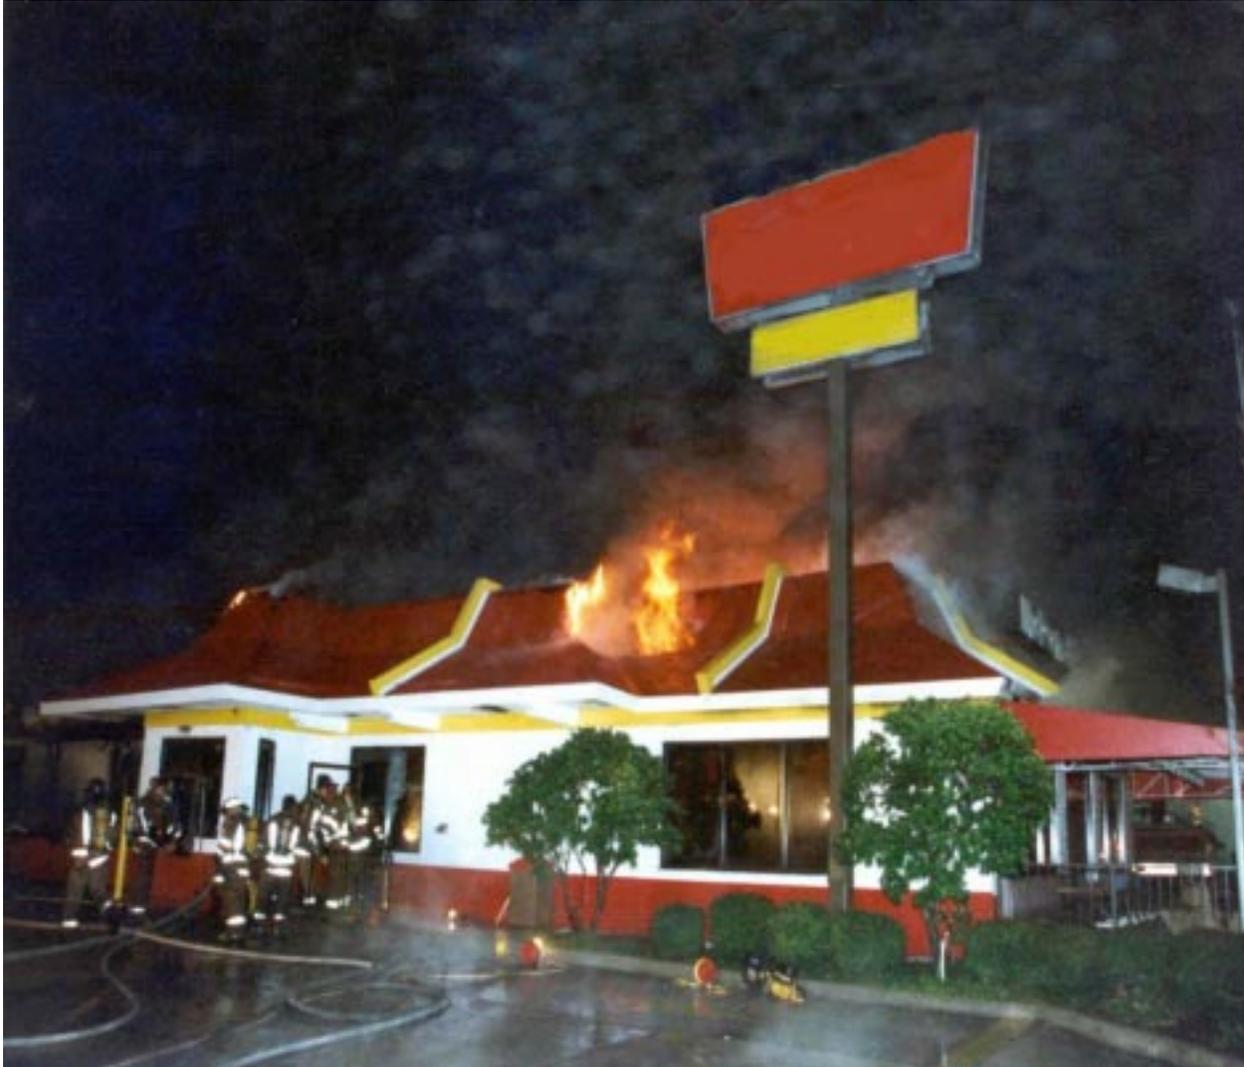
Photo 9. Photo Depicts the Restaurant Fire at the Approximate Time the Roof Collapsed

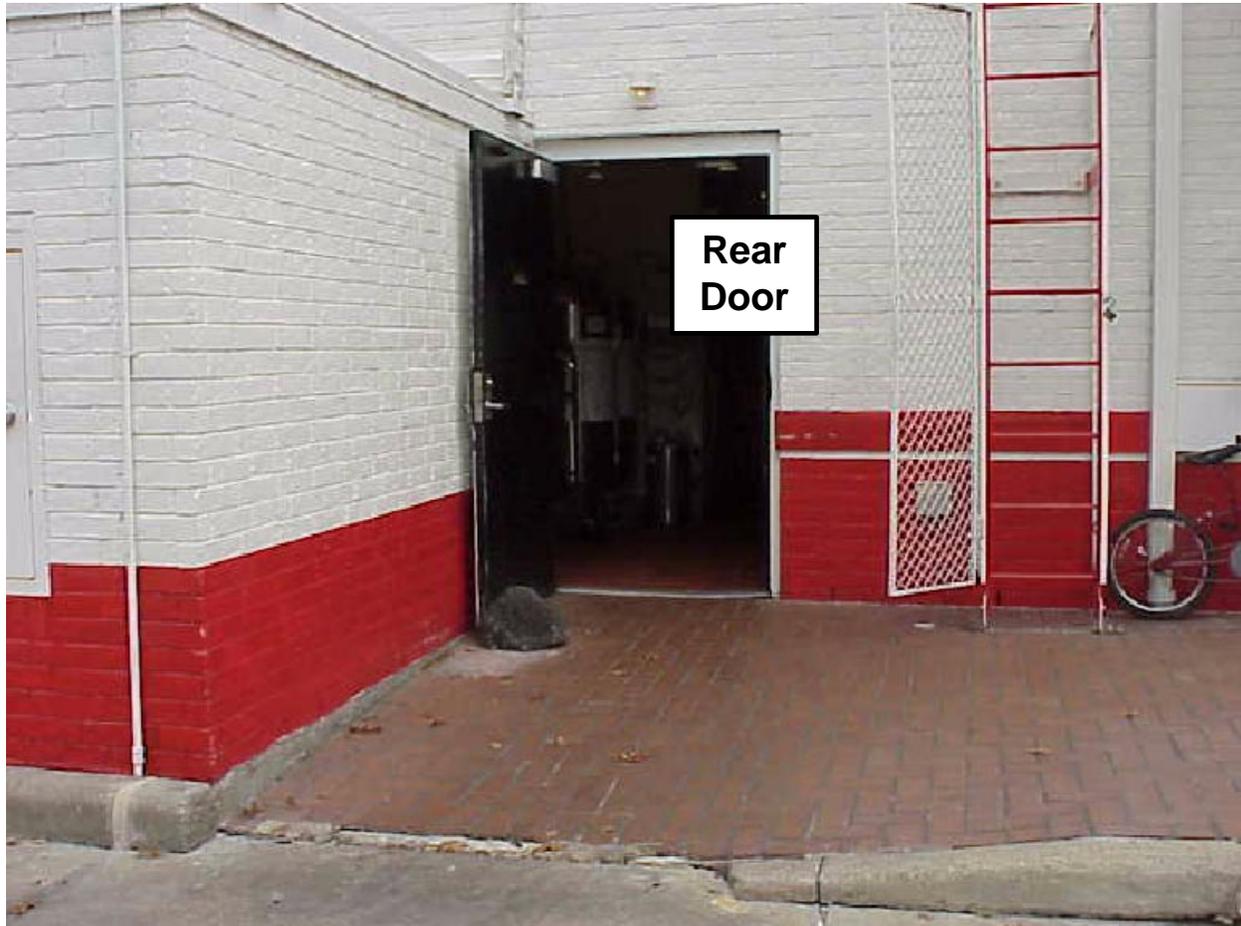
Photo 10. *Rear Door Used by Fire Fighters to Gain Access During Search for Victims*
Note: Photo was taken of a restaurant similar to the one involved in this incident.

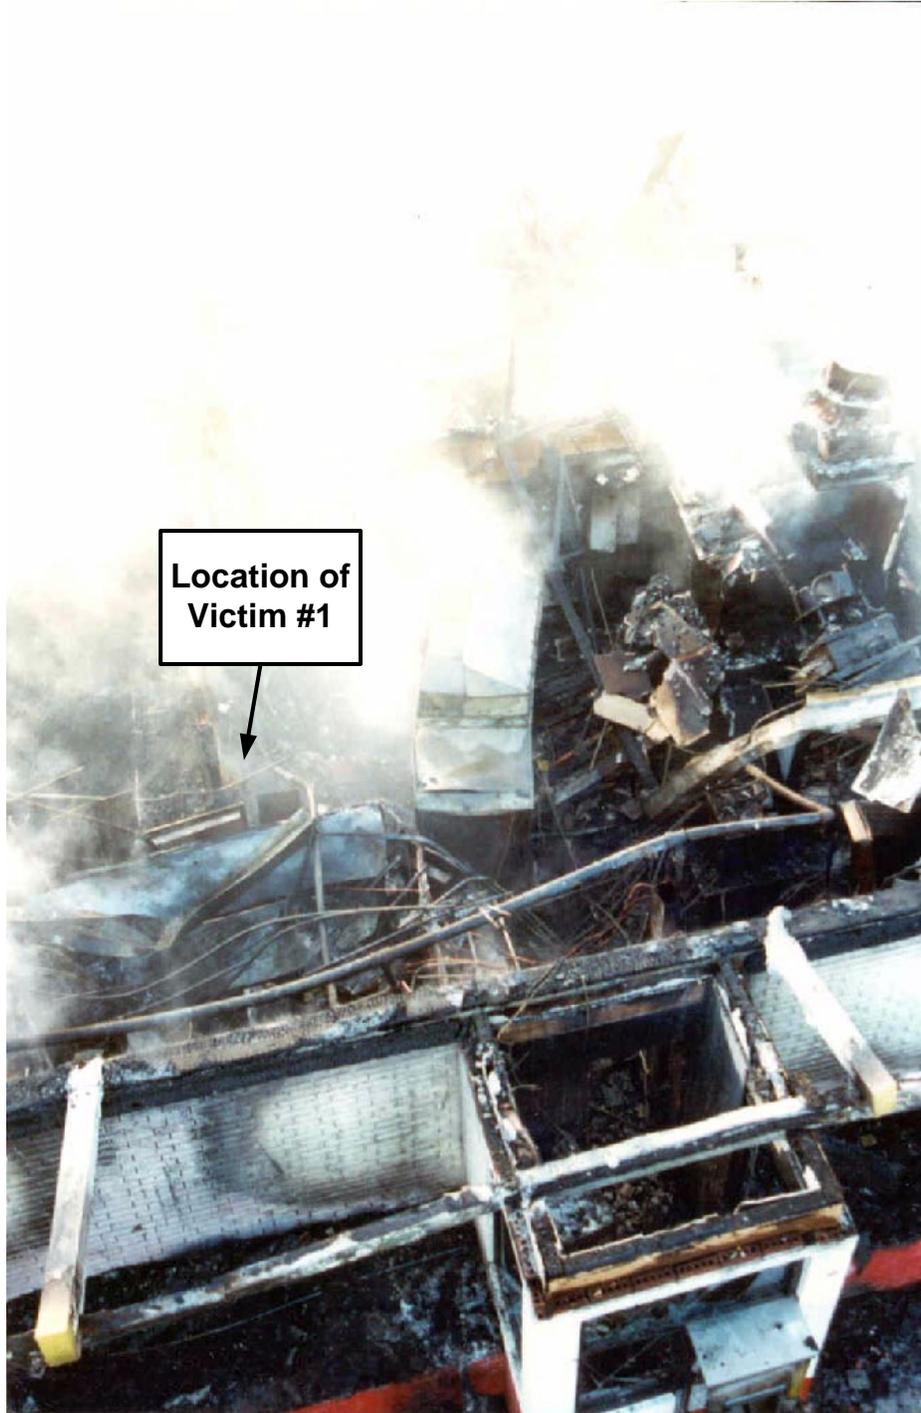
At 0533 hours, Rescue 11 was on the scene and reported to the rear door. Assuming that Victim #2 was in the general vicinity where Victim #1 was found, the IC ordered Rescue 11 to enter the rear door and search for her. The fire fighter from Ladder 68, who found Victim #1, reentered with Rescue 11 (Captain and two fire fighters) and showed them where Victim #1 was found. He then exited as Rescue 11 searched. They searched for approximately 20 minutes and then exited to change their air cylinders. Rescue 11 stated that there was a lot of debris and that there was a 2-inch main gas line burning in the area they were searching. At 0543 hours, the Chief arrived on scene and assumed command. At 0556 hours, Rescue 11 noticed a fire fighter's boot near the area where Victim #1 was found. They radioed the Chief reporting that they thought they had found Victim #2. The Chief, a Captain and two fire fighters from Rescue 11, and the Captain from Ladder 76, entered the rear door of the building. They walked to the area where Victim #1 was found and located the fire fighter's boot, near a HVAC unit on the floor. They assumed—based on the location of the boot and on the nearness to the other victim's location—that Victim #2 was under the fallen debris and HVAC unit (see Photo

11). Concerned about the burning gas line and fearing another collapse, the Chief then ordered everyone out and requested a PAR for all companies. He then ordered all first-alarm companies to report to the designated rehabilitation area. He radioed dispatch and requested the gas company to respond and shut off the gas. He again received a complete PAR for all companies except Engine 76.

Photo 11. Location of Victim #1

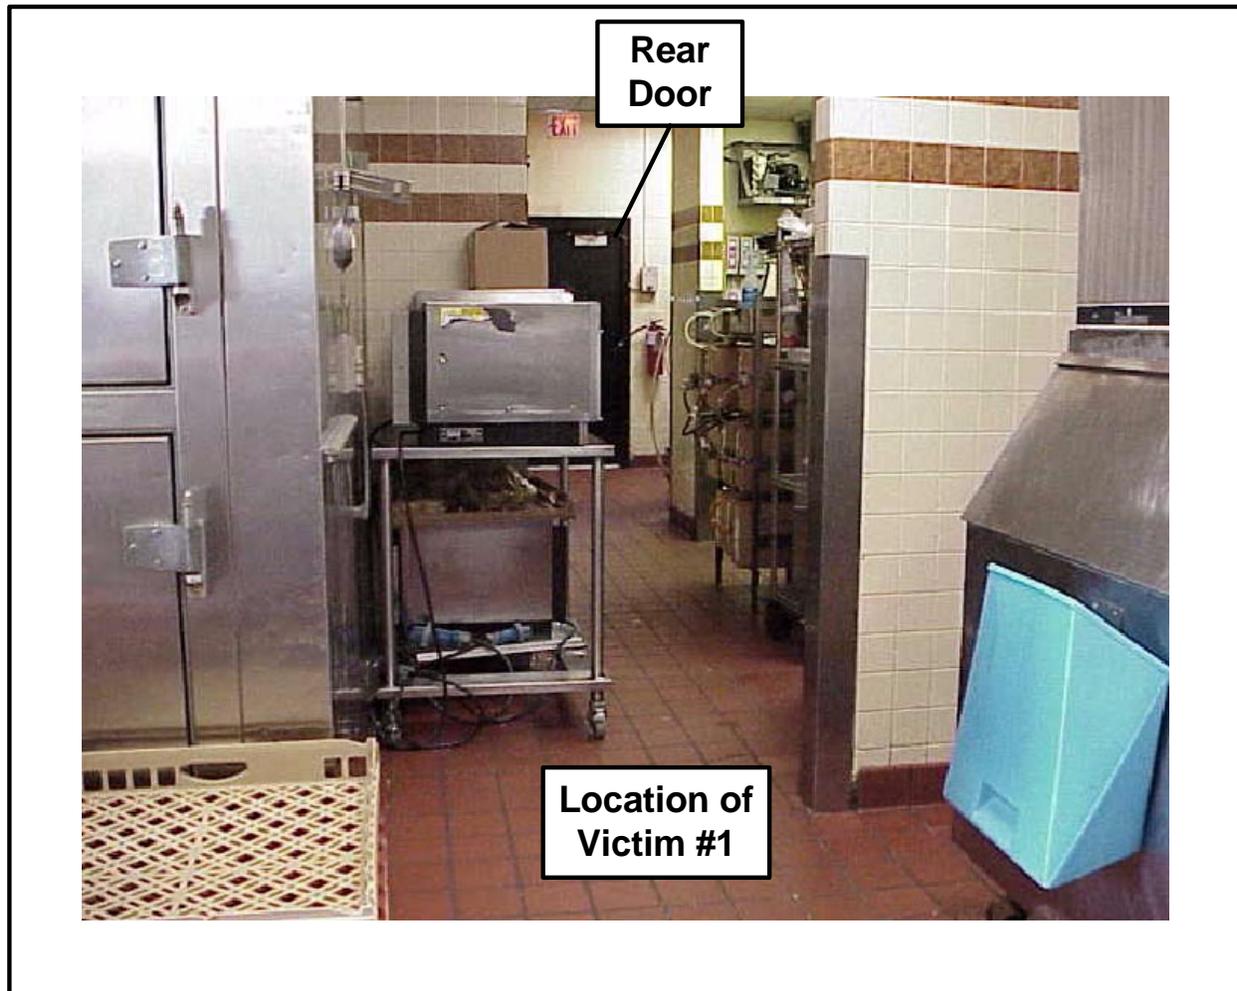
Photo 12. Location of Victim #1 Note: Photo was taken in a restaurant similar to the one involved in this incident.

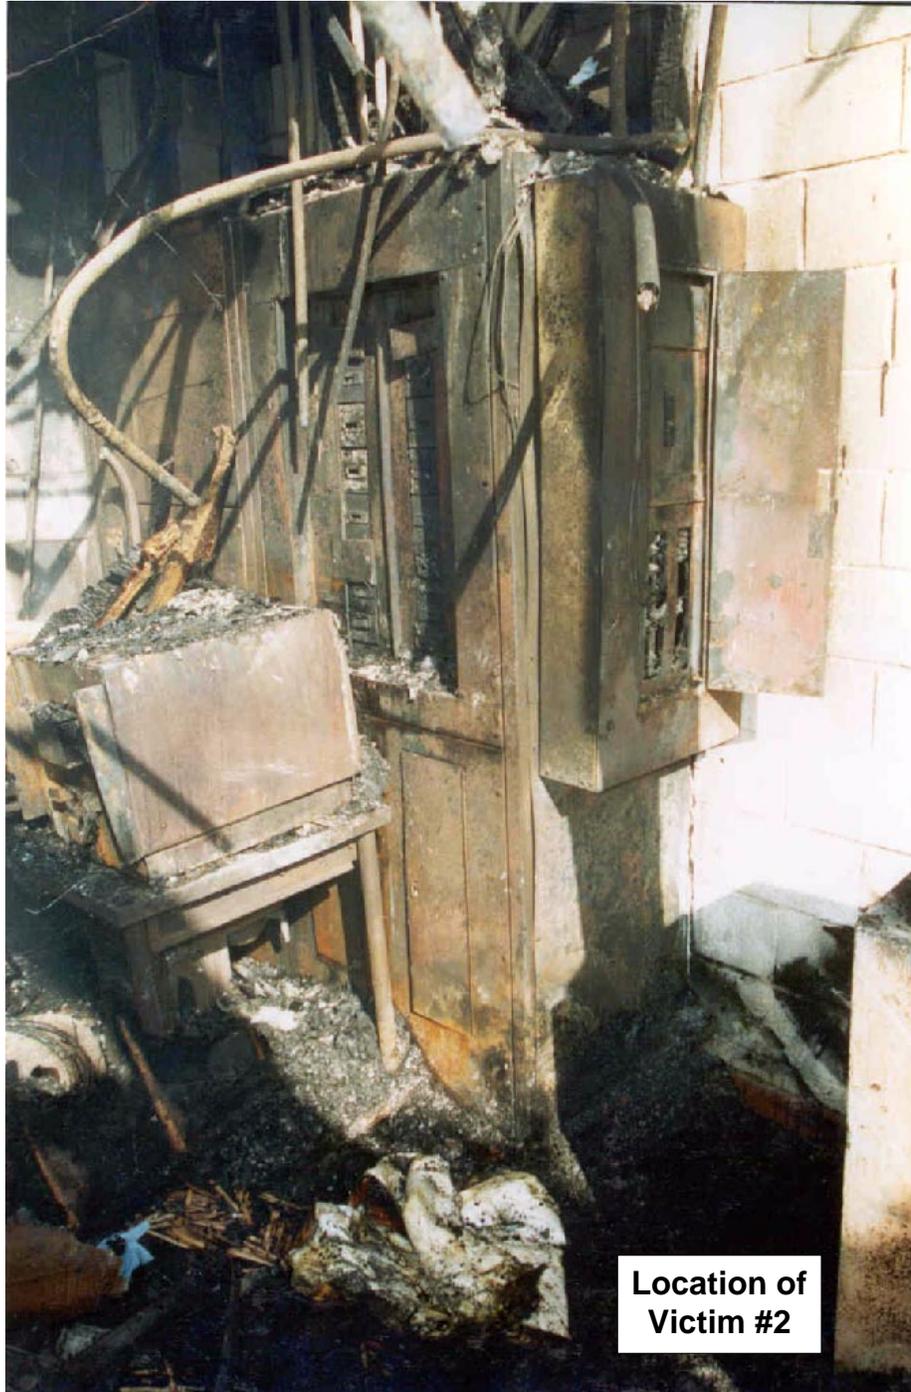
Photo 13. Location of Victim #2

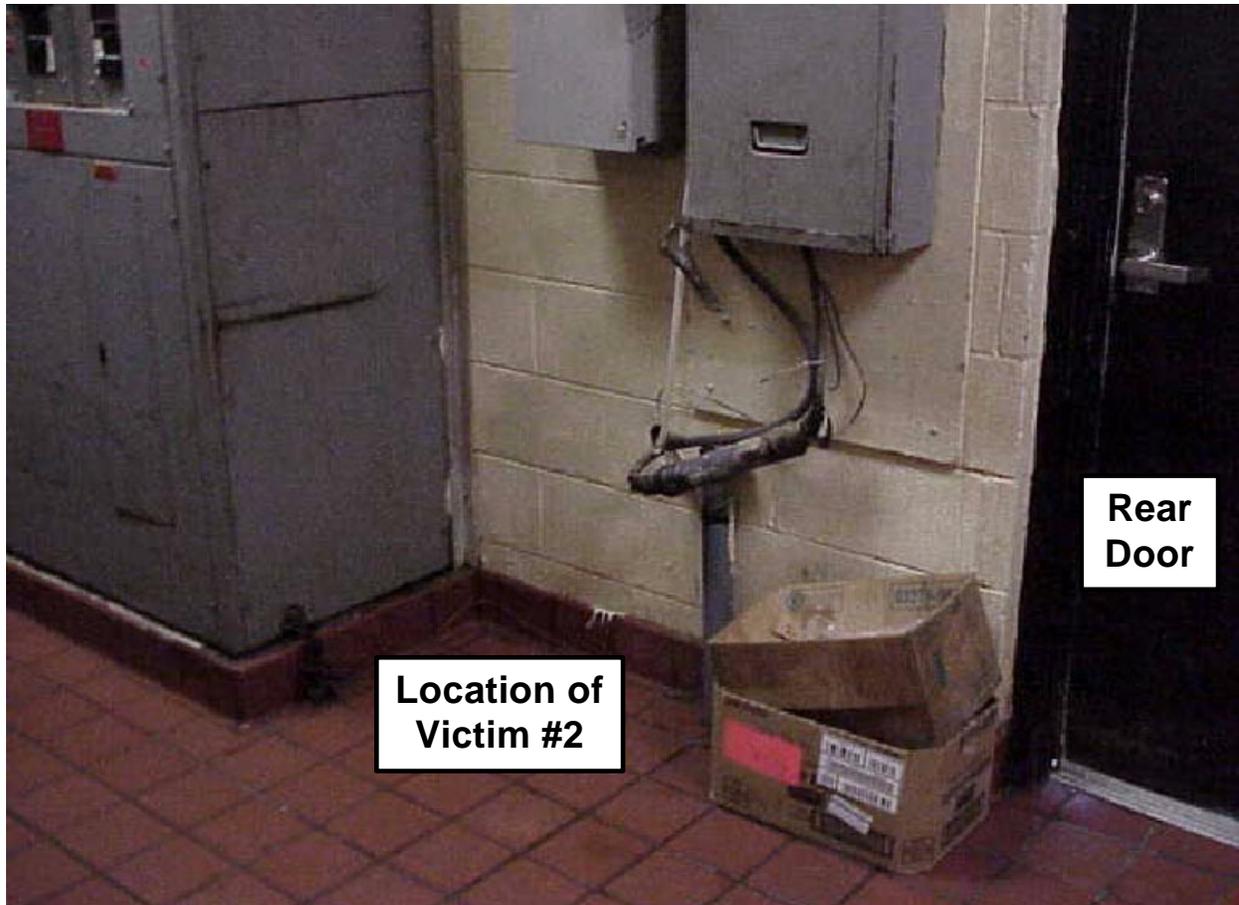
Photo 14. *Location of Victim #2* Note: Photo was taken in a restaurant similar to the one involved in this incident.
