# Death in the line of duty...

A Summary of a NIOSH fire fighter fatality investigation

August 14, 2000

## Motor-Vehicle Incident Involving Amtrak Train Claims Life of Career Fire Fighter/Engineer - North Carolina

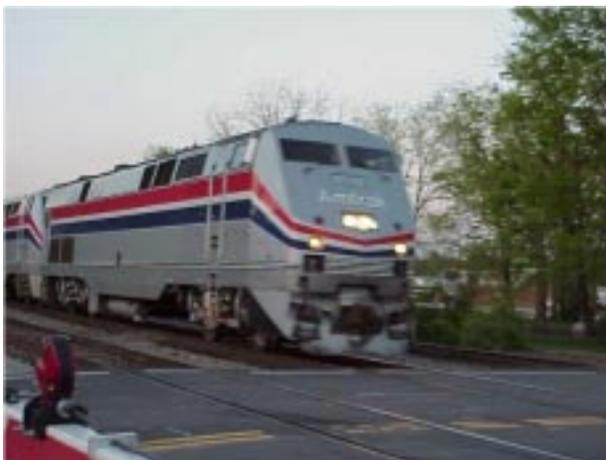
*Similar Amtrak Train Approaching Approximate Point of Impact*

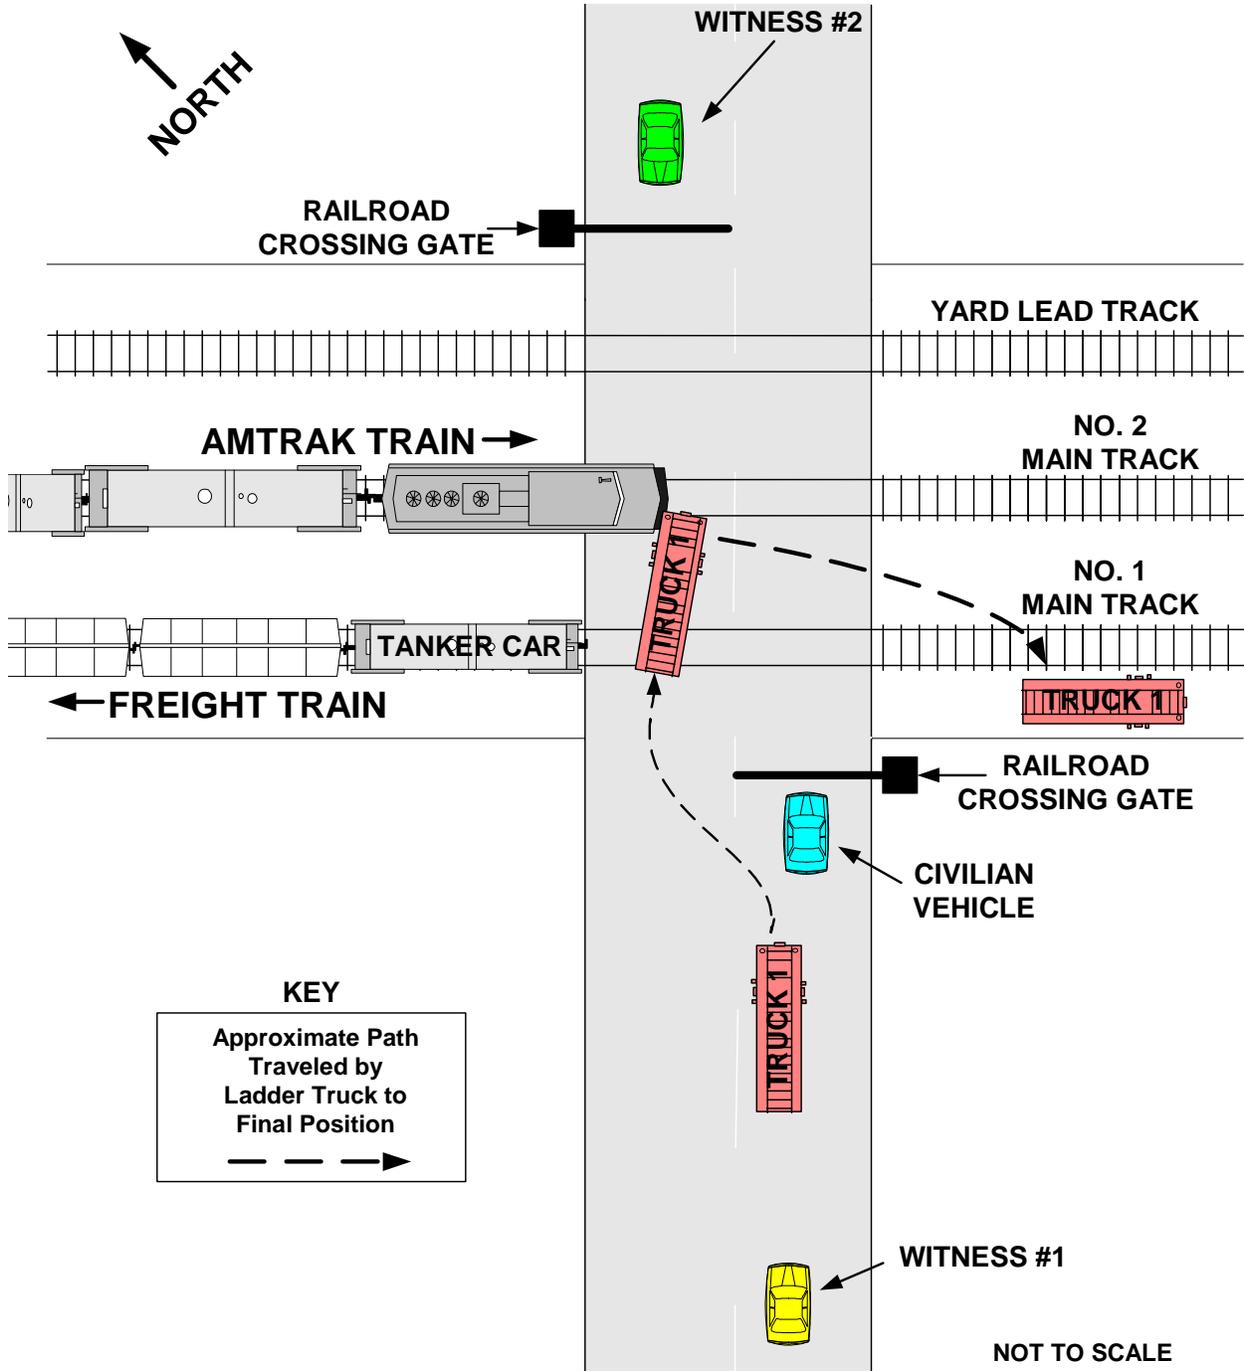
*Diagram. Aerial View*

signal ahead. Truck 1 started to go around the first safety gate and over the track (see Diagram). Witness #1, in a vehicle behind Truck 1, saw a tanker car at the end of the freight train that obstructed the northbound view of the tracks, and he heard a train whistle. Witness #2, waiting in a vehicle on the east side of the crossing, saw a southbound Amtrak train approaching. He also saw Truck 1 driving around the first safety gate, so he honked his horn and flashed his headlights to warn the driver of the Amtrak train. Truck 1 continued around the safety gate and traveled into the path of the train, which struck the truck's left front corner and the bucket of the aerial ladder. The victim was ejected, landing behind the truck's left rear dual wheel. He was killed instantly.

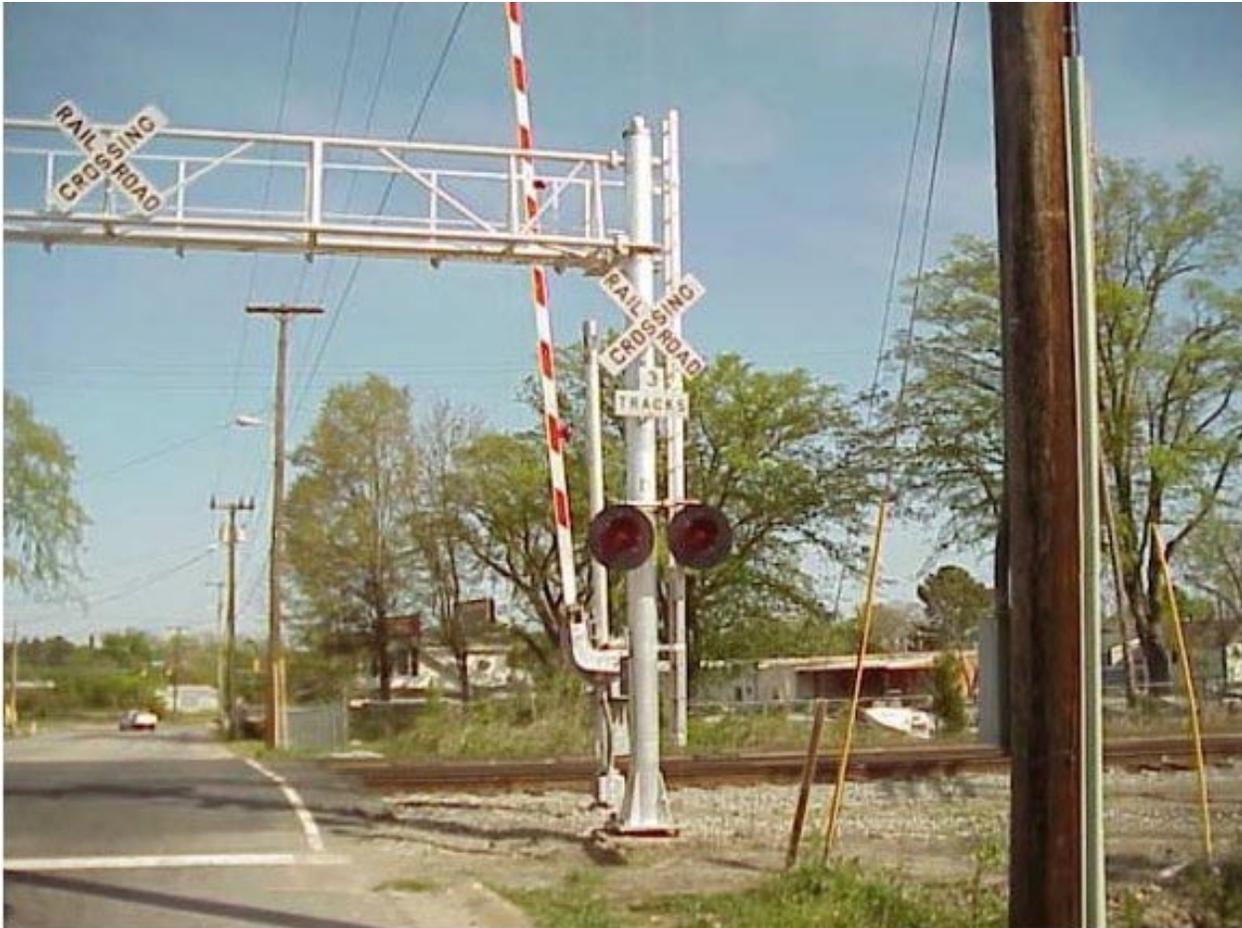
*Photo #1. Railroad Crossing Gate at Incident Site.*

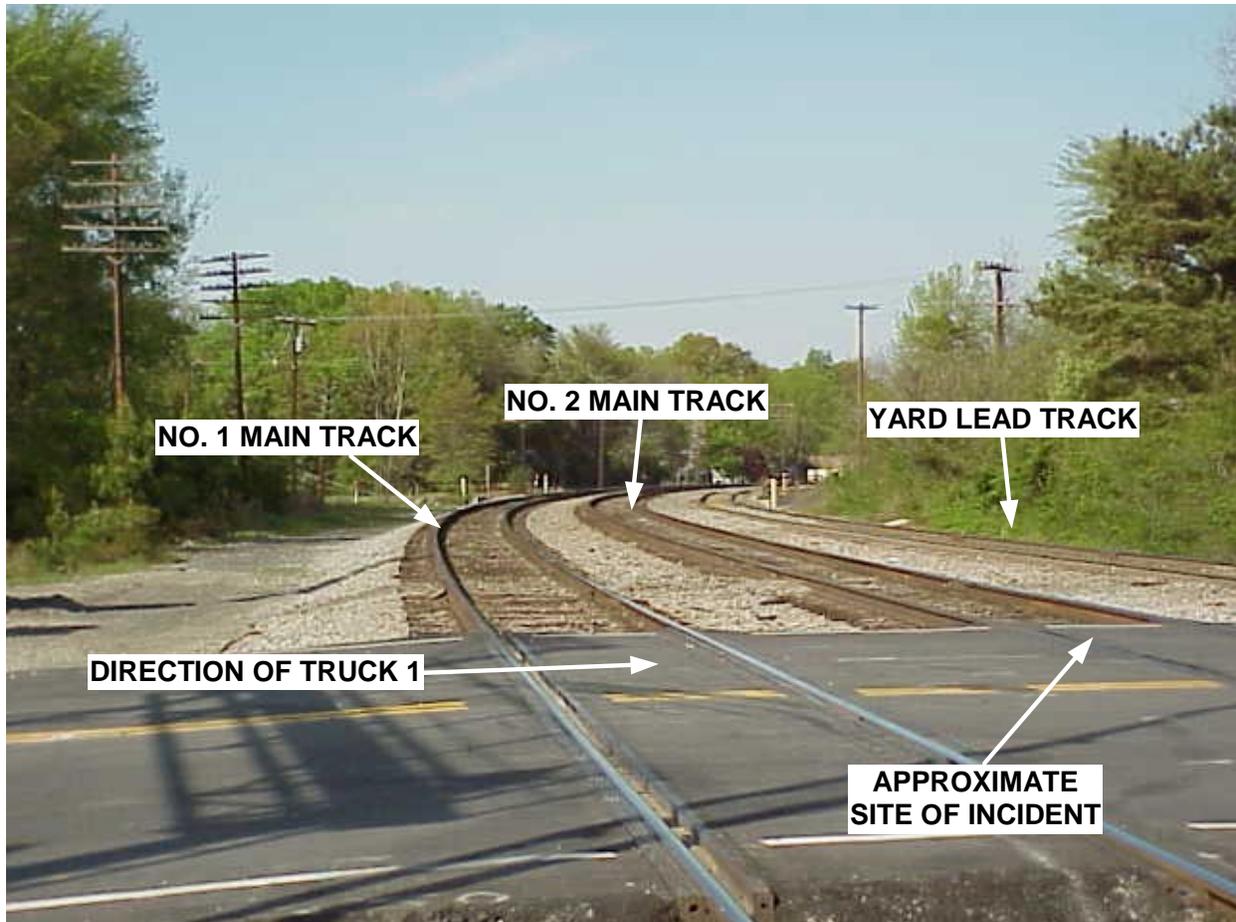
*Photo #2. Highway-Grade Crossing Where Incident Occurred*

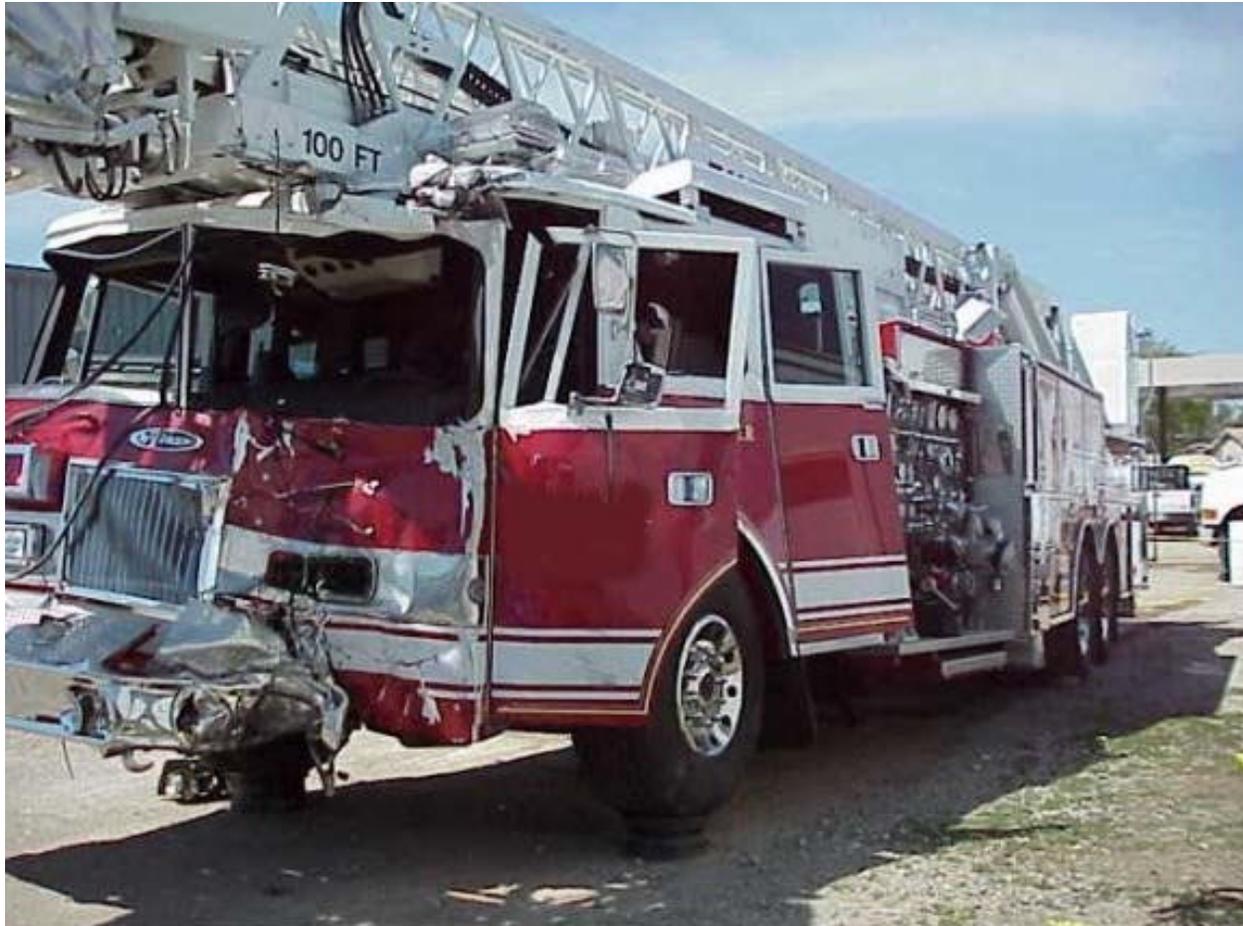
*Photo #3. Ladder Truck (Truck 1) Involved in This Incident.*

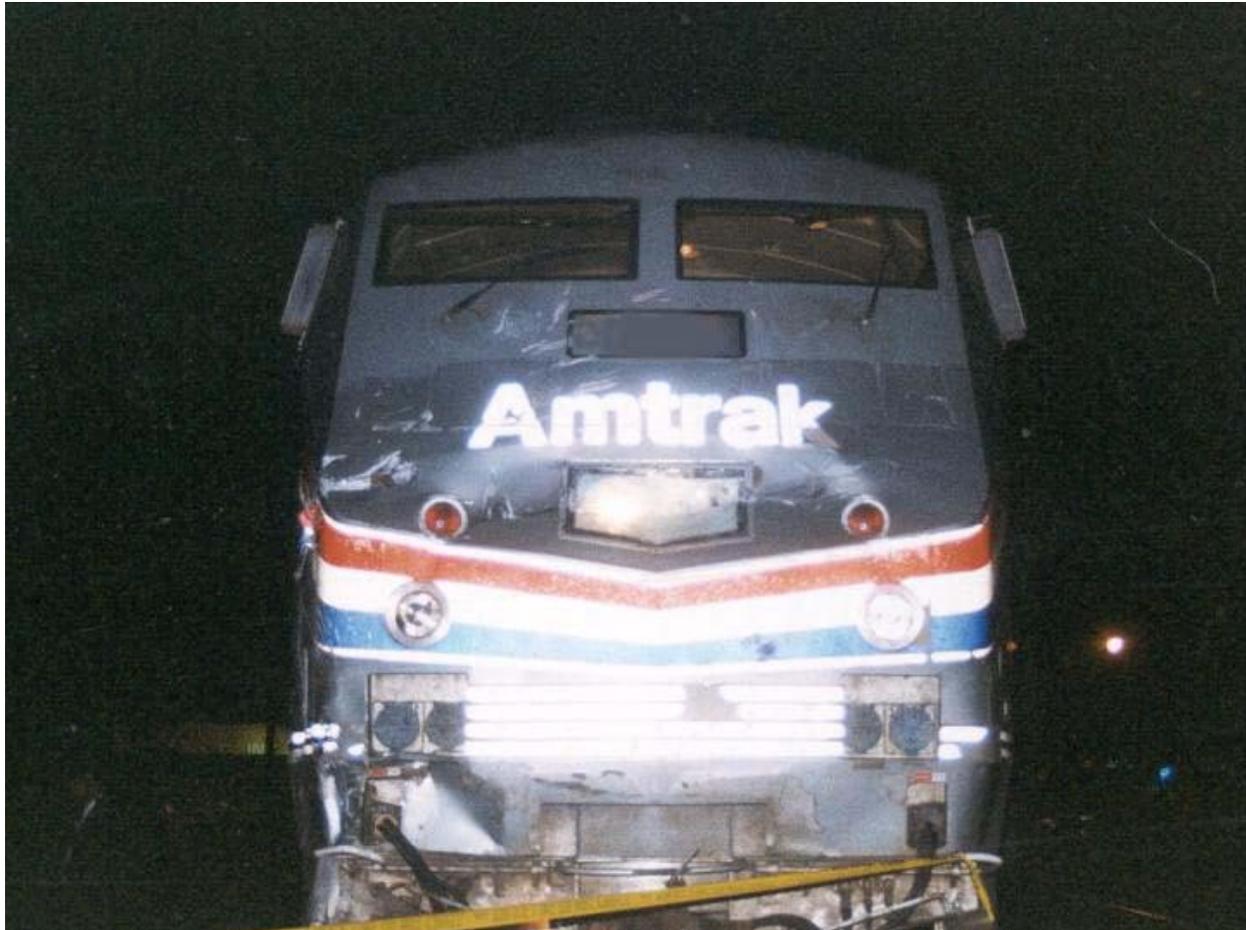
*as part of a scheduled program of signal system upgrades. There is no indication that the department condoned going around railroad safety gates or that drivers engaged in that practice prior to this incident. Witness #1 stated that a tanker car on the end of the freight train obstructed the northbound view of the tracks; however, he could hear a train whistle. Note: Inspection of Truck 1 after the incident revealed that the mechanical levers which raise and lower the driver's manually operated window were in the raised position and the control knob of the air conditioning system was at the maximum position with the fan control set on low. Another civilian (Witness #2) was waiting in his vehicle across the tracks on the east side of the railroad crossing. He reported seeing an Amtrak train heading southbound on the No. 2 Main Track. Note: The Amtrak train consisted of two locomotives, four mail cars, one baggage car, three coaches, two sleepers, one dining car, and six roadrailleurs. Witness #2 stated that as Truck 1 moved forward to go around the first safety gate, he started honking his horn and flashing his headlights to warn Truck 1 about the oncoming Amtrak train. Truck 1 continued traveling through the railroad crossing. The engineer on the Amtrak train reported that he did not see Truck 1, only a flash of white just prior to impact. Note: Manufacturer specifications indicated that the white aerial platform in the stored position on Truck 1 extended 5 feet, 4 inches beyond the front bumper of the truck cab. The Amtrak train made contact with the bucket of the aerial ladder and the left front corner of Truck 1 (see Diagram and Photo #3). After impact Truck 1 continued to travel and came to rest approximately 74 feet south of the point of impact and west of the No.1 Main Track. The Amtrak train listed eastward on impact but did not derail. It continued to travel with the lead locomotive stopping approximately 459 feet south of the point of impact (see Photo #4). The victim was ejected from Truck 1 and came to rest at the back of Truck*

*Photo #4. Amtrak Train Involved in This Incident.*
