Career Fire Fighter Dies and Three Are Injured In a Residential Garage Fire - Utah

Fatality Assessment and Control Evaluation Investigative Report #F2000-23

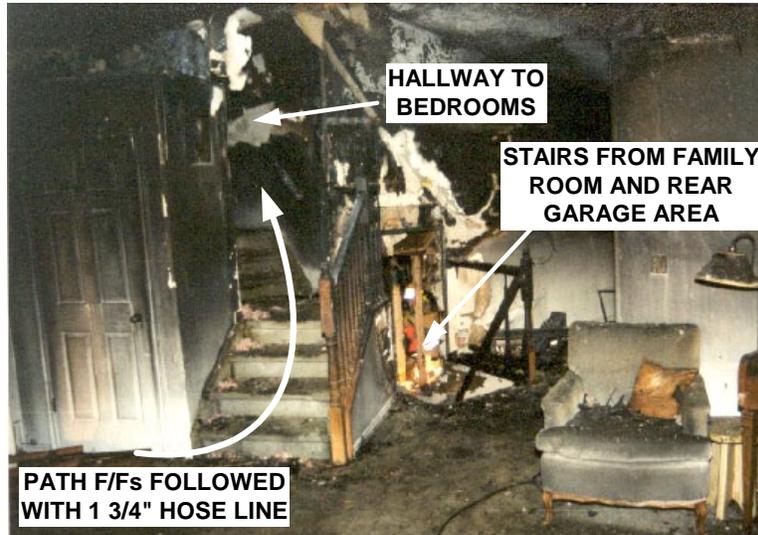
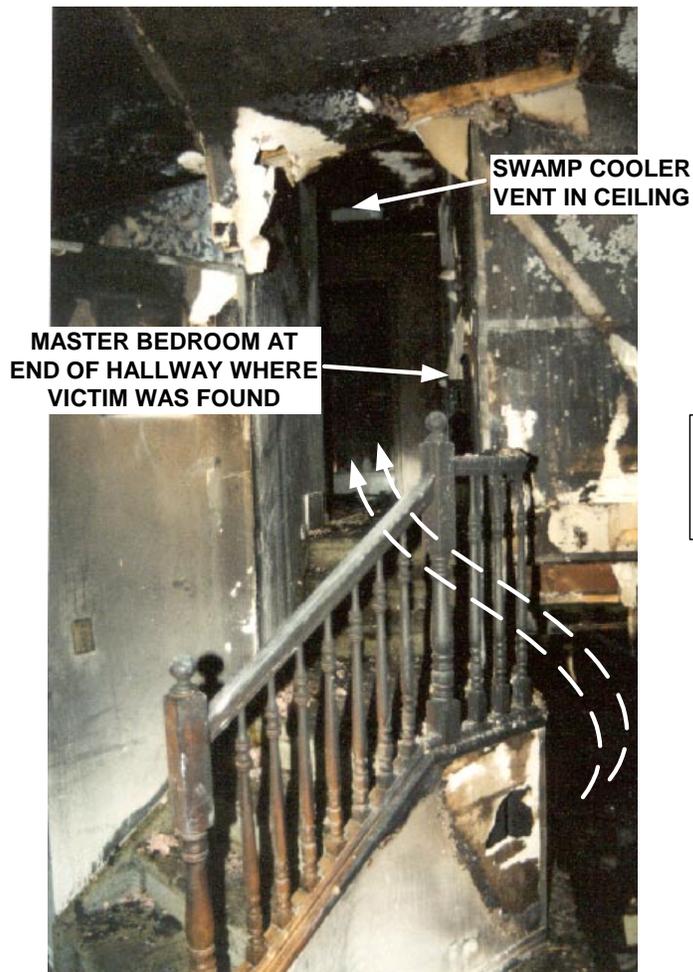
Figure. Interior Views of Stairwell

3. ***Sizing up the stairway design.*** The type of stairway leading to the floor above must also be evaluated by the fire fighter. An open stairway, such as the one found in this structure, is the most dangerous stairway a fire fighter can climb when searching above a fire. It becomes a chimney flue, allowing the flame, heat, smoke, and toxic gases generated by the fire below to flow up the open stairway leading to the second-floor bedrooms.
