Death in the line of duty...

A Summary of a NIOSH fire fighter fatality investigation

July 28, 2000

Career Fire Fighter Dies and Three Are Injured In a Residential Garage Fire - Utah

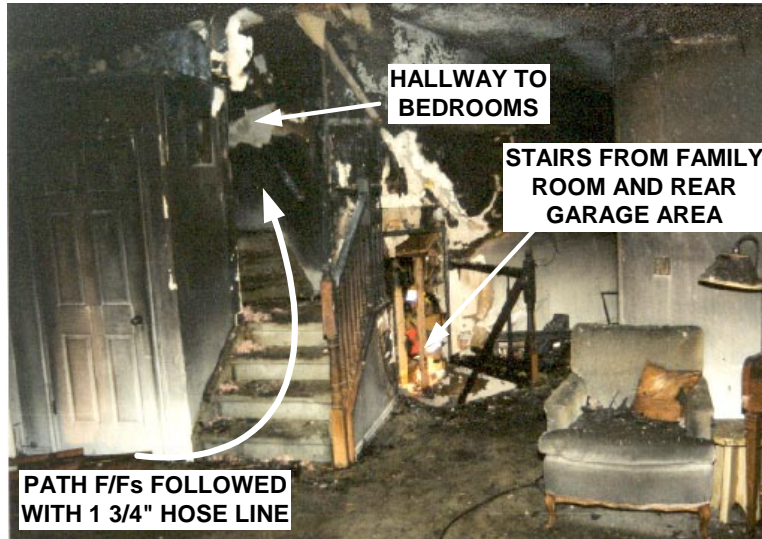
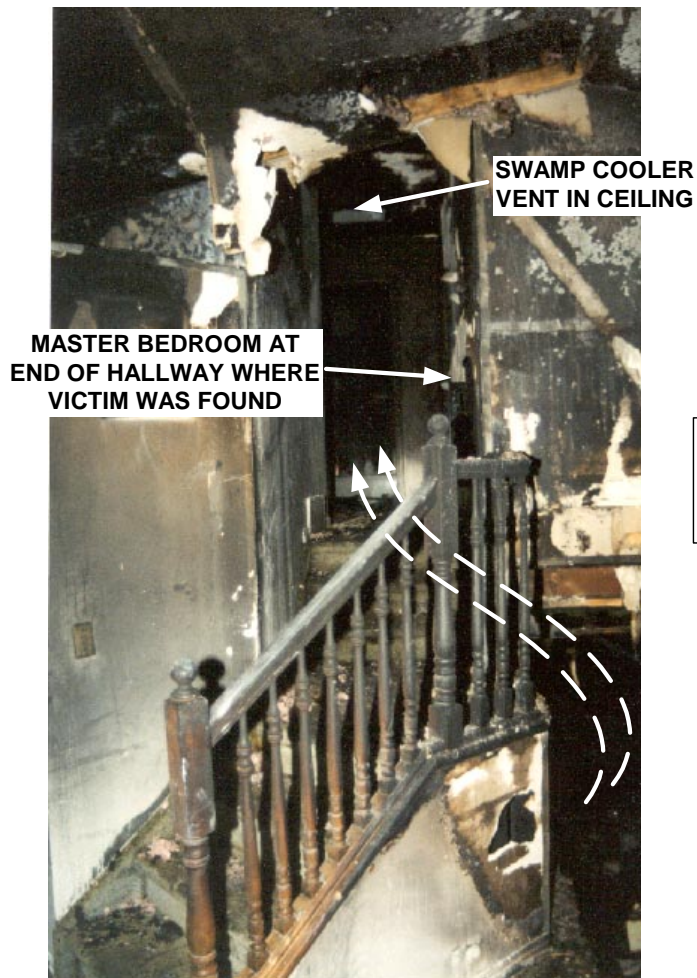
Figure. Interior Views of Stairwell

of them exited the structure. The third crew reported to the IC that the stairs felt “spongy” and that they believed the top of the landing may have burned out. The Lieutenant from Ambulance 3 assembled a Rapid Intervention Team (RIT) with two fire fighters from Ambulance 1 who had just arrived on the scene. The IC, having received a report that the stairway may be compromised, was concerned about sending the RIT into the structure to look for the victim. The IC was also concerned about the stability of the roof over the garage, so he was hesitant about sending fire fighters in through the front bedroom windows above the garage. The Lieutenant from Ambulance 3 directed a fire fighter from Engine 3 and a fire fighter from Ambulance 3 to pull the 1 3/4-inch cross lay to hit the fire showing in the back of the structure. The E/O from Engine 3 and a fire fighter from Engine 3 accompanied them around to the back of the structure. They brought a ladder with them and began pulling siding down and hitting the fire on the southwest corner of the ground floor. While on the ladder, they did not hear any Personal Alert Safety System (PASS) device or low air bells (they were directly below the master bedroom window where the victim was found). The RIT stood by on the front lawn for approximately 2 minutes until the IC decided to have the RIT attempt a search through the upstairs bedroom windows over the garage. The IC instructed the RIT to stay near the edge of the garage roof and to use an ax to “sound” the roof for weak spots. The RIT threw a ladder to the garage roof in front of bedrooms #1 and #2 (see Diagram 1, Photo 1, and Photo 2). They used an ax to “sound” their way to bedroom #1's window. The window had been broken out by a water stream from the 2 1/2-inch line that was positioned in the driveway. As one of the fire fighters looked and yelled into the bedroom window, the other fire fighter proceeded toward bedroom #2's window. A fire fighter from Engine 2 climbed

3. ***Sizing up the stairway design.*** The type of stairway leading to the floor above must also be evaluated by the fire fighter. An open stairway, such as the one found in this structure, is the most dangerous stairway a fire fighter can climb when searching above a fire. It becomes a chimney flue, allowing the flame, heat, smoke, and toxic gases generated by the fire below to flow up the open stairway leading to the second-floor bedrooms.

Recommendation #3: Fire departments should ensure that fire fighters conducting a search above a fire take safety precautions to reduce the risk of being trapped.^{4,5}
