## **A Volunteer Fire Fighter Died and a Second Was Seriously Injured After Fuel Tank Explosion - Iowa**

## Fatality Assessment and Control Evaluation Investigative Report #F2000-25

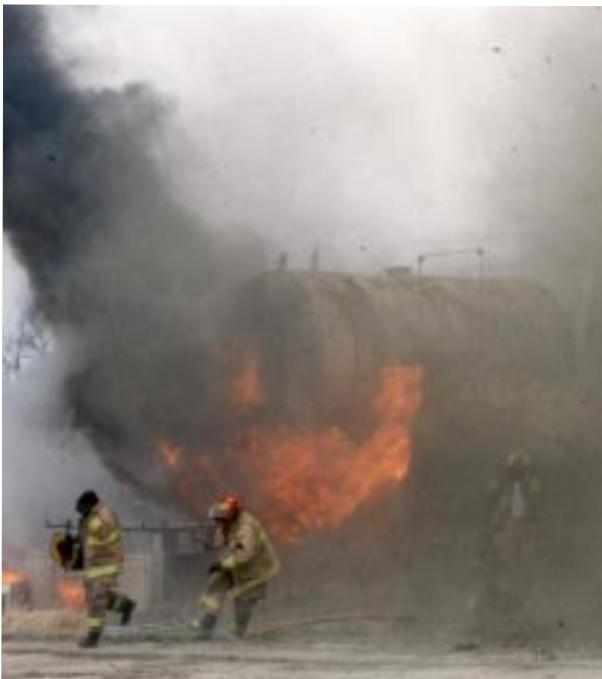
*Burning Fuel Tank Immediately After Explosion*

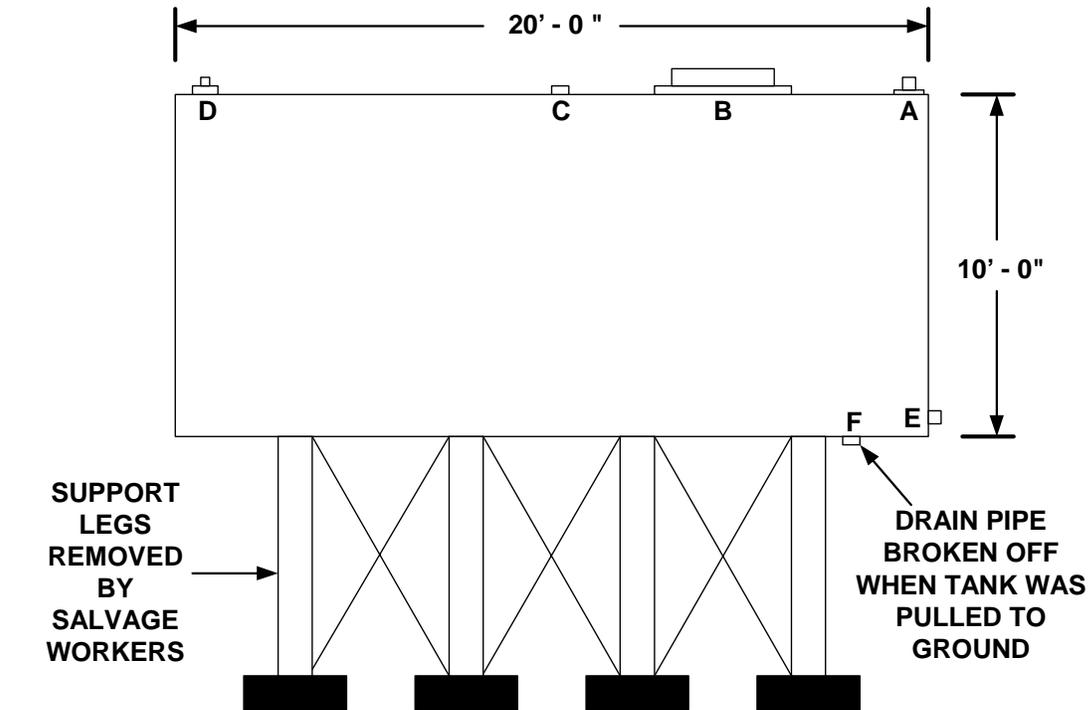
*Diagram 2. Profile of Fuel Tank #1*

The State Fire Marshal’s office found that Tank #1’s venting capacity consisted of two 3-inch vent openings that had both been sealed by a 2¼-inch reduced caps. The 2¼-inch reduced caps made the tank vapor tight. The pressure valve installed on Tank #1 was 6 inches in width. Pressure venting for a 10,000-gallon tank (Tank #1) requires valves 8 inches in width. Thus, the vapors were unable to escape the tank and venting did not occur. The emergency pressure valve acting alone did vent, but did not prevent the rupture of the tank due to the flame from the torch coming in contact with trapped vapors.

- A** = 3-INCH VENT OPENING REDUCED TO A SEALED 2 1/4-INCH PIPE CAP
- B** = EMERGENCY VALVE WITH 6-INCH VALVE AND FLAME ARRESTER PLATE (VALVE AND FLAME ARRESTER PLATE WAS BLOWN OFF AND RECOVERED)
- C** = 1-INCH STEEL TAPE FUEL GAUGE (DISCONNECTED AT TIME OF INCIDENT)
- D** = 3-INCH VENT OPENING REDUCED TO A SEALED 2 1/4-INCH PIPE CAP
- E** = 2-INCH FILL PIPE THREADED CONNECTION (FILL PIPE REMOVED PRIOR TO INCIDENT)
- F** = 1-INCH WATER DRAIN UNDER TANK

***Recommendation #5: Ensure that aboveground tanks are in compliance with NFPA 30 2-3.6 “Emergency Relief Venting for Fire Exposure for Aboveground Tanks.”<sup>6,7</sup>***

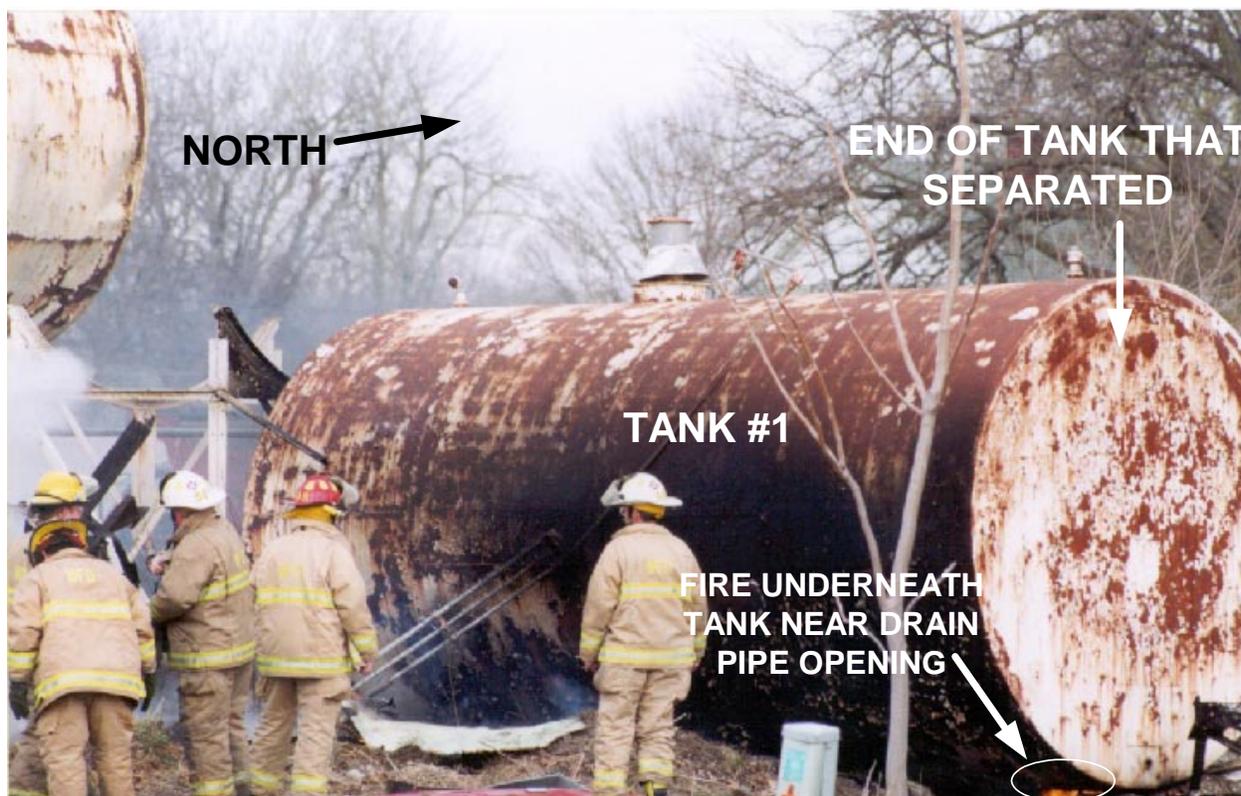
the fire hazards of the tank and its contents to the general public. The area in which the tank is located should be protected by fencing or some form of barricade to deter tampering or trespassing. The State Fire Marshal’s Office found that the tank was not properly labeled. The tanks were not secured or protected from tampering or trespassing. No placards or signs were visible in photographs taken of Tank #1 and Tank #2 at the incident scene.

*Photo 1. Photo of Tank #1 Prior to Explosion*

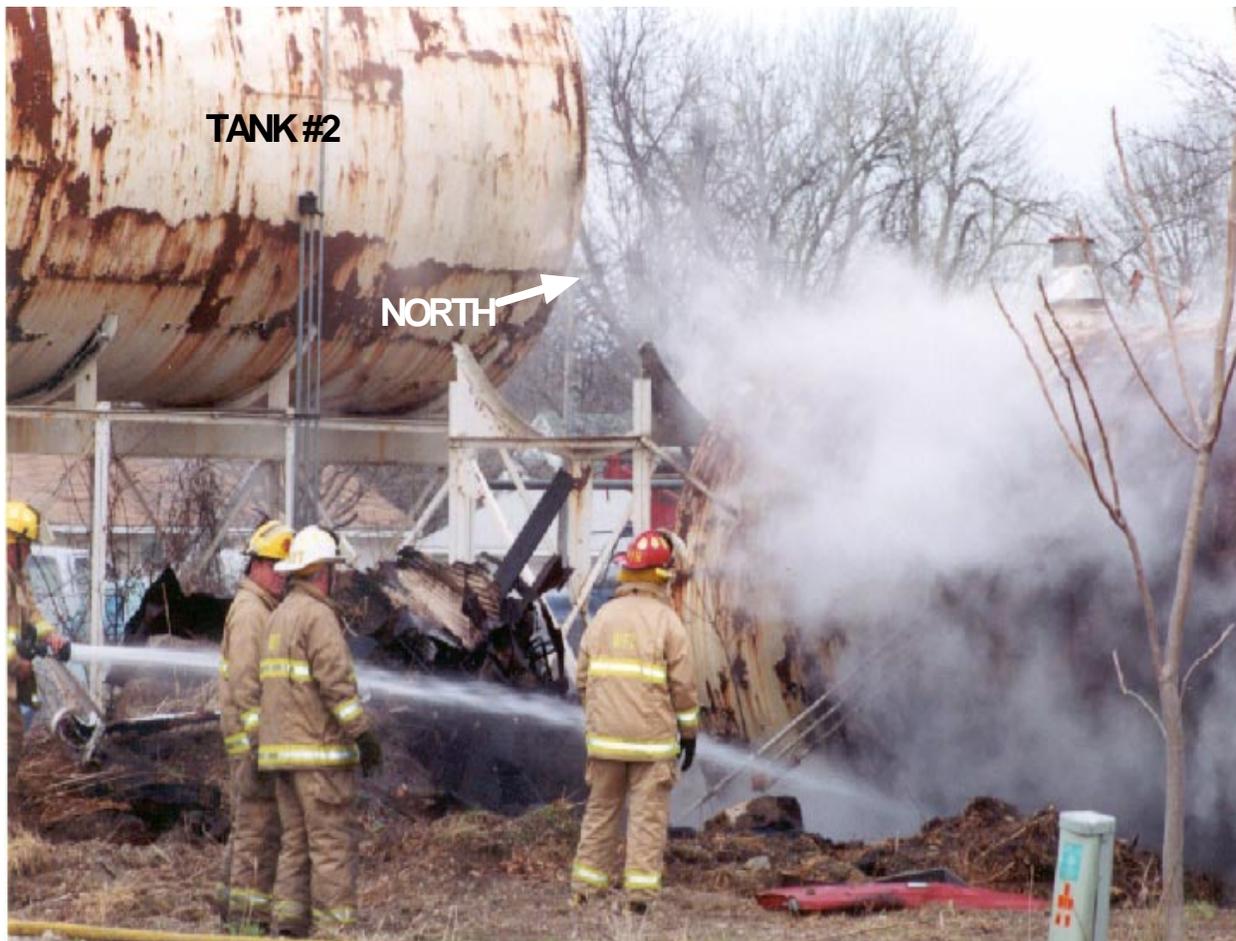
***Photo 2.** Fire Fighters on the South Side of Tank #1, Prior to the Explosion, Applying Water to Tank's Surface to Cool It Down*

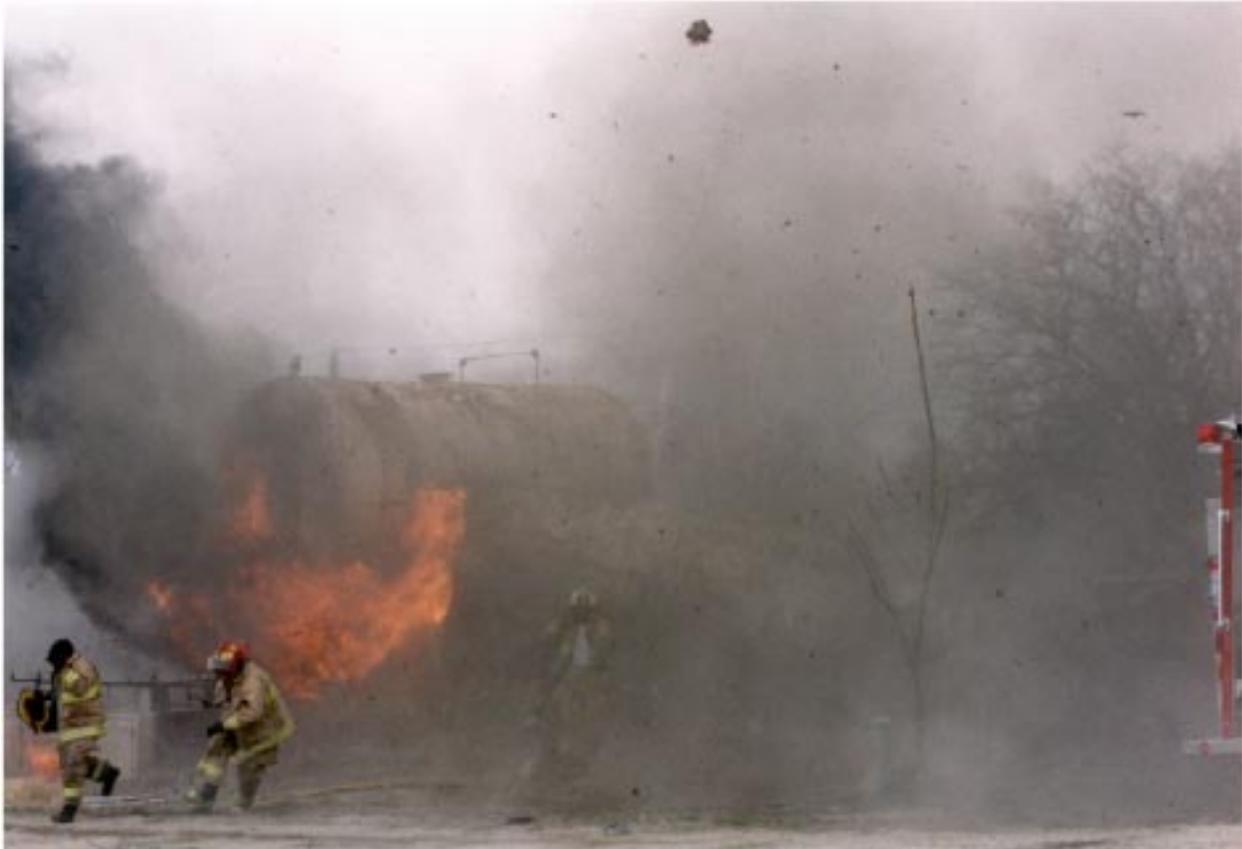
*Photo 3. Burning Fuel Tank Immediately After Explosion*

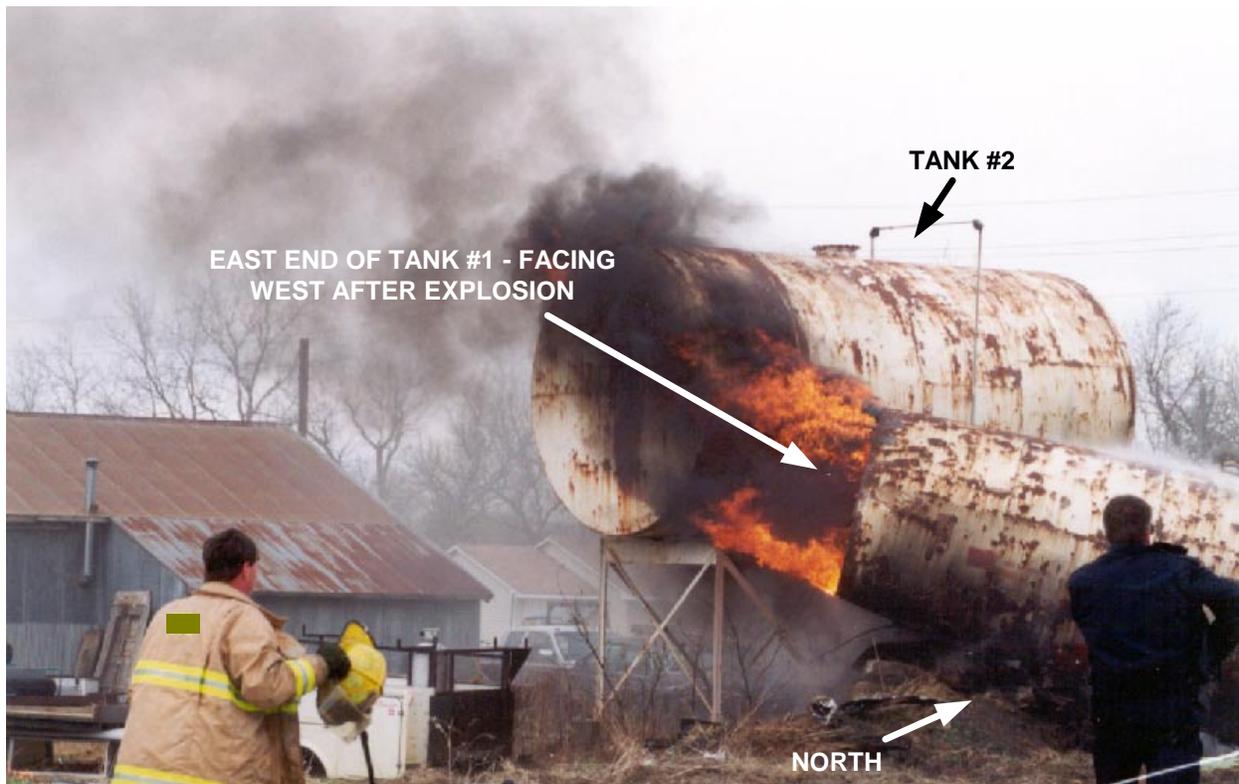
**Photo 4.** Incident Site Immediately After Explosion Occurred.

*Note: Tank #1 turned 180 degrees on its axis.*
