Residential Structure Fire Claims the Life of One Career Fire Fighter—Alabama

Fatality Assessment and Control Evaluation
Investigative Report #F2000-26

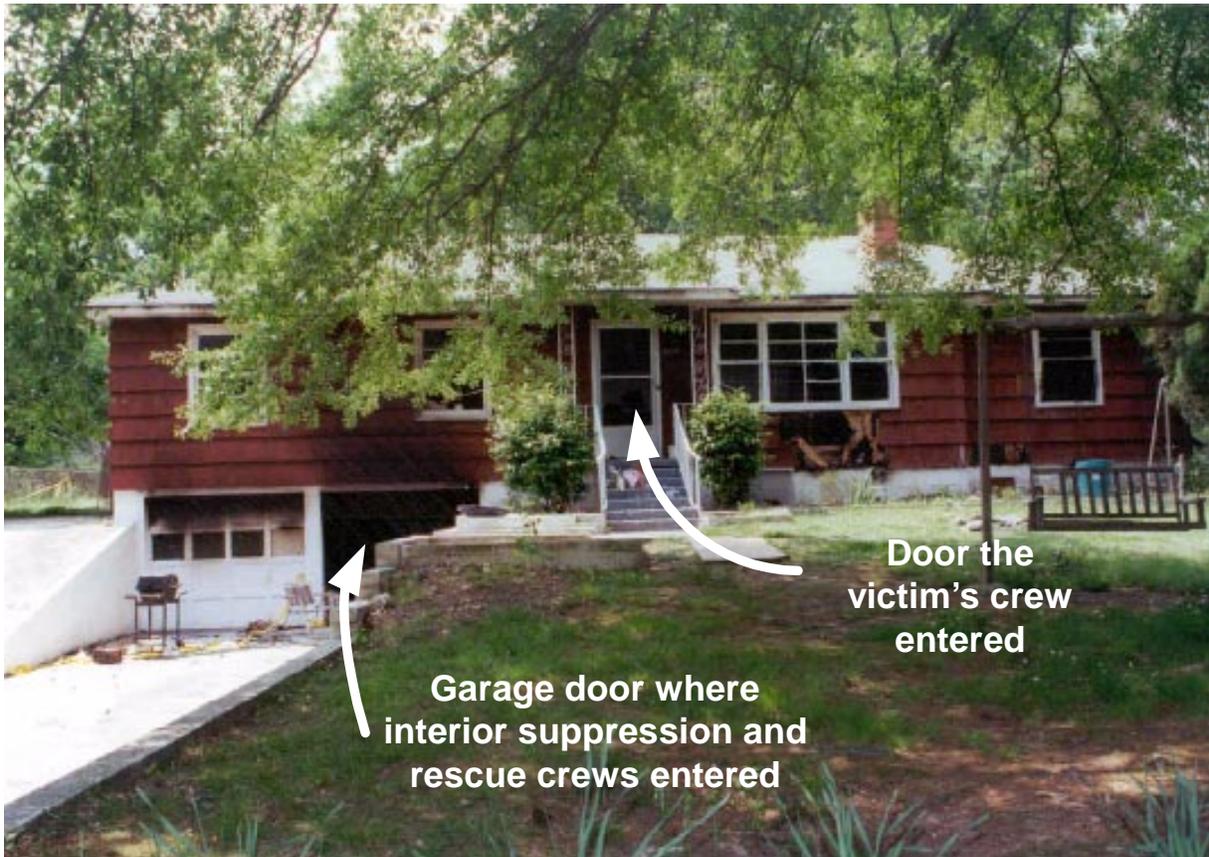
around of the structure, and confirmed to Central Dispatch that there was a working structure fire with thick, black smoke emitting from the garage/basement area (Photo 1). As Engine 1 was approaching the scene, the IC instructed the crew to stop and connect to the hydrant. Rescue 52 met up with Engine 1 at the hydrant and assisted them in making the connection. Engine 1 connected their supply line to the hydrant and proceeded to the scene as Rescue 52 finished making the hydrant connection.

***Photo 1.** Points of Entry of Fireground Personnel for Fire Suppression and Rescue Crews*

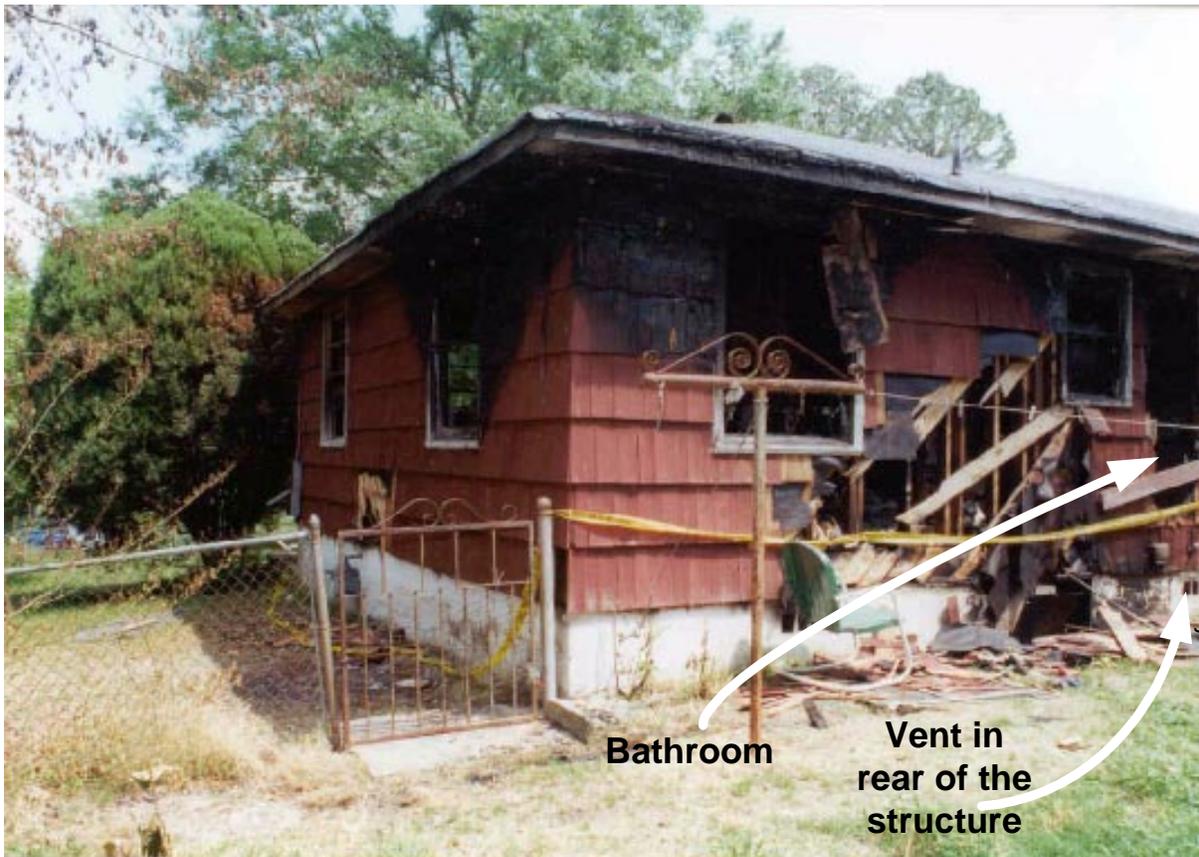
Photo 2. Rear of the Structure, Bathroom Area

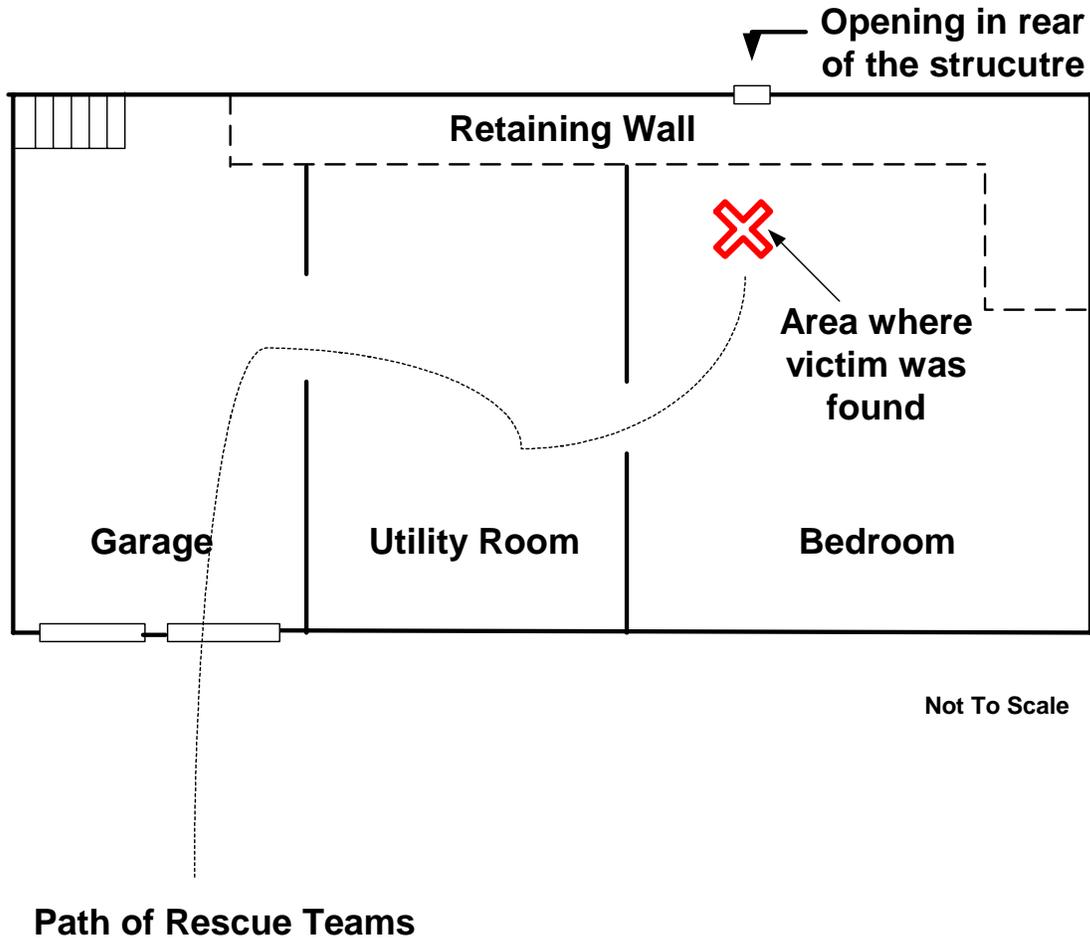
Figure 2. Aerial View of Basement
