Pumper Truck Rollover Claims the Life of a Volunteer Fire Fighter - Missouri

SUMMARY

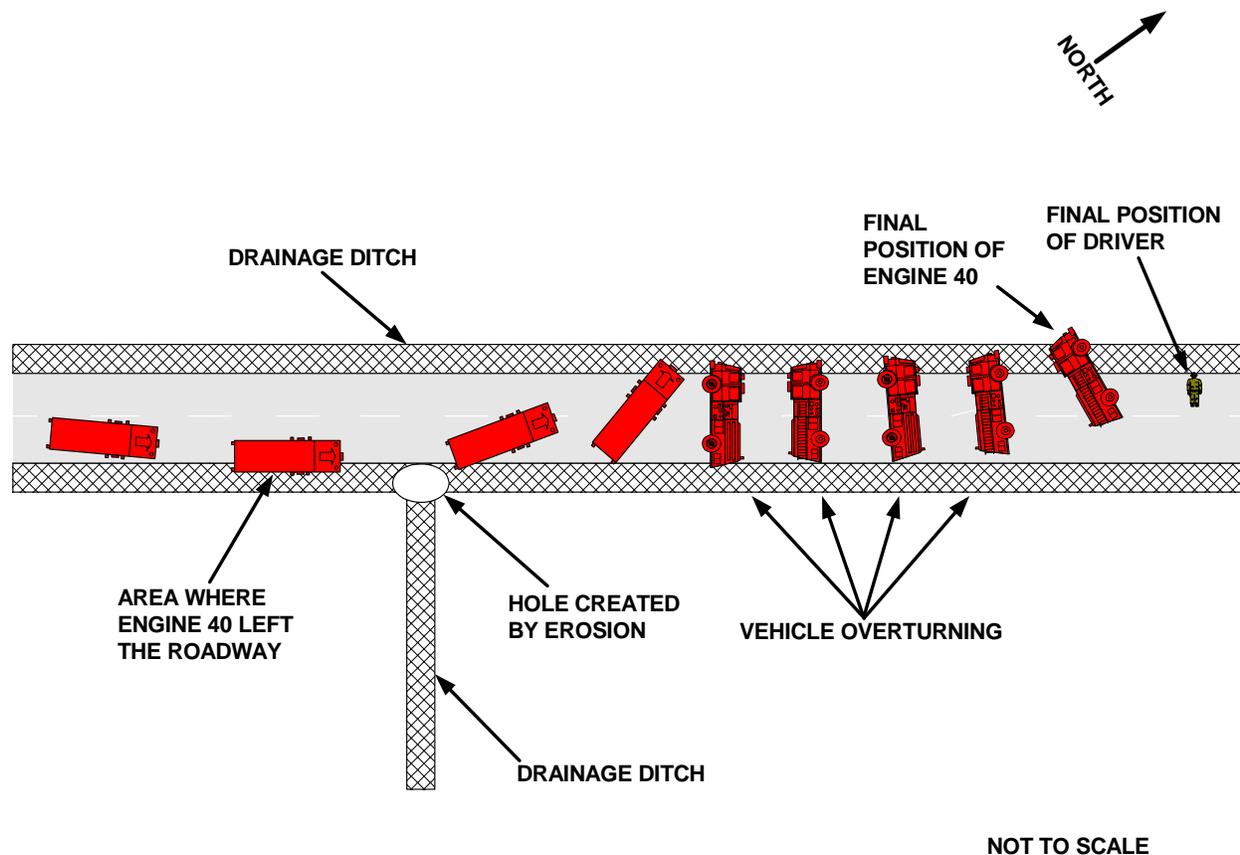
Diagram. Aerial View of Incident Site

counterclockwise, came back onto the roadway and overturned. The engine rolled approximately one and three-quarter revolutions as it continued to skid, traveling northbound (see Diagram). The victim was ejected from the engine and sustained fatal injuries as a result of the collision. The engine came to rest on its left side, facing west and blocking the southbound lane of the roadway. The cab area of the engine burst into flames as it sat at rest.

victim's department were an Assistant Chief in a department vehicle, a Captain, a Lieutenant, and approximately five other fire fighters, who responded in privately owned vehicles (POVs). At 1539 hours, the victim radioed to Central Dispatch that the call was unfounded and he was in service, and returning to the station. The engine was traveling northbound on a two-lane state road with a posted speed limit of 55 mph (see Photo #1). On the return trip the Assistant Chief noticed the engine following behind him, approximately a quarter of a mile back. After traveling approximately 1 mile the Assistant Chief lost sight of the engine. The engine was approximately 1 mile from the station at this time. The Captain's vehicle followed the engine approximately 100 feet behind. During this time another emergency medical call was in progress. The Assistant Chief pulled over at the victim's station and radioed back to the engine to discuss the emergency medical call. However, there was no response from the victim. According to the Captain, who witnessed the event, and from evidence collected by the state highway patrol and from the crash reconstruction report, for unknown reasons the engine drifted off the roadway on the right (east) side. *Note: The highway patrol estimated that the right rear tires of the engine initially left the roadway while the vehicle was traveling approximately 45 mph. This estimated speed was based on the statement of the witness (the Captain), who was following the engine.* There are no shoulders in this area of the road. The engine continued to travel along an earthen embankment off the side of the road. The victim attempted to bring the engine back onto the roadway, however, was unable to. *Note: Rain had occurred on the evening prior to the incident, so the earthen embankment was soft. The right side of the tires traveled along the earthen embankment for approximately 164 feet.* The engine continued to travel and passed over a large

hole created by erosion at the end of a drainage culvert (see Diagram). *Note: The large hole was estimated to be 8 feet in depth and 15 feet in width.* The victim lost control of the engine when he overcorrected and applied his brakes in his attempt to steer the engine back to the roadway left (west) side. The engine rotated counterclockwise, and came back up onto the road and traveled across the roadway. The engine traveled across the road for approximately 18 feet before overturning. The engine rolled approximately one and three-quarter revolutions and slid as it continued northbound. The engine came to rest on the passenger side, partially off the roadway on the left (west) side of the roadway, blocking the southbound lane (see Photo #2). The victim was ejected from the engine, sustaining fatal injuries. *Note: It remains undetermined as to where the victim exited the engine. The victim was wearing ordinary street clothes. The engine was equipped with a shoulder and lap seat belt safety restraint system for the driver and passenger positions. The highway patrol's report indicated that the victim was not wearing his seat-belt safety restraint system at the time of the incident.* The cab area of the engine burst into flames as it sat at rest. The Captain, who was following the engine, stopped approximately 50 feet back from the engine and radioed to Central Dispatch to report the incident and request assistance. Between 1550 hours and 1553 hours, the following were dispatched to the incident scene: two mutual aid fire departments, and an ambulance. The Chief from the department in the incident heard the radio dispatch and responded from his residence in his department vehicle. The Assistant Chief was approximately 1 mile away from the incident scene and heard the radio traffic and responded. At approximately a half-mile away from the scene the Assistant Chief could see smoke coming from the roadway. Once on the scene he observed the Captain looking for the victim near the engine.

Discussion: Fire departments should ensure drivers of fire service vehicles are familiar with the potential hazards/conditions that exist on the roadways (e.g., insufficient shoulder) on which they may be traveling. In this incident, the speed of the engine when it left the roadway was estimated to be under the posted 55 mph speed limit, however, for unknown reasons the engine drifted off the roadway. The potential motor vehicle hazards that existed on the roadway of this incident included (1) the earthen embankment being soft, (2) no shoulders, and (3) a large hole that was created by erosion at the end of a drainage culvert.

Recommendation #1: Fire departments should ensure all drivers of fire department vehicles are responsible for the safe and prudent operation of the vehicle under all conditions.¹

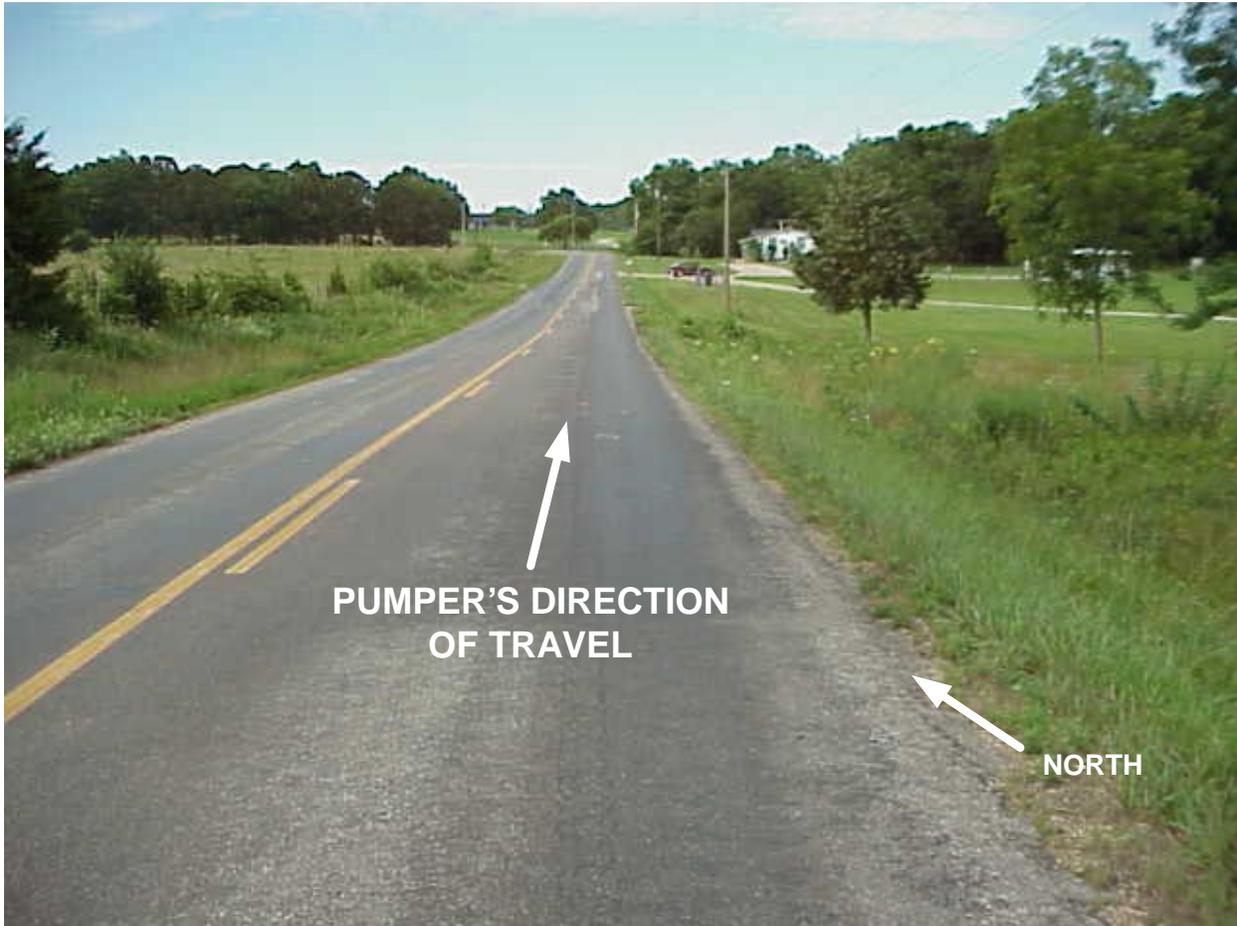
Photo 1. View of Road Traveling Northbound Where Pumper Truck Veered Off Road and Rolled Over

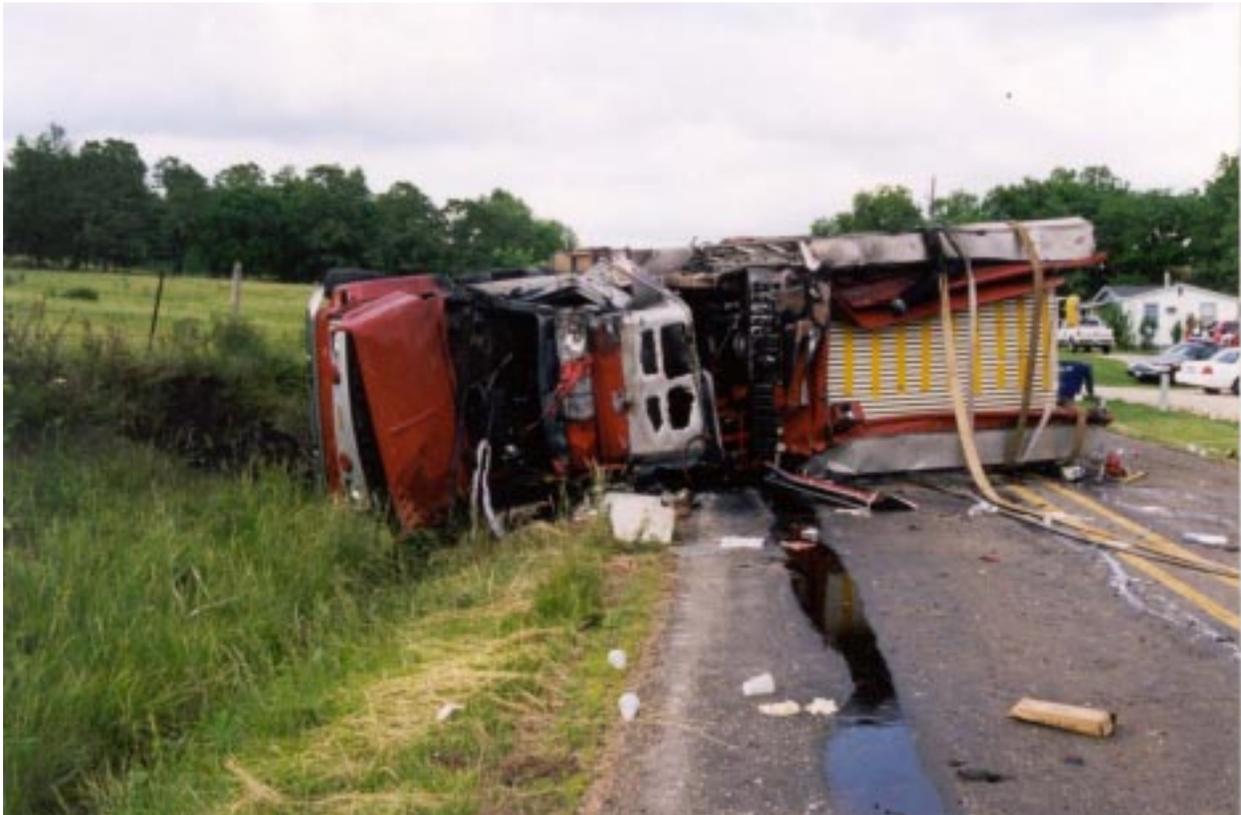
Photo 2. Incident Site

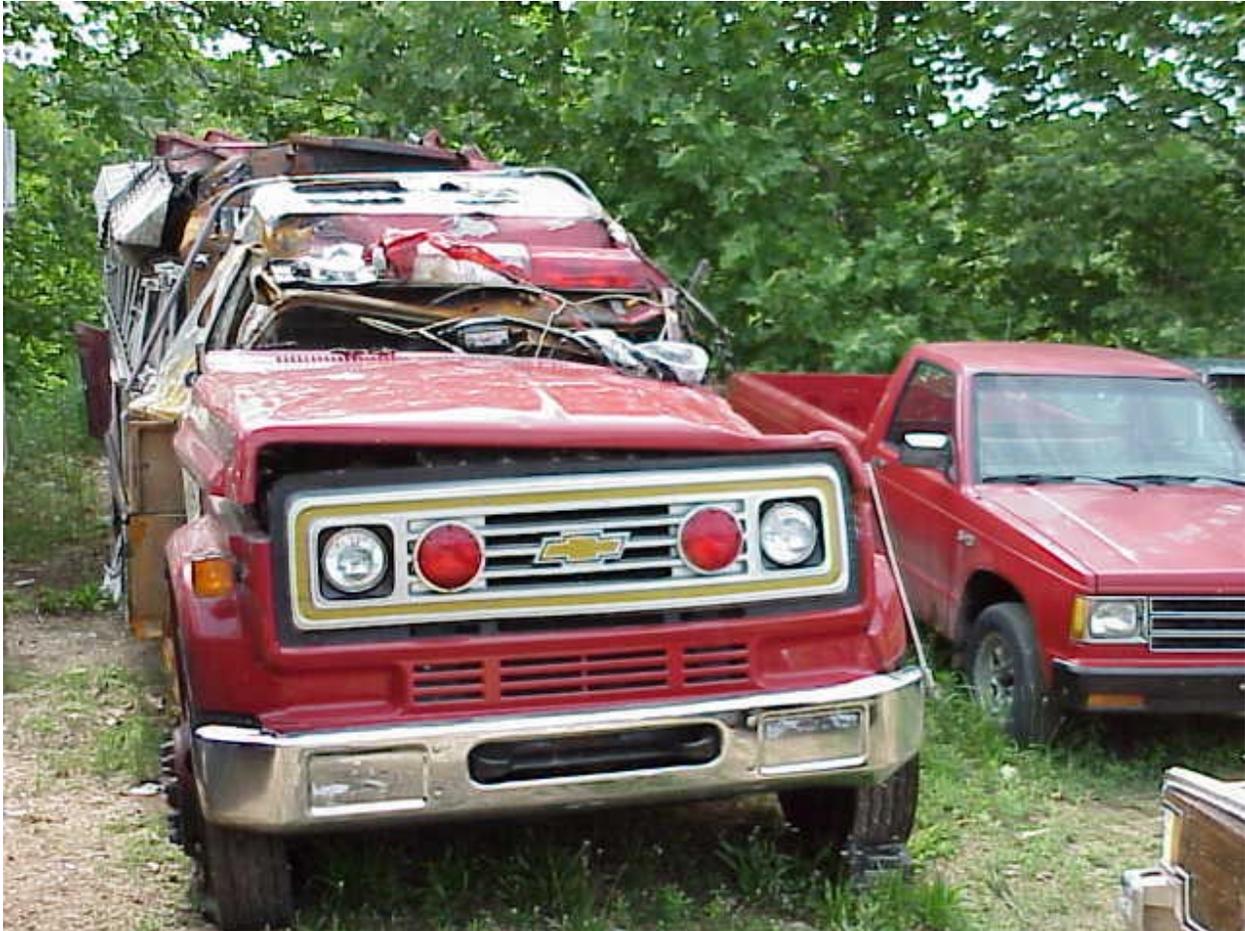
Photo 3. Pumper Truck Involved in This Incident
