NIOSH
Fire Fighter Fatality Investigation
and Prevention Program

A Summary of a NIOSH fire fighter fatality investigation

Fire Fighter Dies After Being Run Over by Ladder Truck While Attempting to Board—Alabama

Fatality Assessment and Control Evaluation Investigative Report #F2000-41

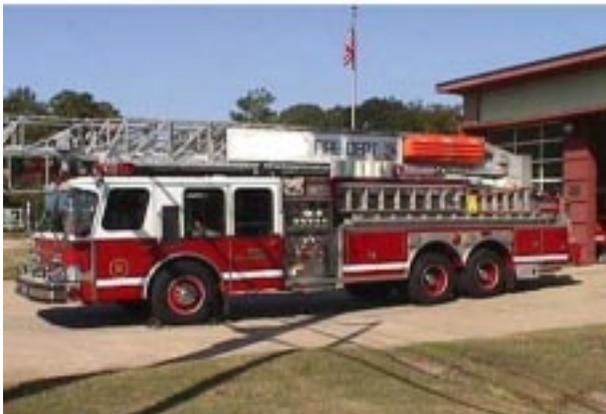
Ladder Truck Involved in Incident

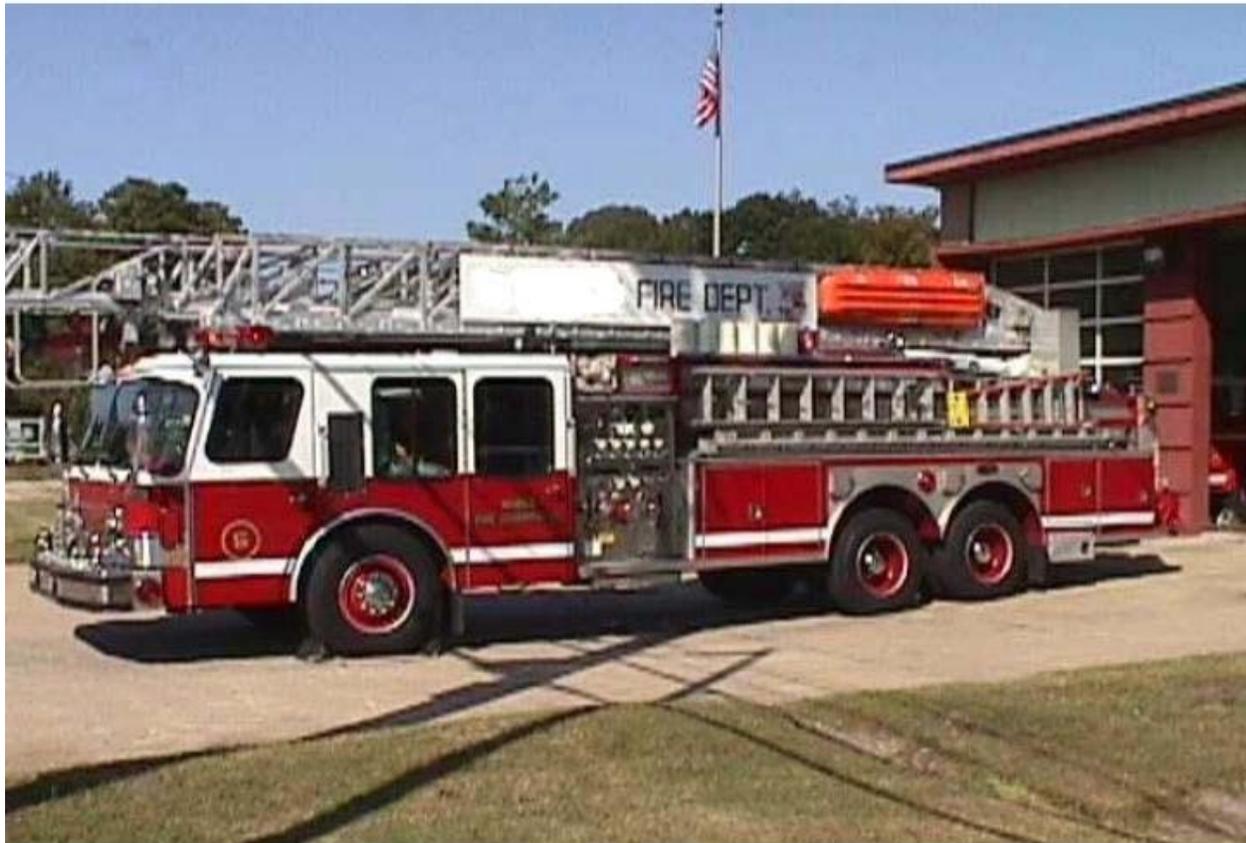
Photo 1. Ladder Truck Involved in Incident

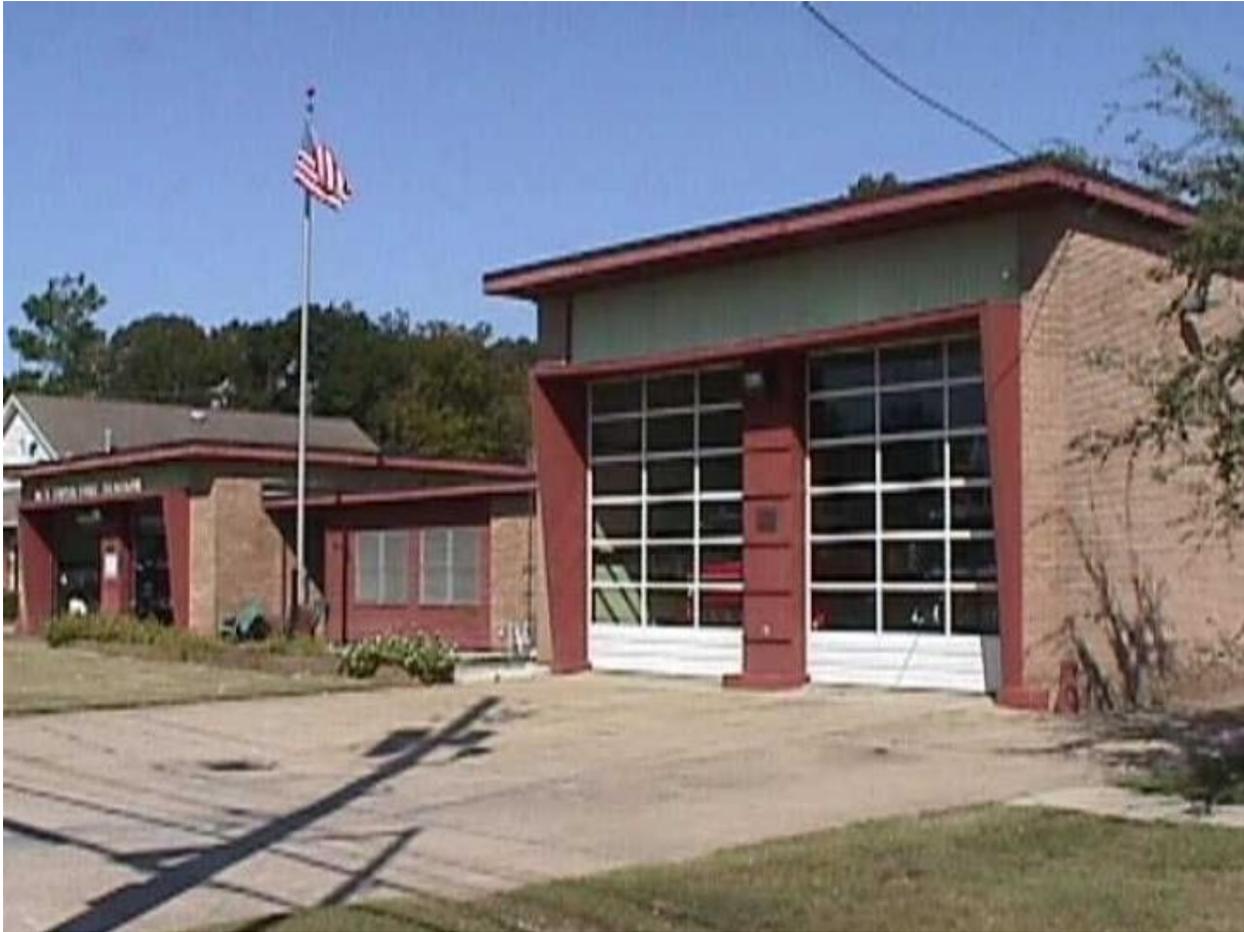
Photo 2. Station's Driveway Apron

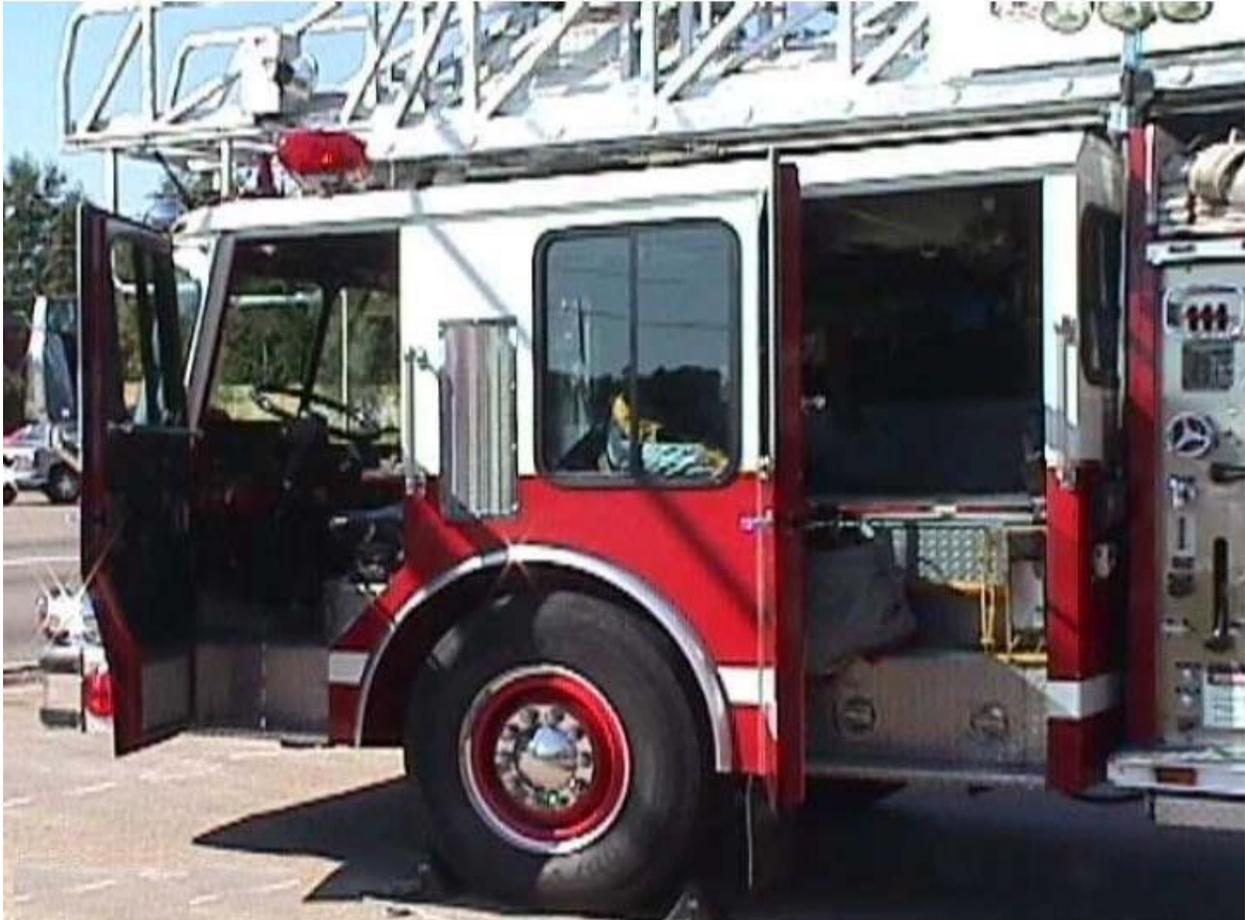
All of the riders on the apparatus should be seated within the cab or body of the emergency or fire apparatus and should be wearing their seat belts before the vehicle is put into motion. The officer (Captain) must always be assured that all fire fighters are properly and safely boarded before giving the order to proceed (i.e., visual contact, verbal contact, or giving personal accountability tags to the officer once on board). At the time of the incident, the fire fighter seated in the jump seat behind the Captain could not see if the victim was on board in the other jump seat because his vision was obstructed by the engine cover on the truck.

Photo 3. Jump-Seat Door That Victim Was Attempting to Board

ensure that fire fighters do not attempt to board moving fire and emergency apparatus.¹

At the fire station, responding fire fighters should quickly assemble on the apparatus floor near the vehicle and don protective clothing, and mount the apparatus while it is stationary. Jumping onto or off moving apparatus is inherently dangerous. If the fire fighter misses the step of the moving fire or emergency apparatus, as was the case with this incident, and falls to the roadway, chances are great that the rear wheels will run over the fire fighter before the driver can stop the vehicle.

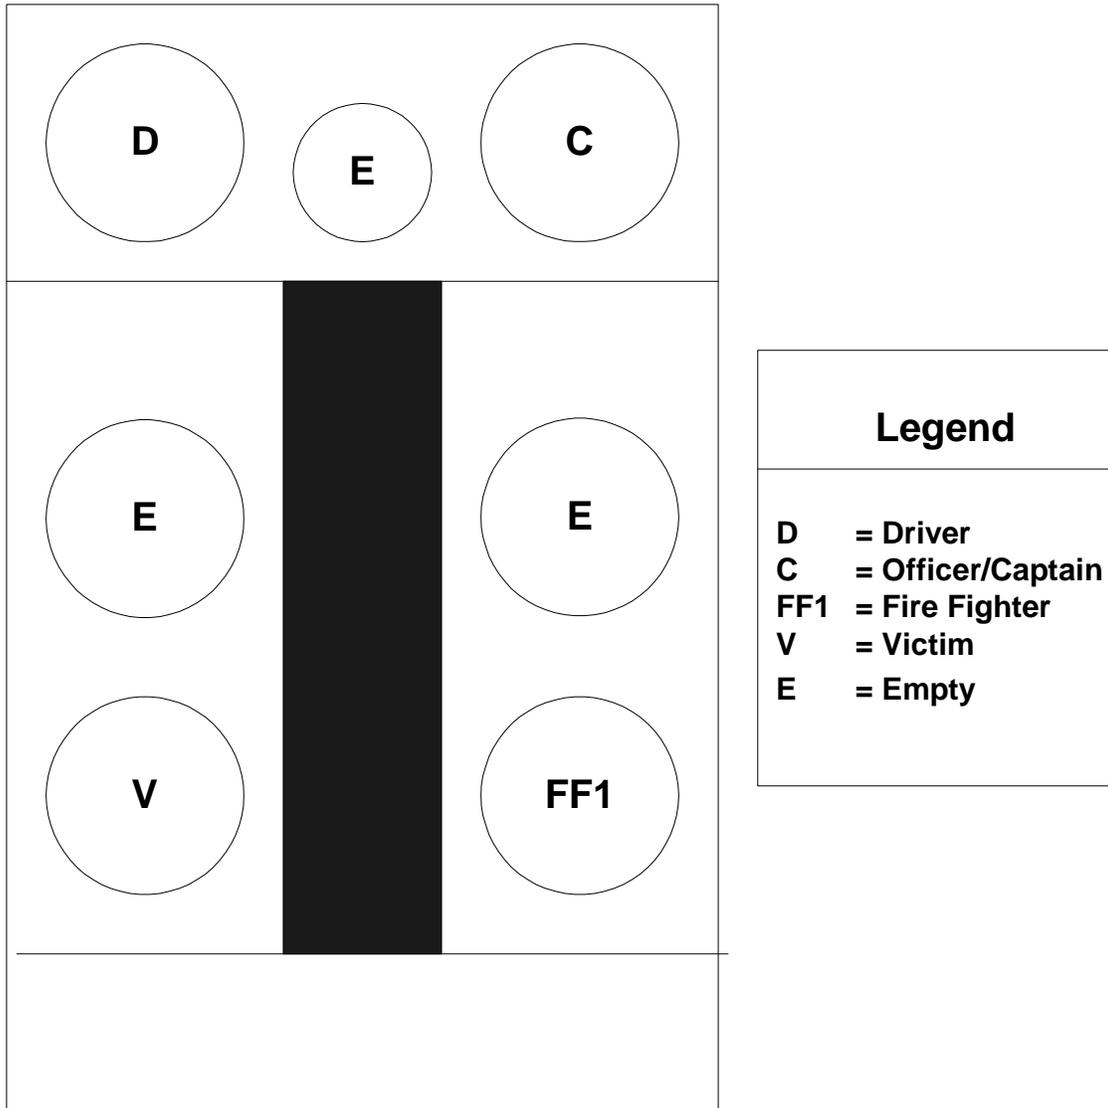
boarded the jump seat facing forward on the Captain's side. *Note: The fire fighter could not see if the victim was on board, due to the height of the engine cover that separated the jump seats.* The Captain boarded the truck and reached for the radio. The driver informed the Captain that he had already radioed in to Fire Alarm. The driver stated that he had heard both jump-seat doors close and he checked his rear view mirrors. Both jump-seat doors were in the closed position when the truck left the station. At approximately 1810 hours with lights and sirens activated, the truck exited the station bay. The truck made its way down the station's driveway apron and briefly paused waiting for the westbound traffic to clear (see Photo 2). Upon traffic clearance the driver drove the truck across the three westbound traffic lanes and made a left turn into an inside eastbound-turn lane to get around the traffic (see Diagram 1). *Note: According to several civilian witnesses' statements, during this time the victim was running beside the driver's side jump-seat door while trying to catch up to the truck. As reported by witnesses, the victim grasped the hand-grab bar with his right hand and opened the driver's side jump-seat door with his left hand as he ran beside the truck, while making several attempts to board (see Photo 3).* The truck accelerated after making the left turn. *Note: The police estimated the speed of the truck to be approximately 25 mph.* With the turning lane ending at the upcoming intersection, the driver looked into the rear view mirror on the Captain's side as he made a right turn to merge the truck into the center lane. *Note: According to witnesses' statements, at this point the victim made his final attempt to board the truck. It was reported that as the victim lost his grip and footing, he fell onto the roadway. The victim was then run over by the truck's left rear outside dual tandem wheels. At approximately this time, all three personnel on the truck felt a "thump" and thought they had been hit by another vehicle. The driver looked in the rear view mirrors and saw*

Figure. Assigned Riding Positions on Ladder Truck

Recommendation #3: Fire departments should ensure that personnel on board emergency and fire apparatus are seated, belted, and accounted for, prior to movement.^{1,3,5}
