A Volunteer Assistant Chief Was Seriously Injured and Two Volunteer Fire Fighters Were Injured While Fighting a Townhouse Fire—Delaware

Fatality Assessment and Control Evaluation Investigative Report #F2000-43

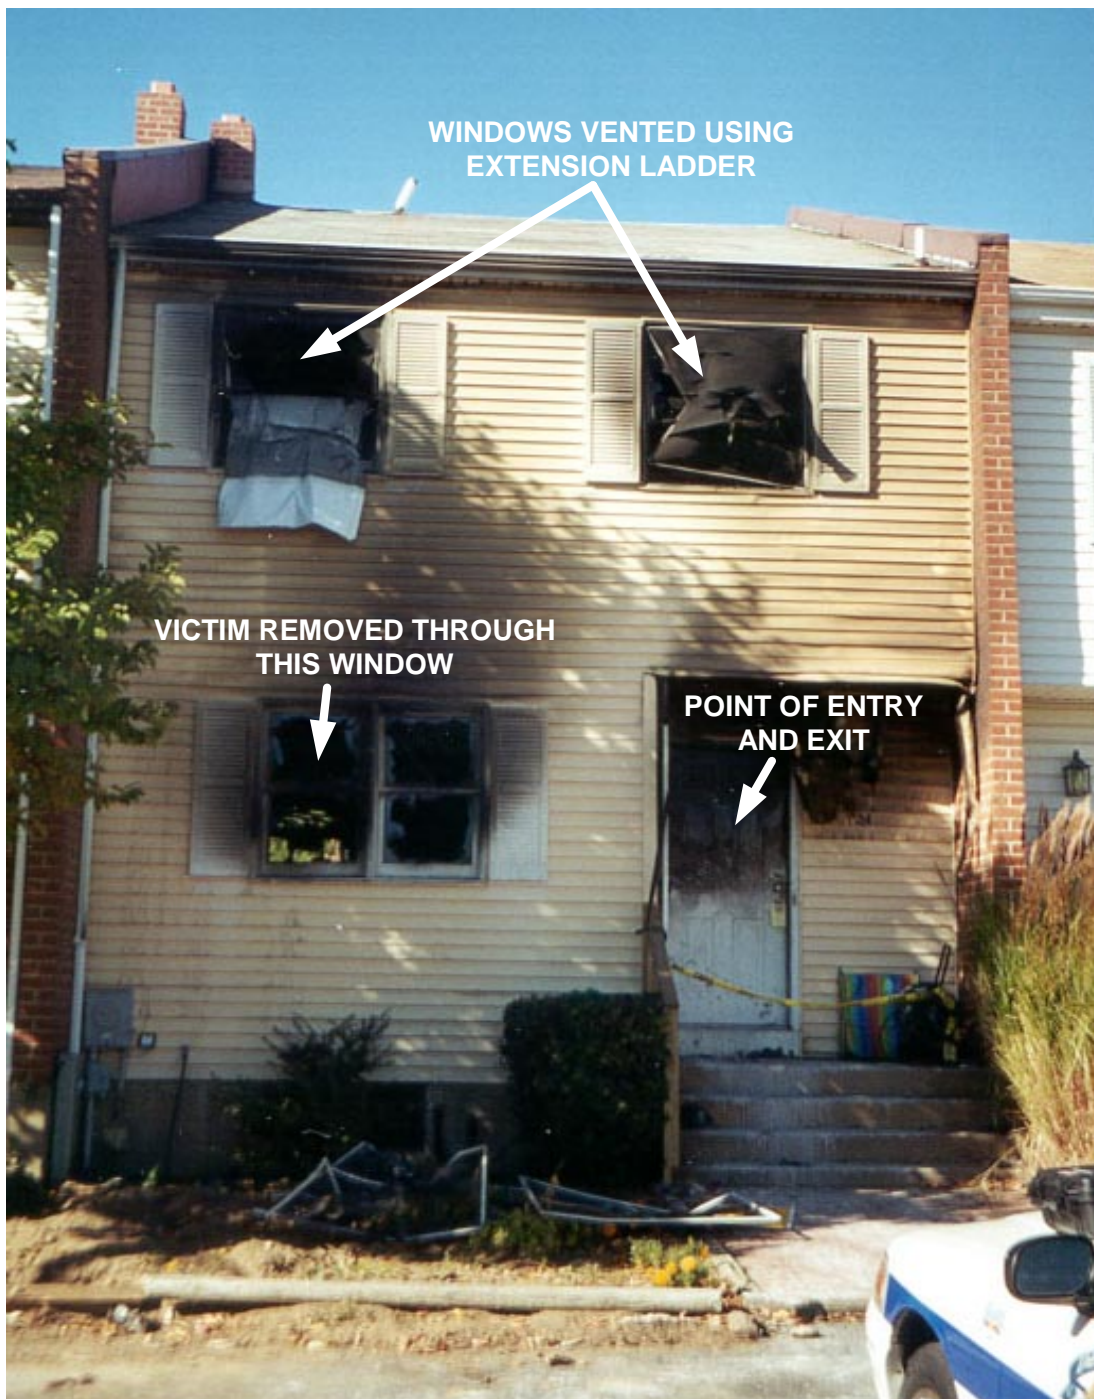
Photo 1. View of Side 1

duty fire fighter) used an extension ladder to ventilate the second-story windows above the front door (see Photo 1). *Note: The police officer and off-duty fire fighter assisted the driver of Engine 9 in laying the 5-inch supply line to the hydrant. The police officer and off-duty fire fighter then ventilated the second-story front windows using the tip of the extension ladder. They left the ladder positioned under the front bedroom window as a possible means of egress for the fire fighters inside.*
