A Fire Fighter Drowns After Attempting to Rescue a Civilian Stranded in Flood Water - Colorado

Fatality Assessment and Control Evaluation Investigative Report #F2001-02

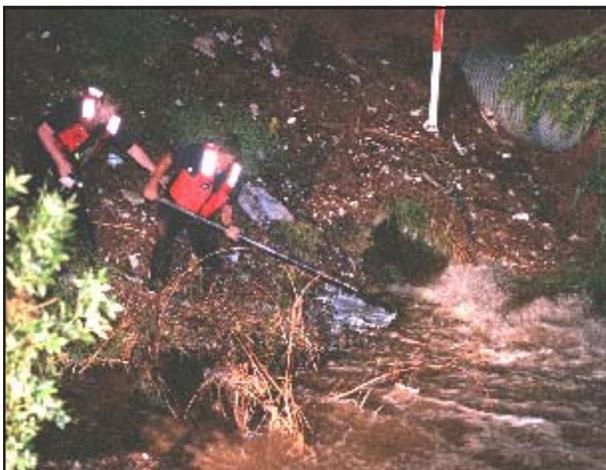
View of drainage pipe where victim was found

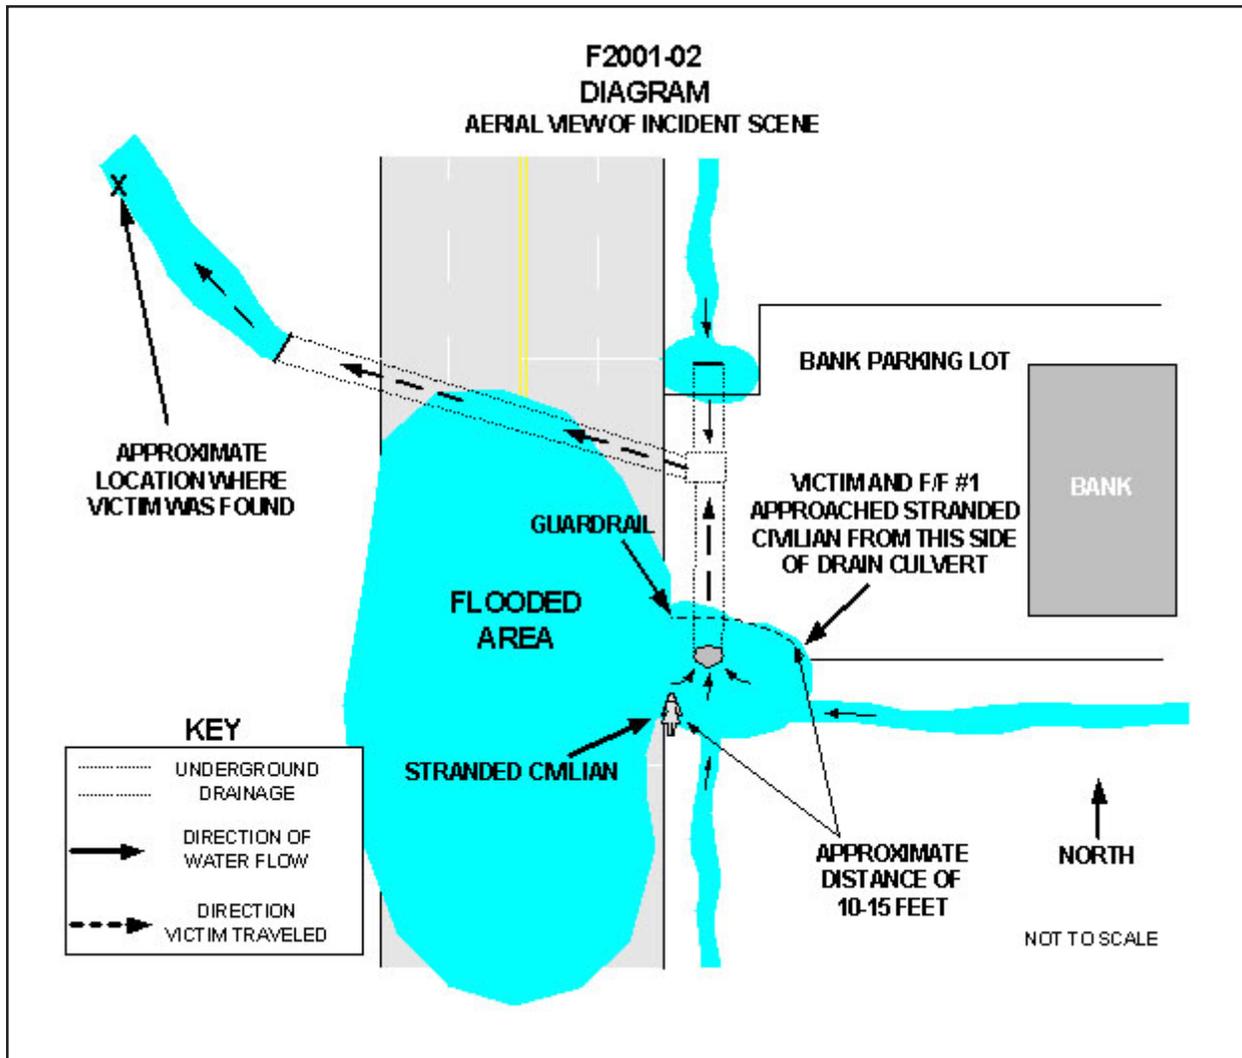
Diagram of incident site

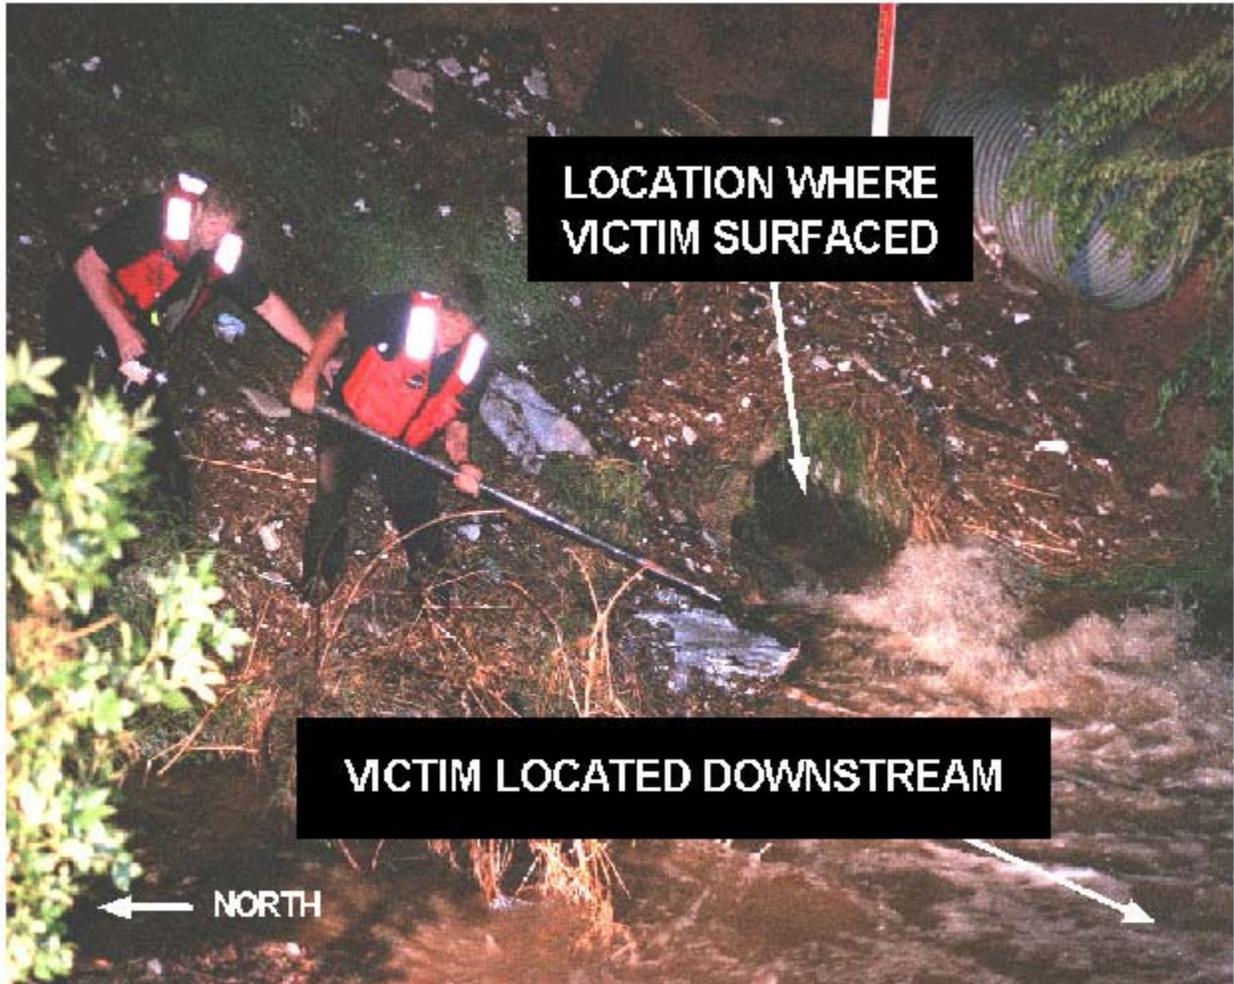
Discussion: Before this incident, the city had received several complaints about the large amount of standing water and flooding in this area. The drainage pipe involved in this incident was originally installed in 1960 and measures 60 inches in diameter. It was on a 6-year plan to be replaced with a larger velocity pipe (approximately 72 - 84 inches in diameter) and covered to prevent accidental injury during times of flooding. Work to replace this pipe was expected to begin in year 2003. Since this incident, a junction box and a trash grate have been installed to help prevent future injuries.

Photo courtesy of the Denver Post: View of drainage pipe where victim was found

Recommendation #7: Municipalities should identify flood-related hazards and take steps to correct them as soon as possible in order to minimize potential for injury.
