A Summary of a NIOSH fire fighter fatality investigation

October 30, 2001

## Roof Collapse Injures Four Career Fire Fighters at a Church Fire- Arkansas

## Fatality Assessment and Control Evaluation Investigative Report #F2001-03

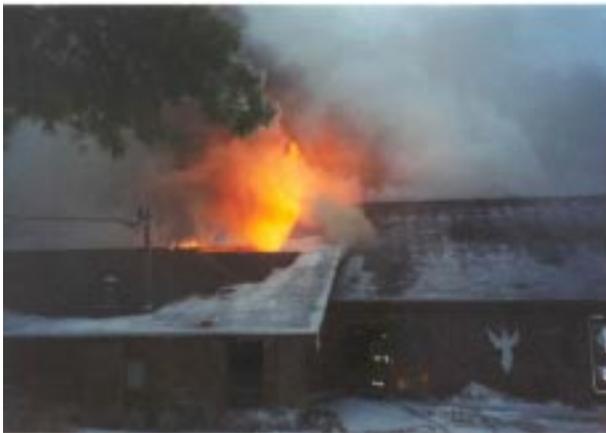
*Structure Involved in this Incident*

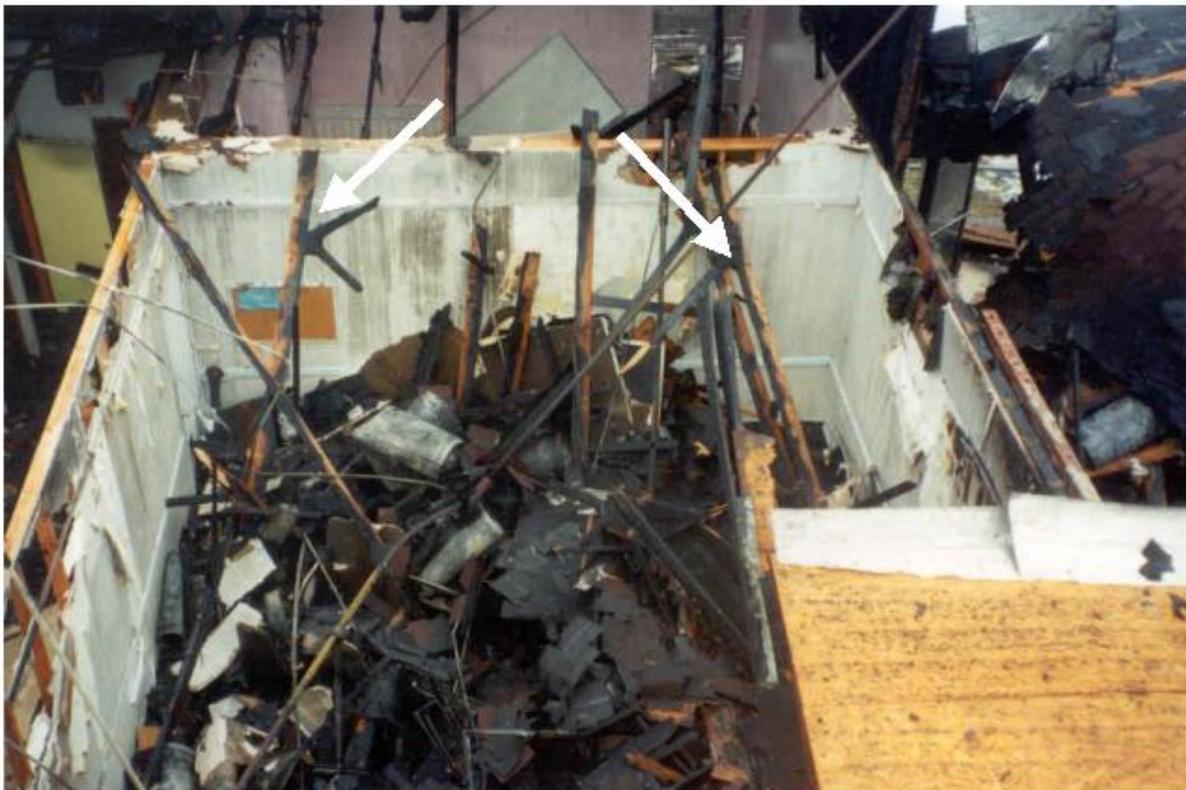
*Photo 1. Truss and Gusset Plates*

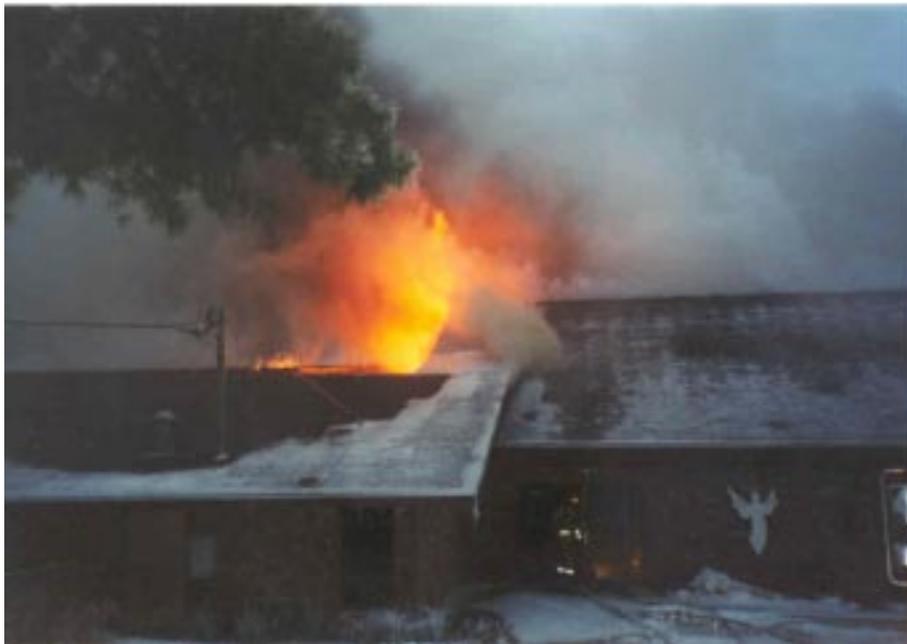
*Photo 2. Doors where crews entered and fire venting over collapse area*

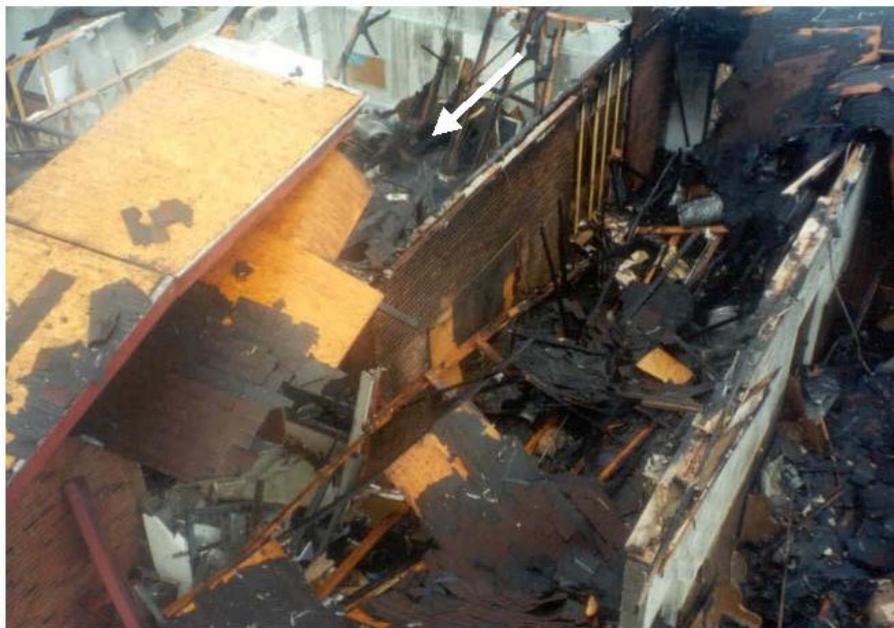
*Photo 3. Collapsed Area*
