# Death in the line of duty...

## Volunteer Fire Fighter (Lieutenant) Killed and One Fire Fighter Injured During Mobile Home Fire— Pennsylvania

Fatality Assessment and Control Evaluation  
Investigative Report #F2001-04

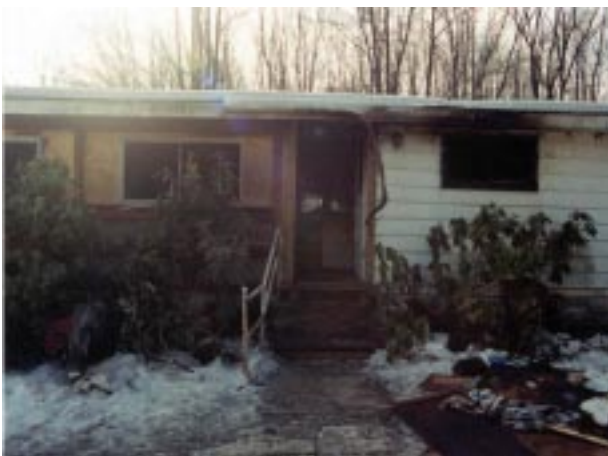
*Mobile Home Involved in Fire*

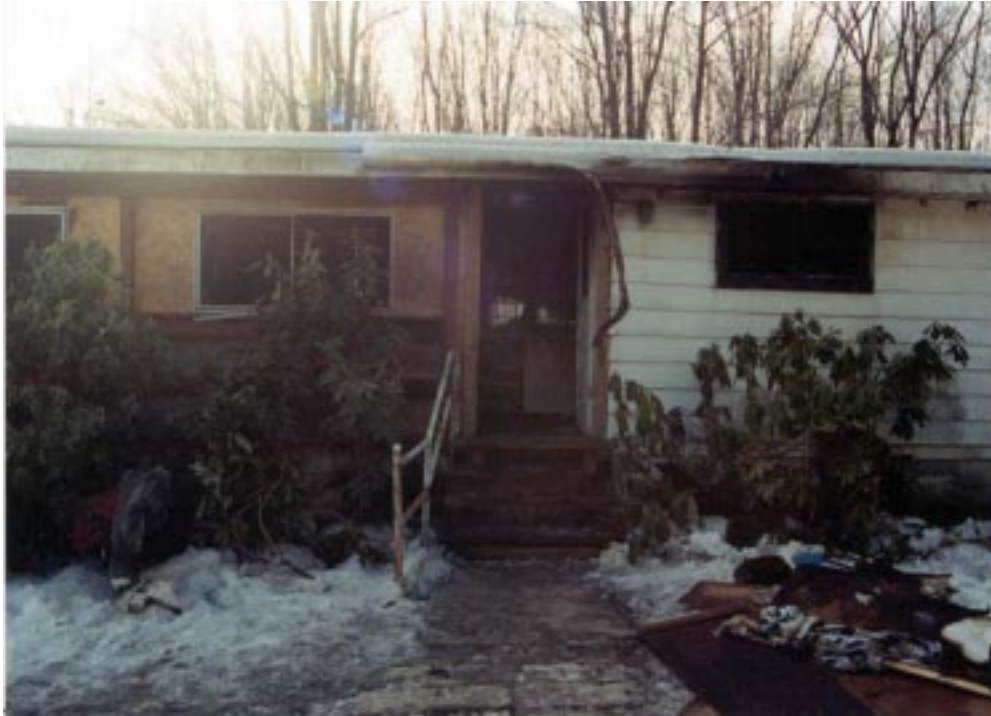
In the interim, the First Assistant Chief and a fire fighter from Engine 19 pulled a 1 ¾-inch line to the front door (first floor, Side 1) entrance of the mobile home and entered (see Figure 1 and Photo 1). After entering, they moved left along a wall and discovered they were in an enclosed porch on the outside of the mobile home (see Photo 2), but could see fire through the windows in the interior of the home. The First Assistant Chief gave the nozzle to the fire fighter and an unidentified fire fighter, and he began breaking windows along the outside wall of the mobile home. The two fire fighters hit the fire through the windows, but had little effect on the fire. The two fire fighters then proceeded through another door off the porch area into the interior (addition) of the mobile home to attack the fire (see Photo 3). At that time, the First Assistant Chief's low-air alarm sounded on his self-contained breathing apparatus (SCBA), and he turned over interior command to the 2<sup>nd</sup> Assistant Chief, who had arrived earlier in his POV. The First Assistant Chief changed his air bottle, then pulled a 1 ¾-inch line off the front of Engine 19 to Side 3 and began hitting the fire through the doorway (Side 3, first floor) into the corner bedroom (see Photo 4).

*Photo 1. Front Door Entrance to Mobile Home (Side 1)*

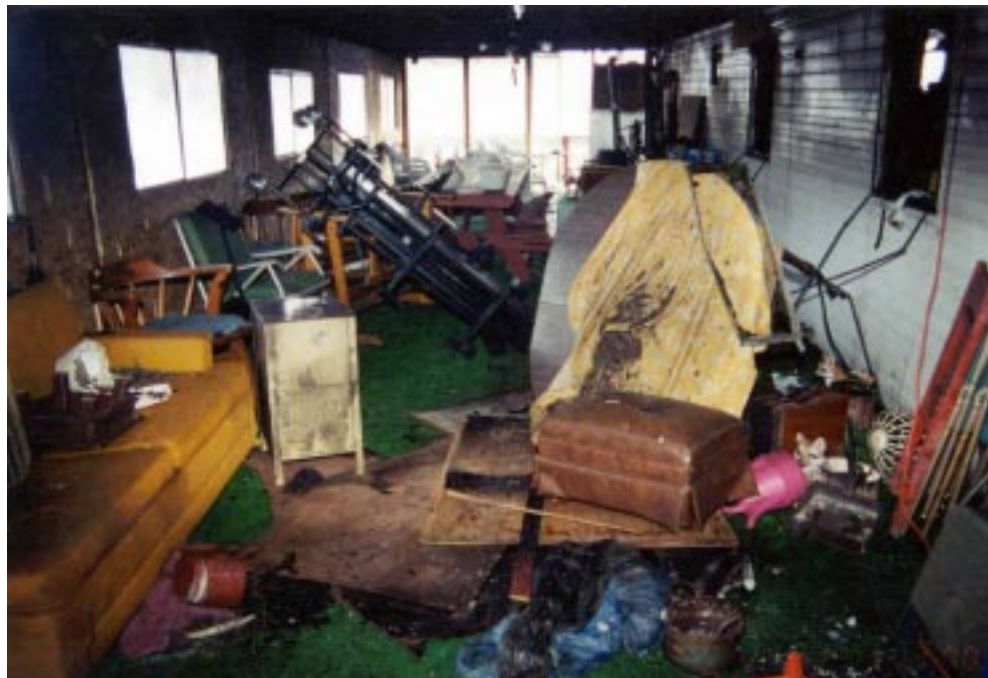
*Photo 2. Enclosed Porch Attached to Mobile Home*

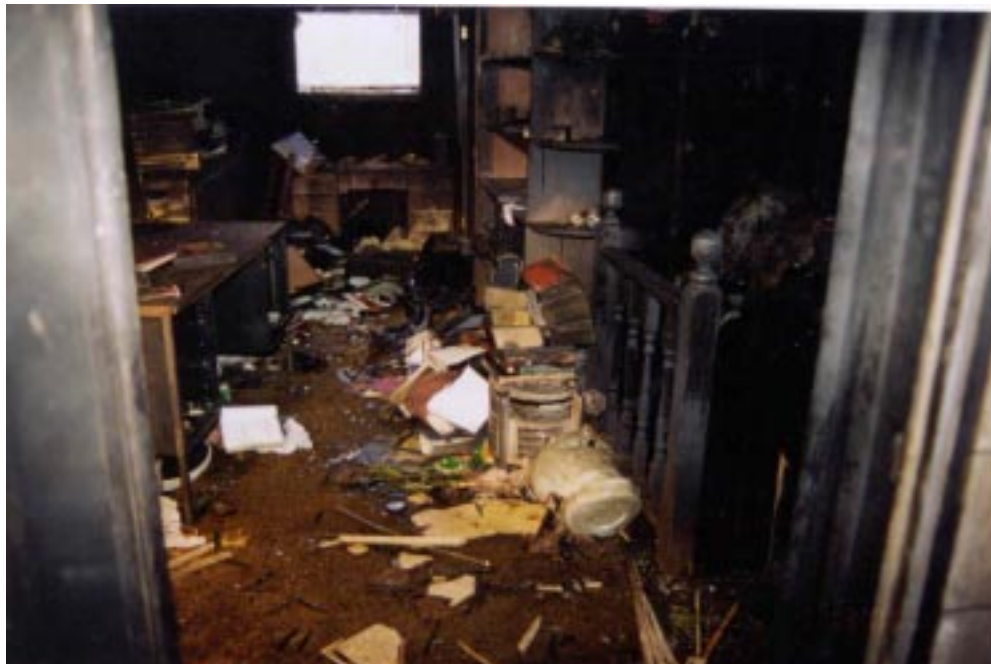
several times, and the two fire fighters became disoriented, got off the line, and crawled into an addition (12 ft x 12 ft) to the mobile home. The fire fighter from Engine 19 found a window, broke through it, and fell outside the mobile home. Other fire fighters assisted him, and he was transported to the local hospital, at 1202 hours.

*Photo 3. Addition to Mobile Home (12 ft x 12 ft)*

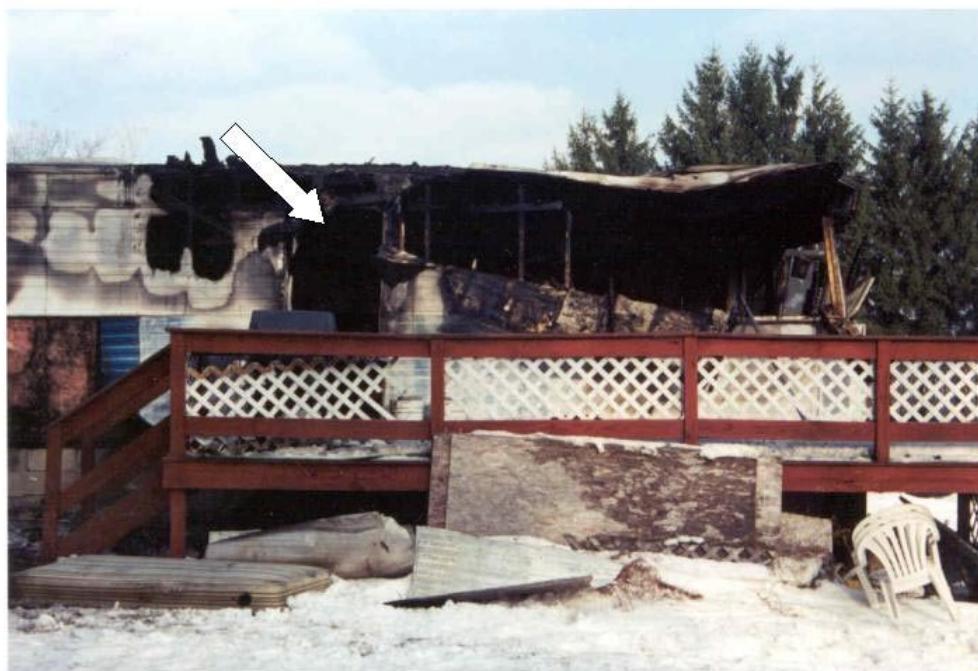
*Photo 4. Doorway Into Corner Bedroom (Side 3)*

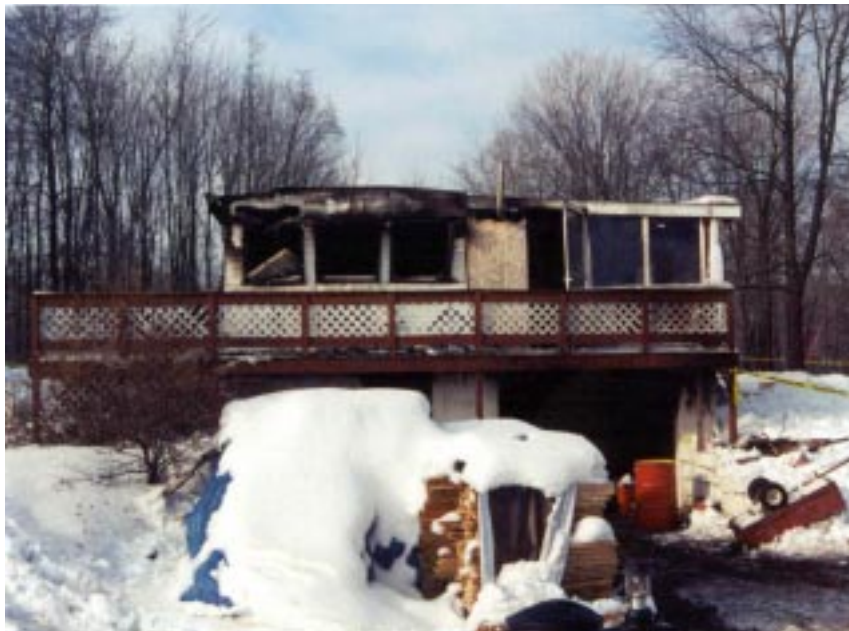
Side 2) by a fire fighter from Engine 19 and a fire fighter from Engine 15 (see Figure 2 and Photo 5). They entered the garage area and started hitting the fire in the basement area. A Lieutenant (the victim) from Engine 15 approached the two fire fighters in the basement and asked if they needed anything. A fire fighter replied that they needed a large hand light. The victim acknowledged the request, left the area, and returned a minute later with a hand light. Shortly thereafter, the SCBA low-air alarm for the fire fighter from Engine 19 sounded, and he left the basement area to change his air bottle. The remaining crew in the basement (fire fighter from Engine 15 and the victim) proceeded to the front door (first floor, Side 1) with their line and entered the porch area. After trying to knock down the fire through the windows on the outside wall of the mobile home, they moved inside the mobile home with their line. Shortly thereafter the fire fighter from Engine 19 who changed his air bottle followed one of the lines into the interior of the mobile home. Because of limited (zero) visibility, the fire fighter crawled on his hands and knees in order to follow the line. He followed the line until he met up with two other fire fighters, but never made identification of either fire fighter. About that time, the low-air alarm on the fire fighter from Engine 15 who was on the interior line began to sound, and he left the line and found his way out of the house. The remaining two fire fighters moved back through the hallway hitting fires in various rooms off to their left (see Photo 6). They reached a point in the hallway where they were hitting the fire in the corner bedroom and conditions worsened. The crew began backing out as the heat and smoke became more intense. The second hose crew, which was hitting the fire in another part of the house, backed out and exited as the heat and smoke intensified. As the crew that was in the hallway backed out

*Photo 5. Entrance to Garage and Basement Area (Side 2)*

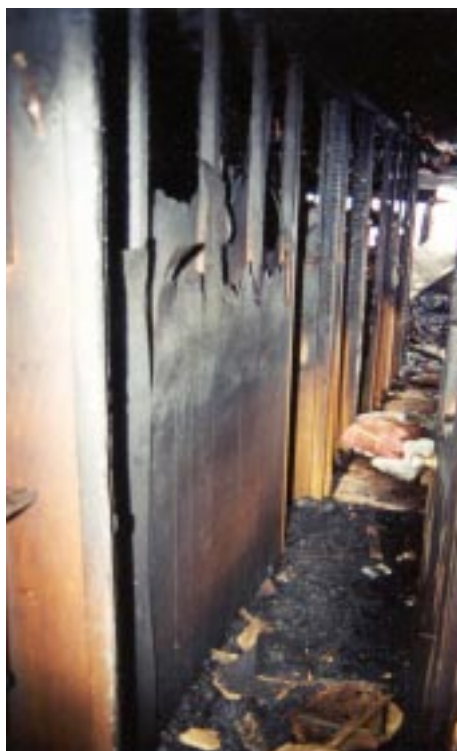
*Photo 6. Hallway to Corner Bedroom*

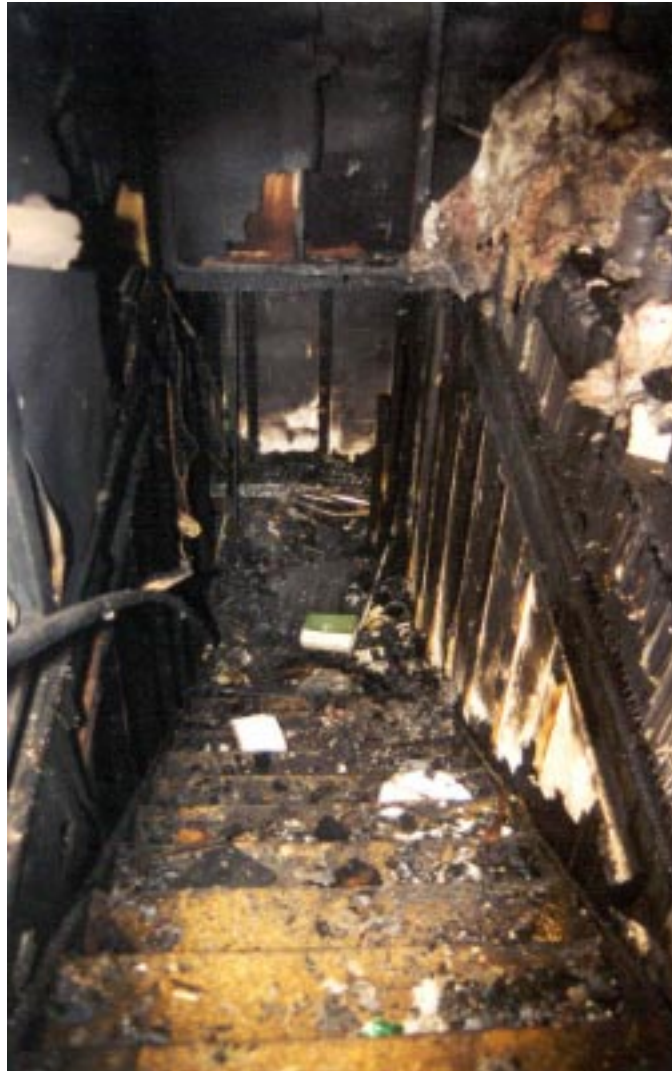
*Photo 7. Stairway Connecting Addition to Basement*

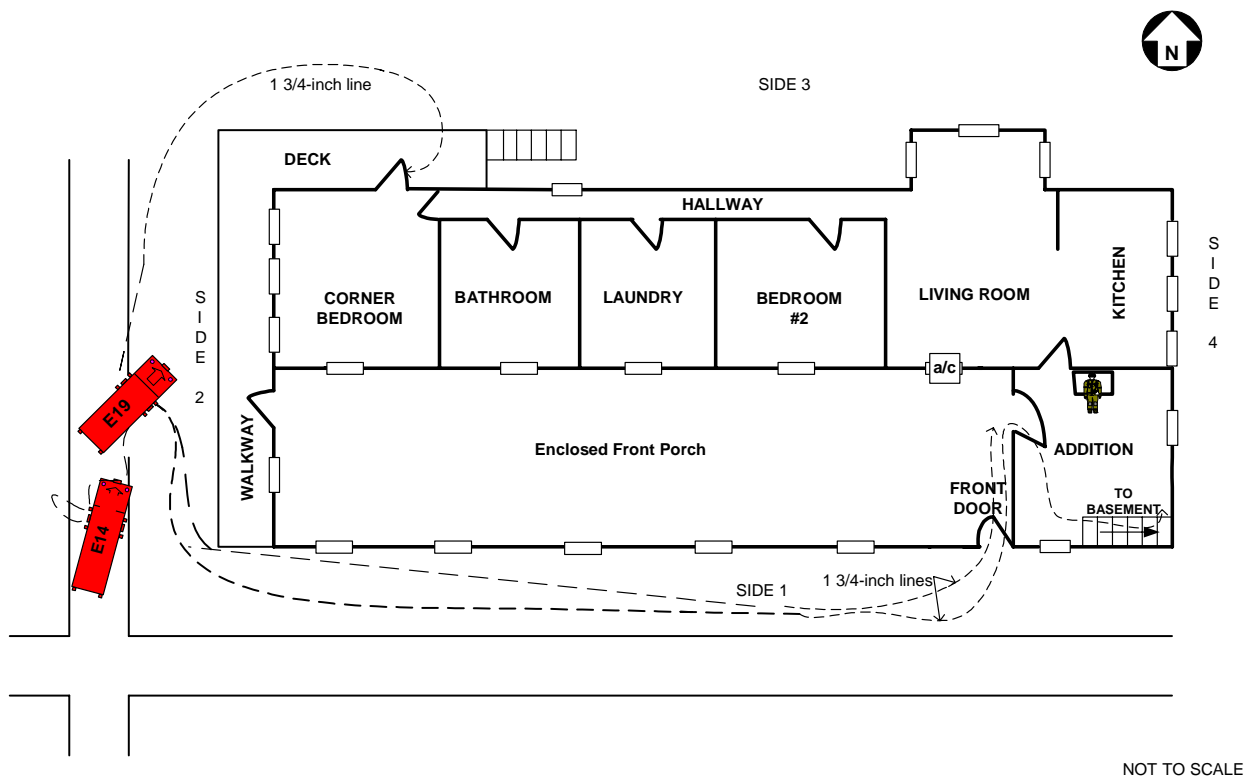
*Figure 1. Mobile Home, First Floor Layout*

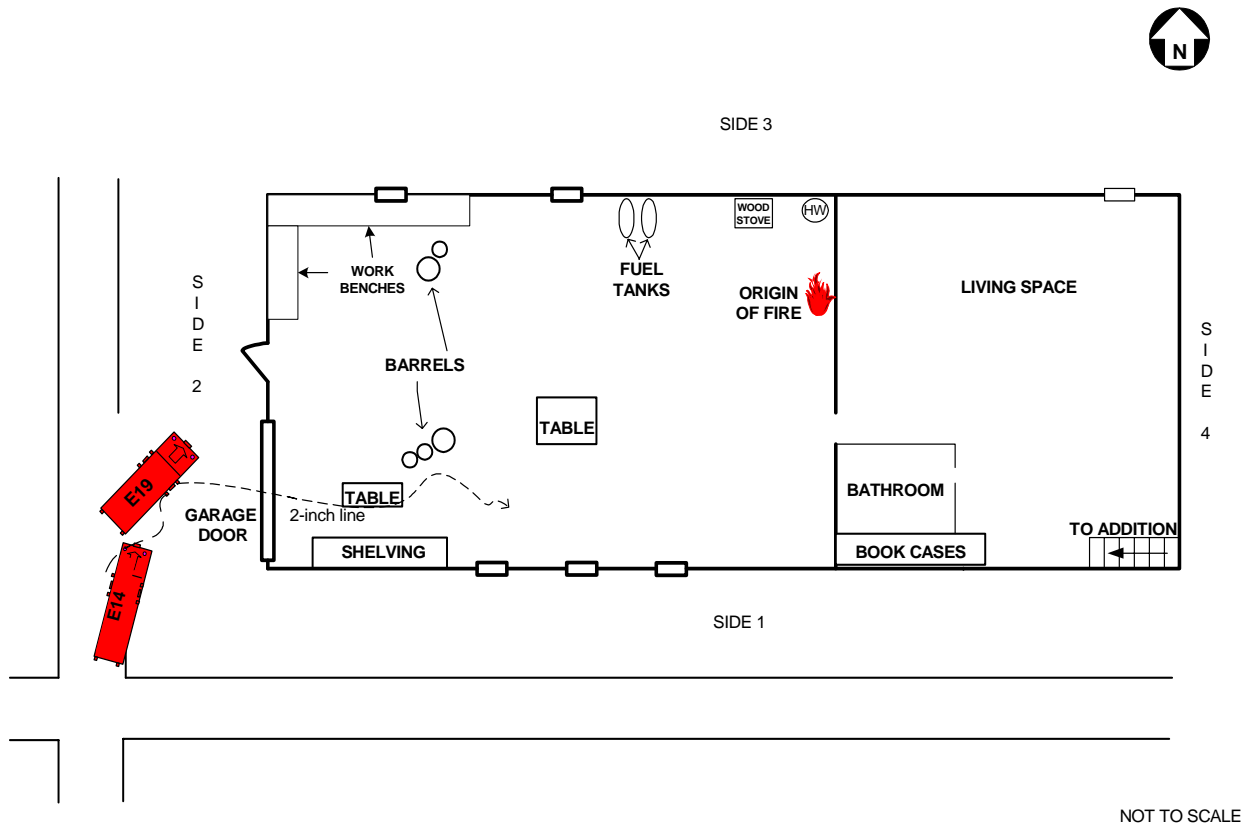
*Figure 2. Mobile Home, Basement Floor Layout*
