NIOSH
Fire Fighter Fatality Investigation
and Prevention Program

August 8, 2001

Volunteer Fire Fighter (Lieutenant) Killed and One Fire Fighter Injured During Mobile Home Fire— Pennsylvania

Fatality Assessment and Control Evaluation
Investigative Report #F2001-04

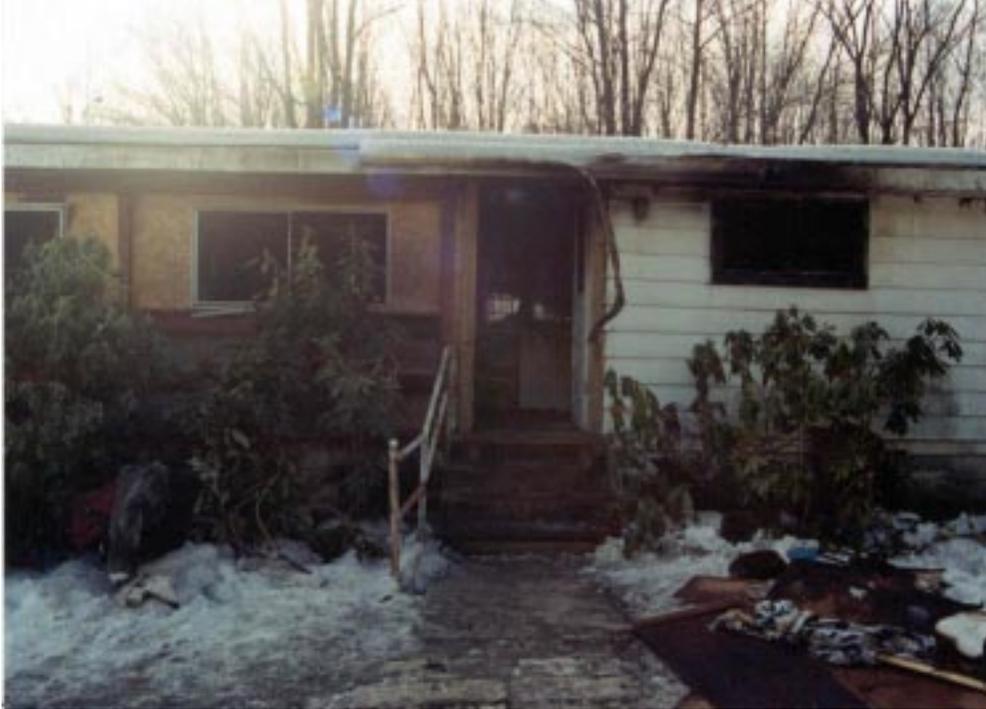
In the interim, the First Assistant Chief and a fire fighter from Engine 19 pulled a 1 ¾-inch line to the front door (first floor, Side 1) entrance of the mobile home and entered (see Figure 1 and Photo 1). After entering, they moved left along a wall and discovered they were in an enclosed porch on the outside of the mobile home (see Photo 2), but could see fire through the windows in the interior of the home. The First Assistant Chief gave the nozzle to the fire fighter and an unidentified fire fighter, and he began breaking windows along the outside wall of the mobile home. The two fire fighters hit the fire through the windows, but had little effect on the fire. The two fire fighters then proceeded through another door off the porch area into the interior (addition) of the mobile home to attack the fire (see Photo 3). At that time, the First Assistant Chief's low-air alarm sounded on his self-contained breathing apparatus (SCBA), and he turned over interior command to the 2nd Assistant Chief, who had arrived earlier in his POV. The First Assistant Chief changed his air bottle, then pulled a 1 ¾-inch line off the front of Engine 19 to Side 3 and began hitting the fire through the doorway (Side 3, first floor) into the corner bedroom (see Photo 4).

Photo 1. Front Door Entrance to Mobile Home (Side 1)

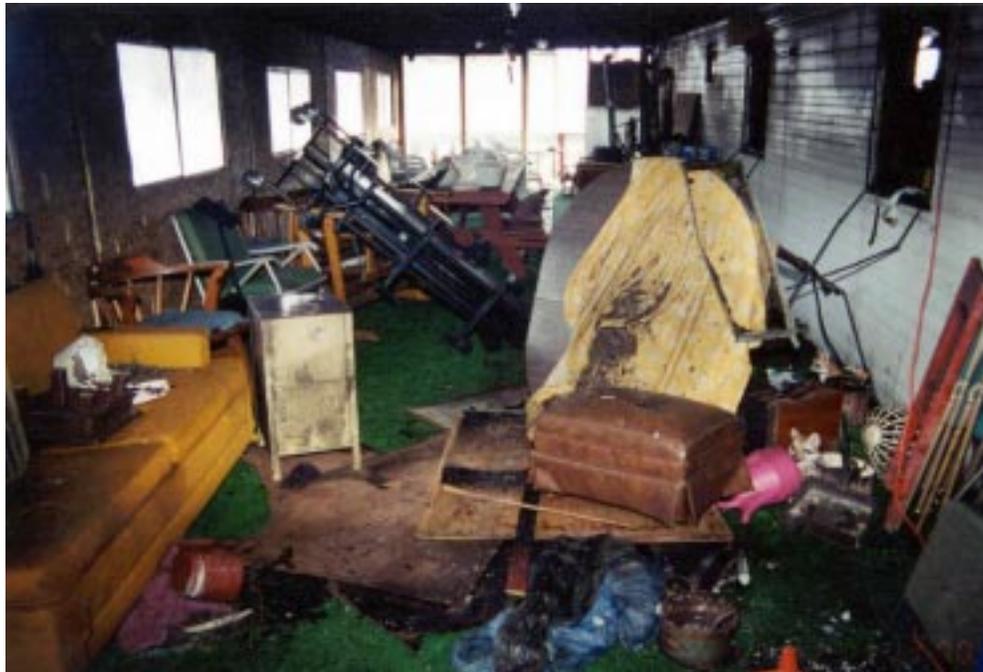
Photo 2. Enclosed Porch Attached to Mobile Home

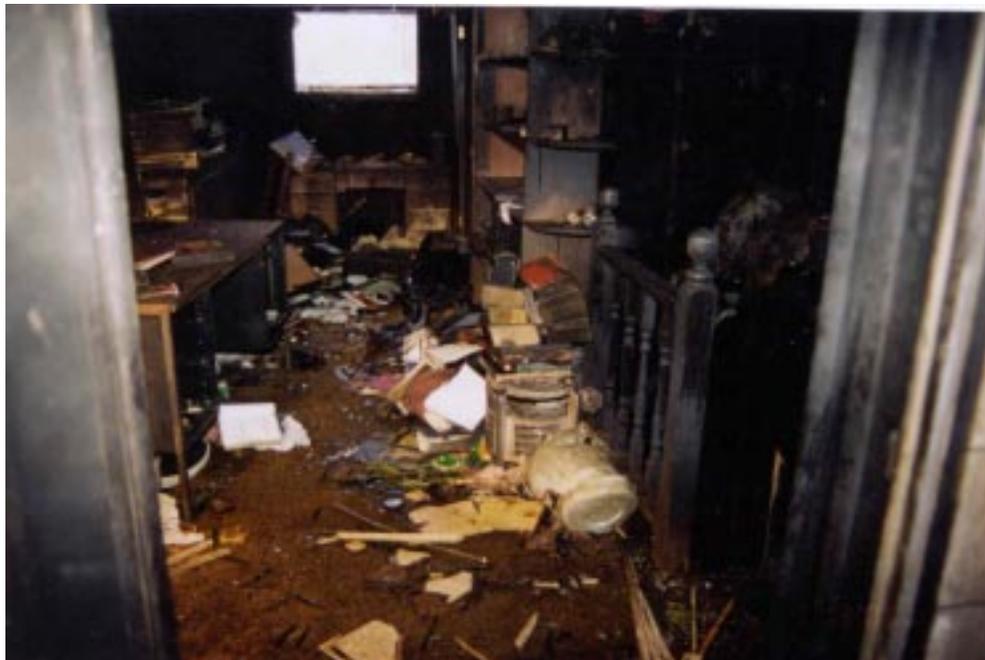
several times, and the two fire fighters became disoriented, got off the line, and crawled into an addition (12 ft x 12 ft) to the mobile home. The fire fighter from Engine 19 found a window, broke through it, and fell outside the mobile home. Other fire fighters assisted him, and he was transported to the local hospital, at 1202 hours.

Photo 3. Addition to Mobile Home (12 ft x 12 ft)

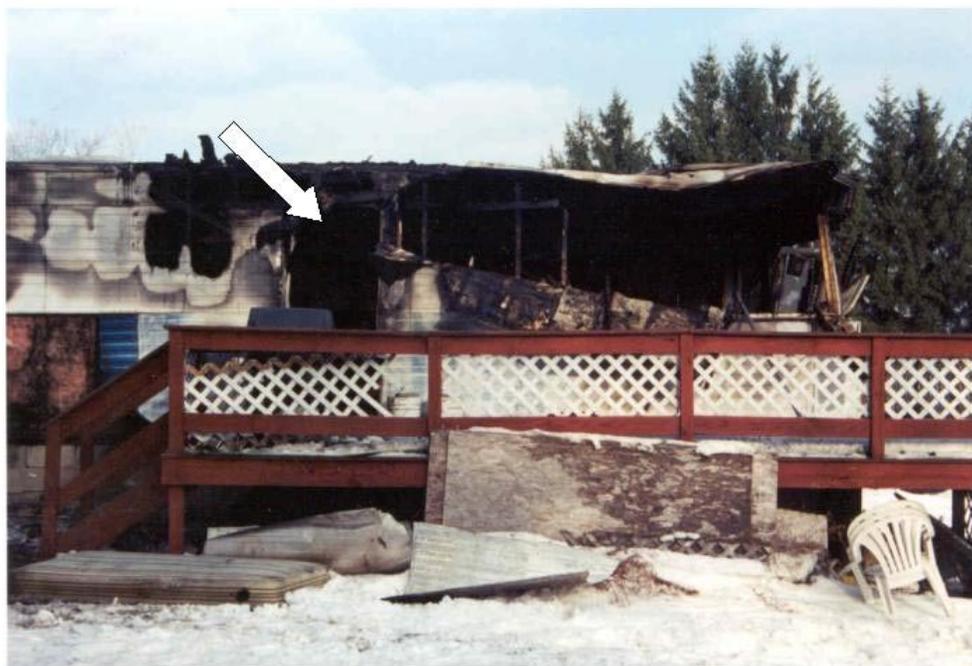
Photo 4. Doorway Into Corner Bedroom (Side 3)

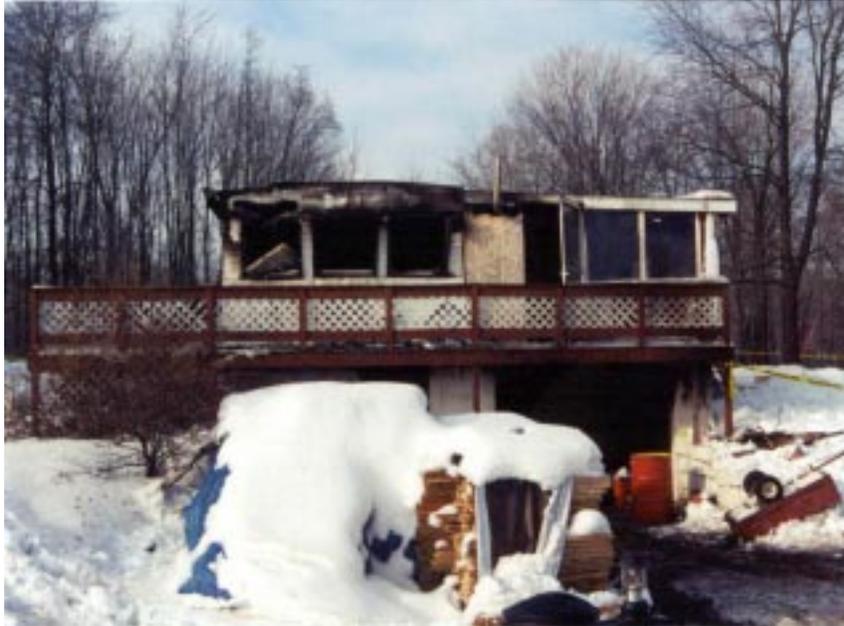
Side 2) by a fire fighter from Engine 19 and a fire fighter from Engine 15 (see Figure 2 and Photo 5). They entered the garage area and started hitting the fire in the basement area. A Lieutenant (the victim) from Engine 15 approached the two fire fighters in the basement and asked if they needed anything. A fire fighter replied that they needed a large hand light. The victim acknowledged the request, left the area, and returned a minute later with a hand light. Shortly thereafter, the SCBA low-air alarm for the fire fighter from Engine 19 sounded, and he left the basement area to change his air bottle. The remaining crew in the basement (fire fighter from Engine 15 and the victim) proceeded to the front door (first floor, Side 1) with their line and entered the porch area. After trying to knock down the fire through the windows on the outside wall of the mobile home, they moved inside the mobile home with their line. Shortly thereafter the fire fighter from Engine 19 who changed his air bottle followed one of the lines into the interior of the mobile home. Because of limited (zero) visibility, the fire fighter crawled on his hands and knees in order to follow the line. He followed the line until he met up with two other fire fighters, but never made identification of either fire fighter. About that time, the low-air alarm on the fire fighter from Engine 15 who was on the interior line began to sound, and he left the line and found his way out of the house. The remaining two fire fighters moved back through the hallway hitting fires in various rooms off to their left (see Photo 6). They reached a point in the hallway where they were hitting the fire in the corner bedroom and conditions worsened. The crew began backing out as the heat and smoke became more intense. The second hose crew, which was hitting the fire in another part of the house, backed out and exited as the heat and smoke intensified. As the crew that was in the hallway backed out

Photo 5. Entrance to Garage and Basement Area (Side 2)

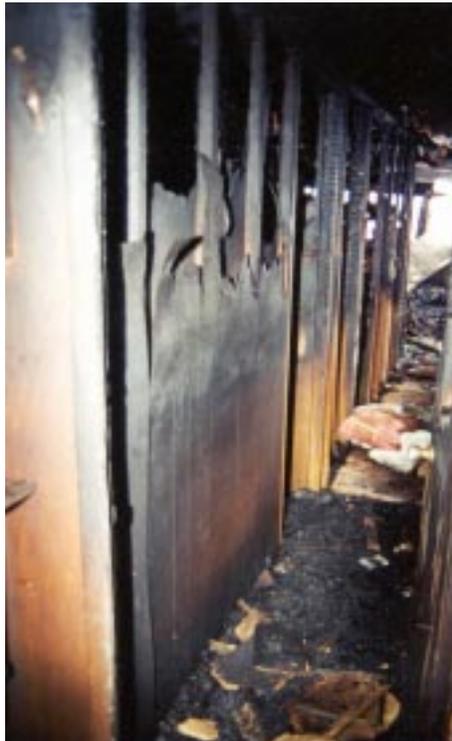
Photo 6. Hallway to Corner Bedroom

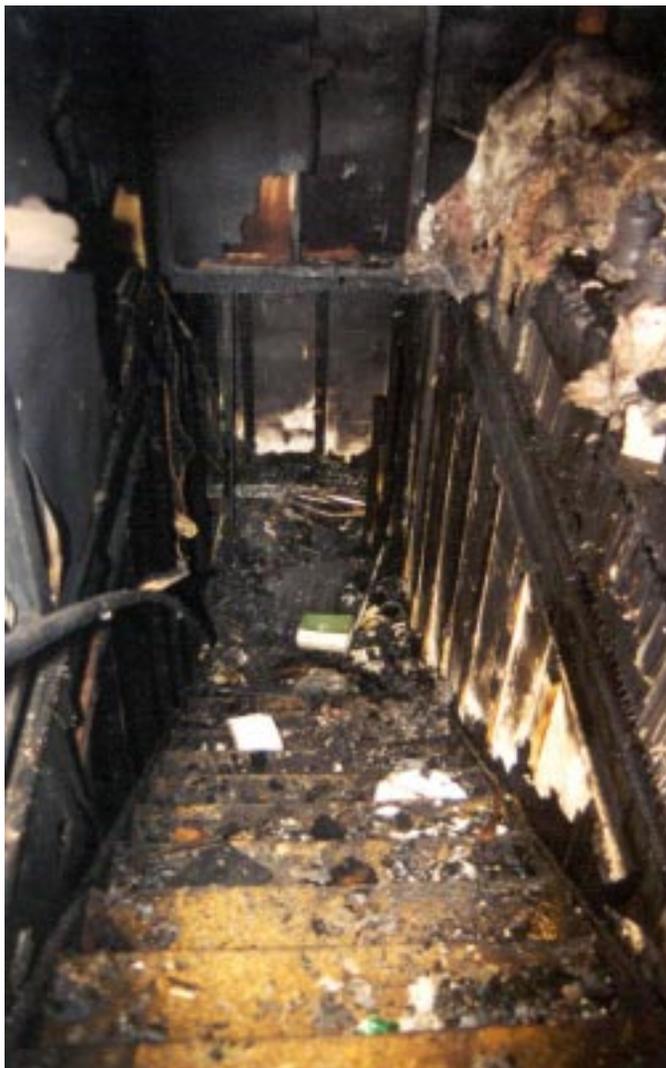
Photo 7. Stairway Connecting Addition to Basement

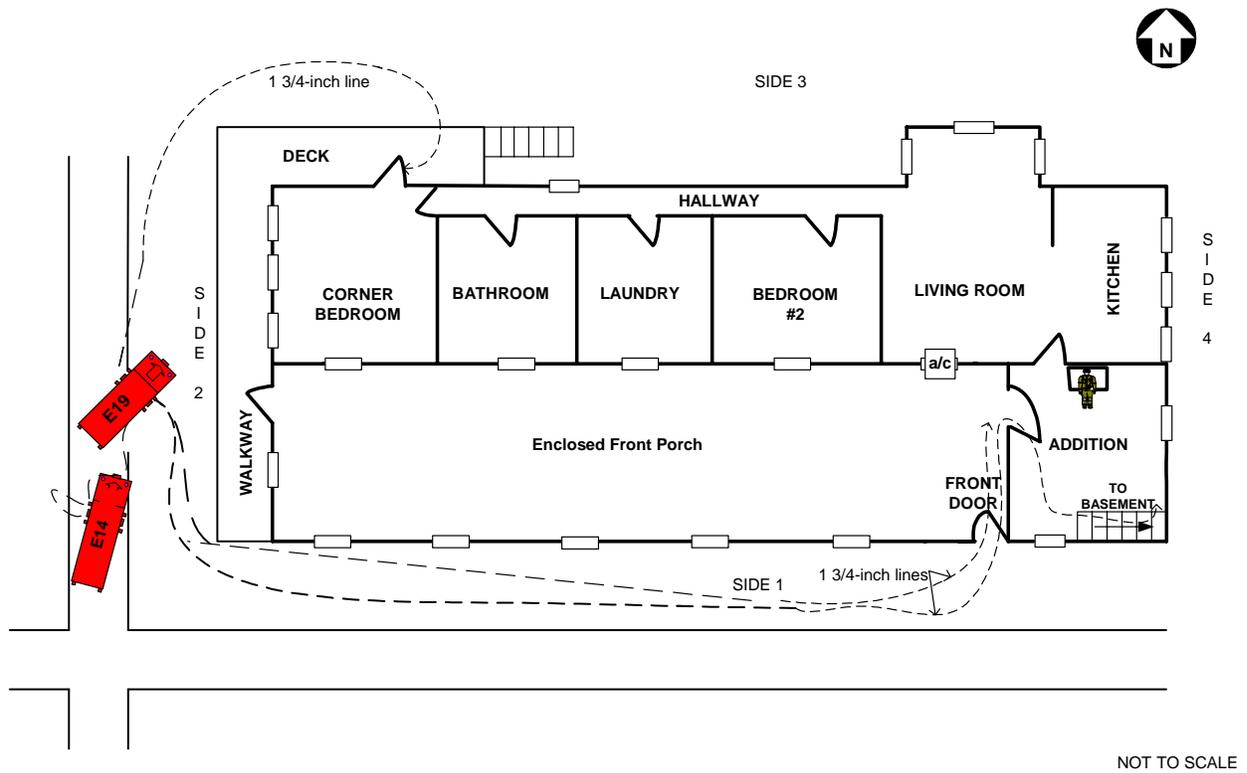
Figure 1. Mobile Home, First Floor Layout

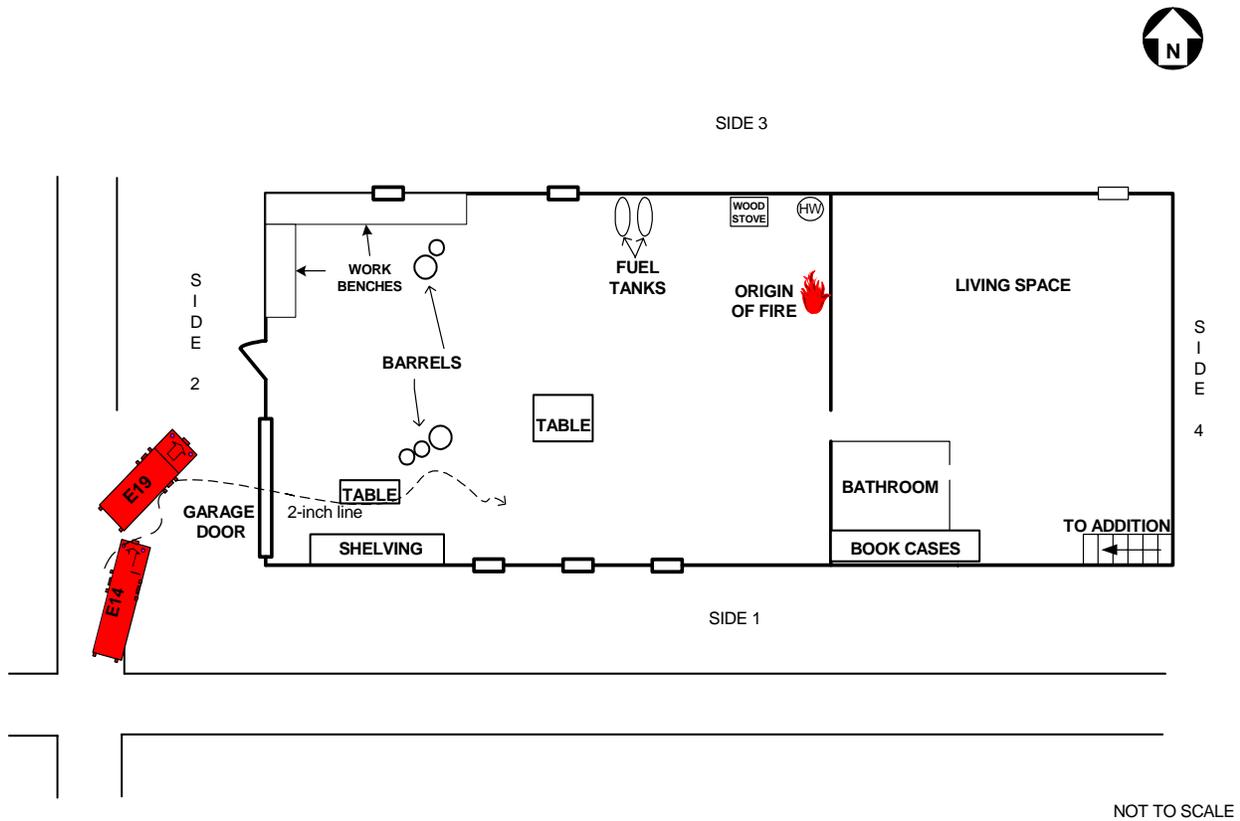
Figure 2. Mobile Home, Basement Floor Layout
