Fire Fighter Dies After the Tanker Truck he was Driving Strikes a Utility Pole and Overturns While Responding to a Grass Fire—Kentucky

Fatality Assessment and Control Evaluation Investigative Report #F2001-06

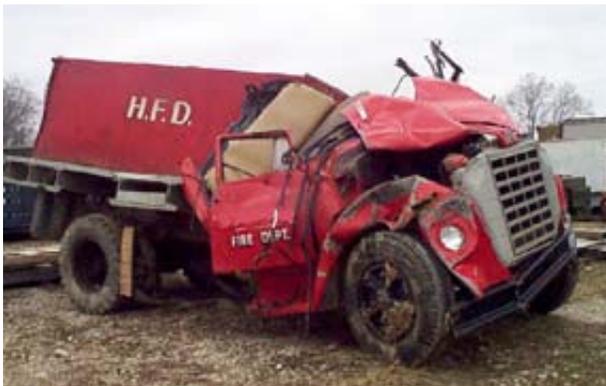
Tanker Truck Involved in This Incident

Discussion: The Gross Axle Weight Rating (GAWR) and the Gross Combination Weight Rating (GCWR) or Gross Vehicle Weight Rating (GVWR) of the fire apparatus must be adequate to carry the weight of the unequipped apparatus, the tank fully loaded with water, the specified hose load, personnel weight, ground ladders, and the miscellaneous equipment allowance. The GVWR for the chassis on the tanker in this incident was 16,000 lb. The tanker at the time of the incident was hauling 1500 gallons of water and had a baffled steel tank. The combined weight

of the 1500 gallons of water and the tank was estimated to be in excess of 13,600 lbs. The estimated weight did not include the additional weight of the tank frame, engine, cab, personnel, and other equipment, which would have exceeded the Gross Vehicle Weight Rating.

Recommendation #2: Fire departments should ensure that the apparatus chassis is adequate to carry the weight of the unequipped apparatus, the water and tank, hose load, personnel weight, ground ladders, and the designed miscellaneous equipment allowance.⁵

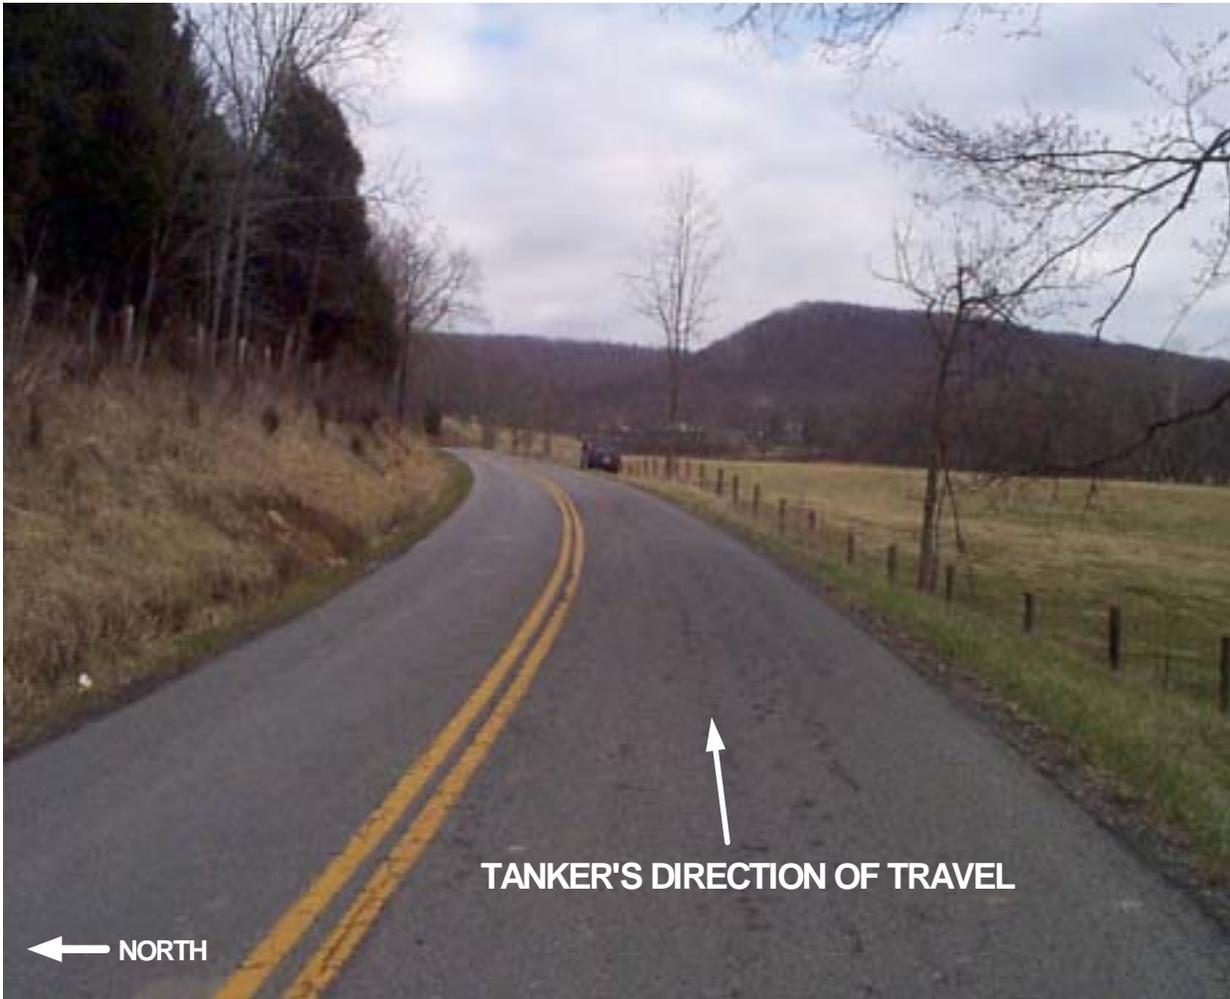
Photo 1. Eastbound View of the Road Where the Tanker Veered off of Road and Overturned

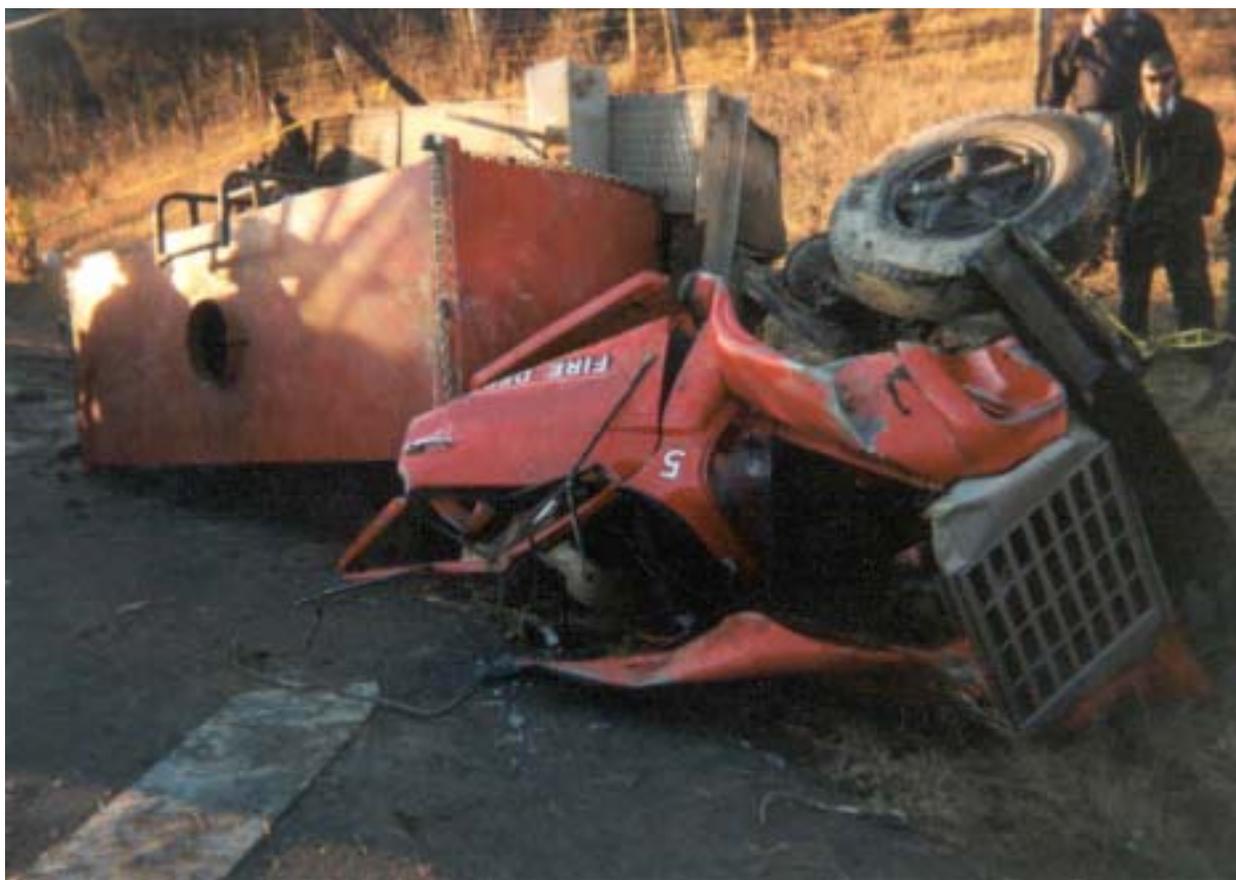
On January 12, 2001, at 1404 hours, the volunteer fire department was notified by Central Dispatch of a grass fire. At approximately 1407 hours, Unit 2 responded with two fire fighters on board and at approximately 1409 hours, Tanker 5 responded with a fire fighter (the victim) driving. At approximately 1420 hours, Unit 3 responded with a Chief driving, an Assistant Chief, a Captain, and a fire fighter on board. The tanker was traveling eastbound on a two-lane state road, with a speed limit of 55 mph (see Photo #1). *Note: The speed of the tanker could not be determined by the state police.* After making a moderate curve approximately 3 miles from the station, for unknown reasons the tanker's right-side tires drifted off the roadway on the right eastbound side. *Note: The tanker continued to travel approximately 100 feet.* There were no driveable shoulders in this area of the road. The victim lost control of the tanker as he attempted to bring it back onto the roadway. The victim overcorrected when the tanker came back onto the roadway. The tanker continued to travel across the left westbound side of the roadway, entered a ditch, hit an embankment, and struck a utility pole (see Diagram). *Note: When the tanker proceeded back onto the roadway it traveled approximately 12 feet before hitting the embankment.* The tanker overturned approximately one complete revolution and slid on the driver's side as it continued to travel on the left westbound side of the roadway. *Note: After the tanker struck the utility pole it traveled approximately 30 feet until it came to rest.* The tanker came to rest on the passenger side, partially off the left (north) side of the roadway (see Photo 2). The victim was entrapped on the passenger side under the crushed area of the tanker. A fire fighter,

Photo 2. Incident Scene

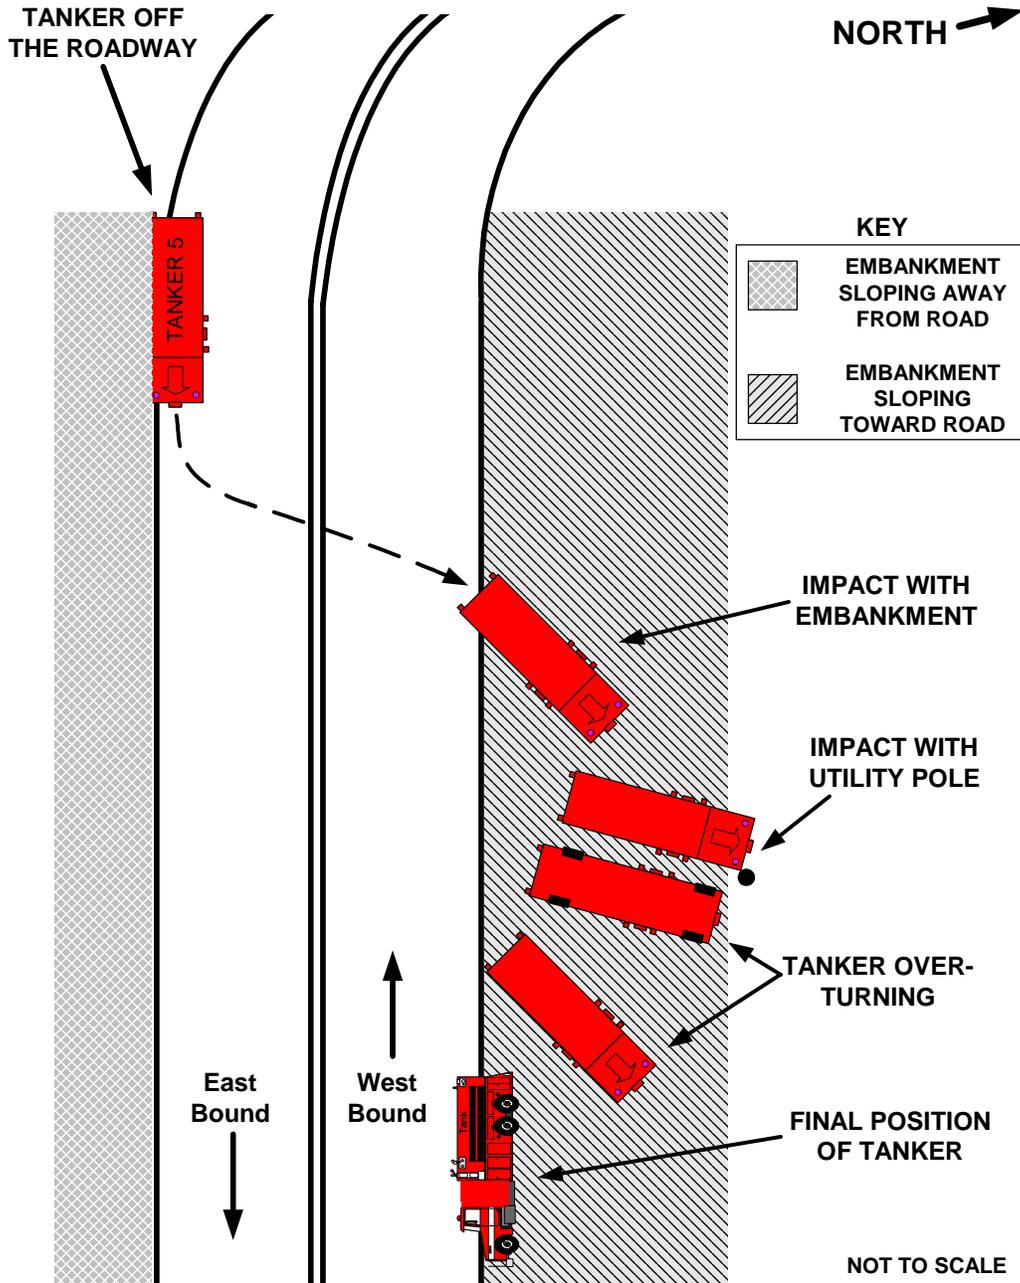
Diagram. Aerial View of Incident Site
