Two Volunteer Fire Fighters Die Fighting a Basement Fire - Illinois

Fatality Assessment and Control Evaluation Investigative Report #F2001-08

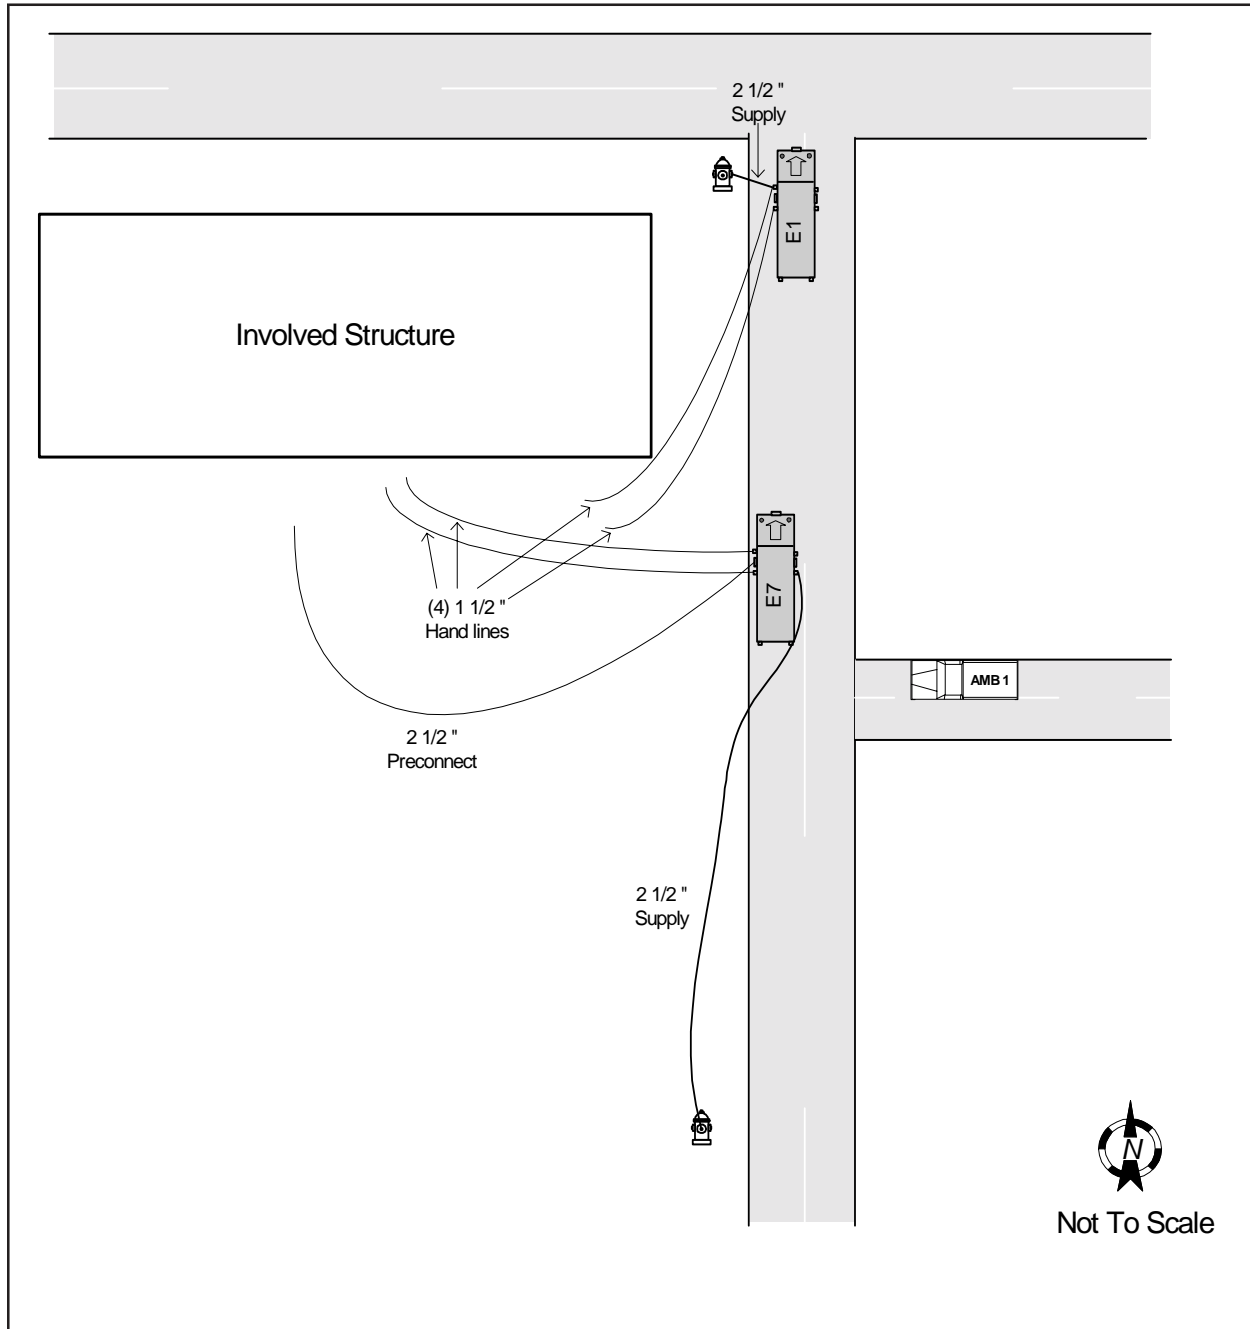
Diagram 1. Apparatus Layout

At 0823 hours, Engine 1 and Ambulance 15 were the first to arrive on the scene. When approaching the scene, the crew noticed a small amount of white smoke emitting from the house. Fire fighters from Engine 1 pulled two 1 ½- inch preconnects and stretched both lines to the south door of the structure (Diagram 1). The Chief assumed Incident Command (IC) and was informed by a relative of the resident that no one was inside the structure and that the resident had noticed smoke in the bathroom on the first floor (Diagram 2). Engine 7 and Ambulance 23 arrived on the scene at 0824 hours. While Engine 7 connected their supply line to a hydrant and pulled a 1 ½- inch preconnect to the south side of the structure, the Assistant Chief conducted a scene size-up while walking around the structure. He noticed light gray smoke emitting from the eaves and around the chimney with no visible flames. The Chief informed the Assistant Chief they had two 1 ½-inch lines pulled to the south (rear) door.

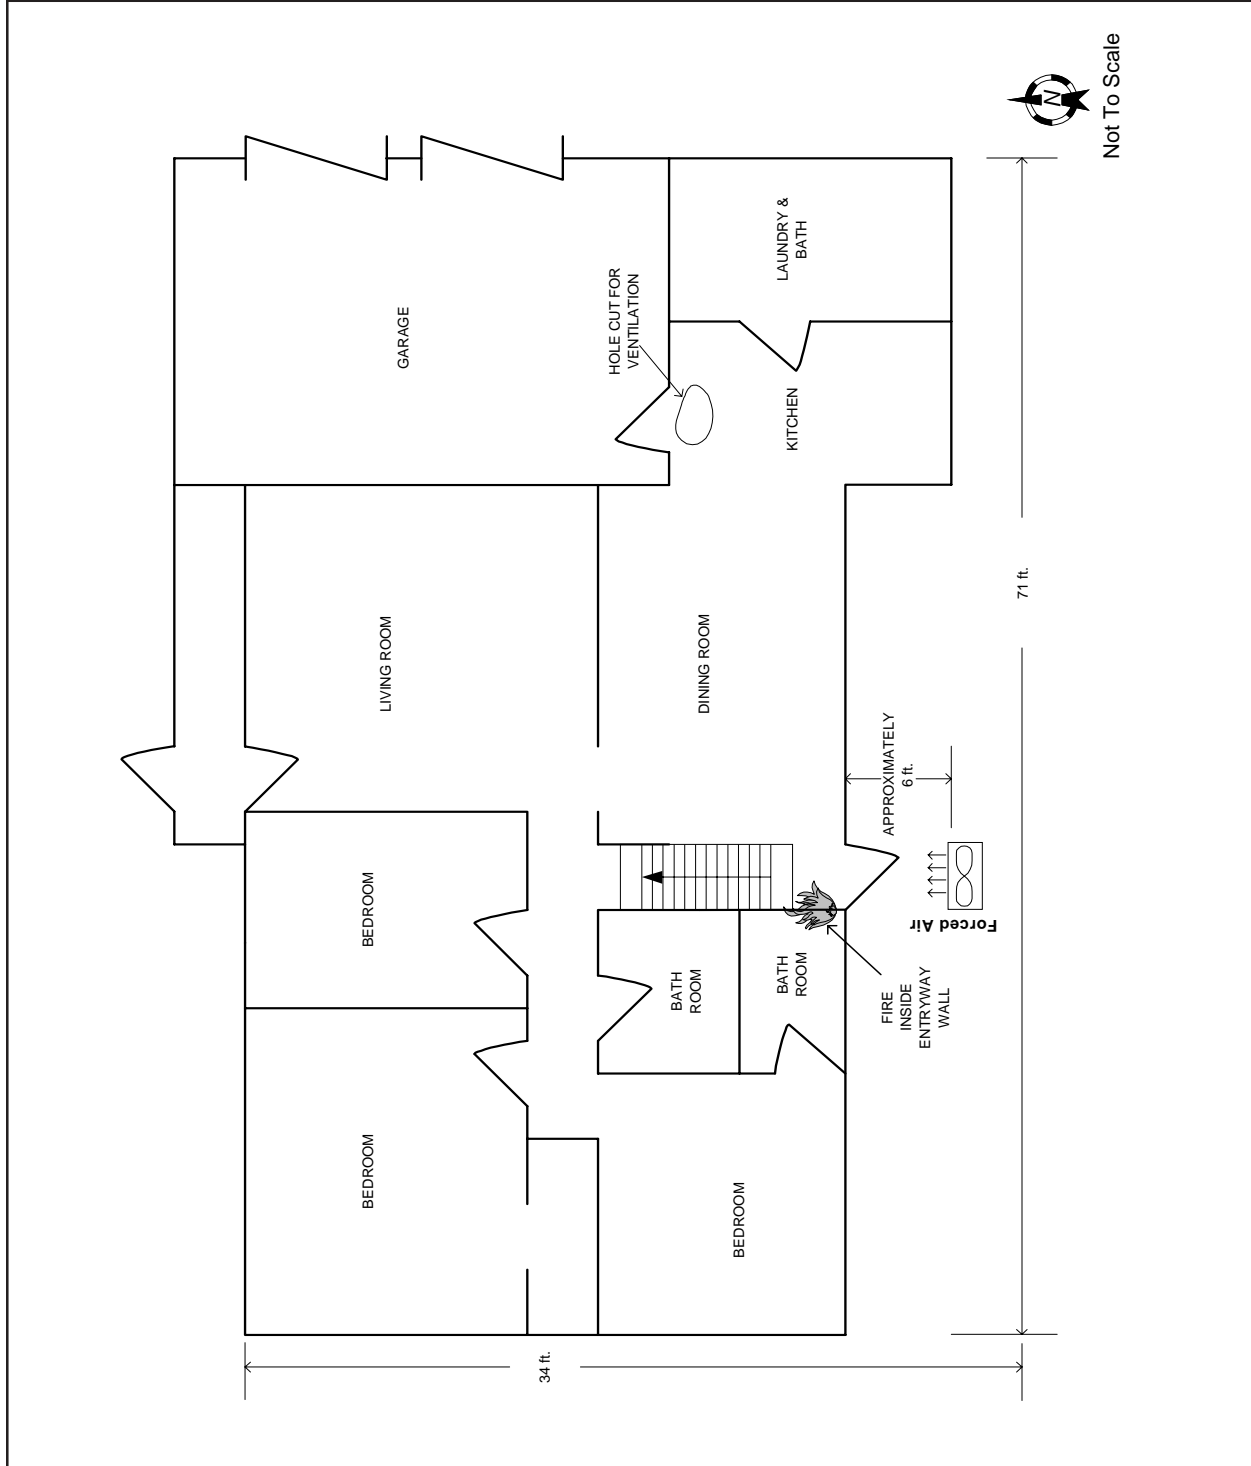
Diagram 2. First Floor

The IC sent a Captain, two fire fighters and Victim #2 to the roof to provide ventilation. Two fire fighters from Engine 1 entered the south side of the structure with a 1 ½-inch hoseline, and a second 1 ½-inch hoseline was in place for backup. While searching for the location of the fire, the crew noted that the smoke was thick, brown, and banked to the floor. Scattered throughout the home were large amounts of furnishings and debris, which hindered fire fighters' efforts during the entire attack. The two fire fighters continued their search; however, they could not find any visible fire. They found no fire on the first floor and began to back out of the structure, taking the nozzle with them. On the way out, part of the dining room ceiling collapsed (Diagram 2), and fire began rolling out of the collapsed area. They opened the

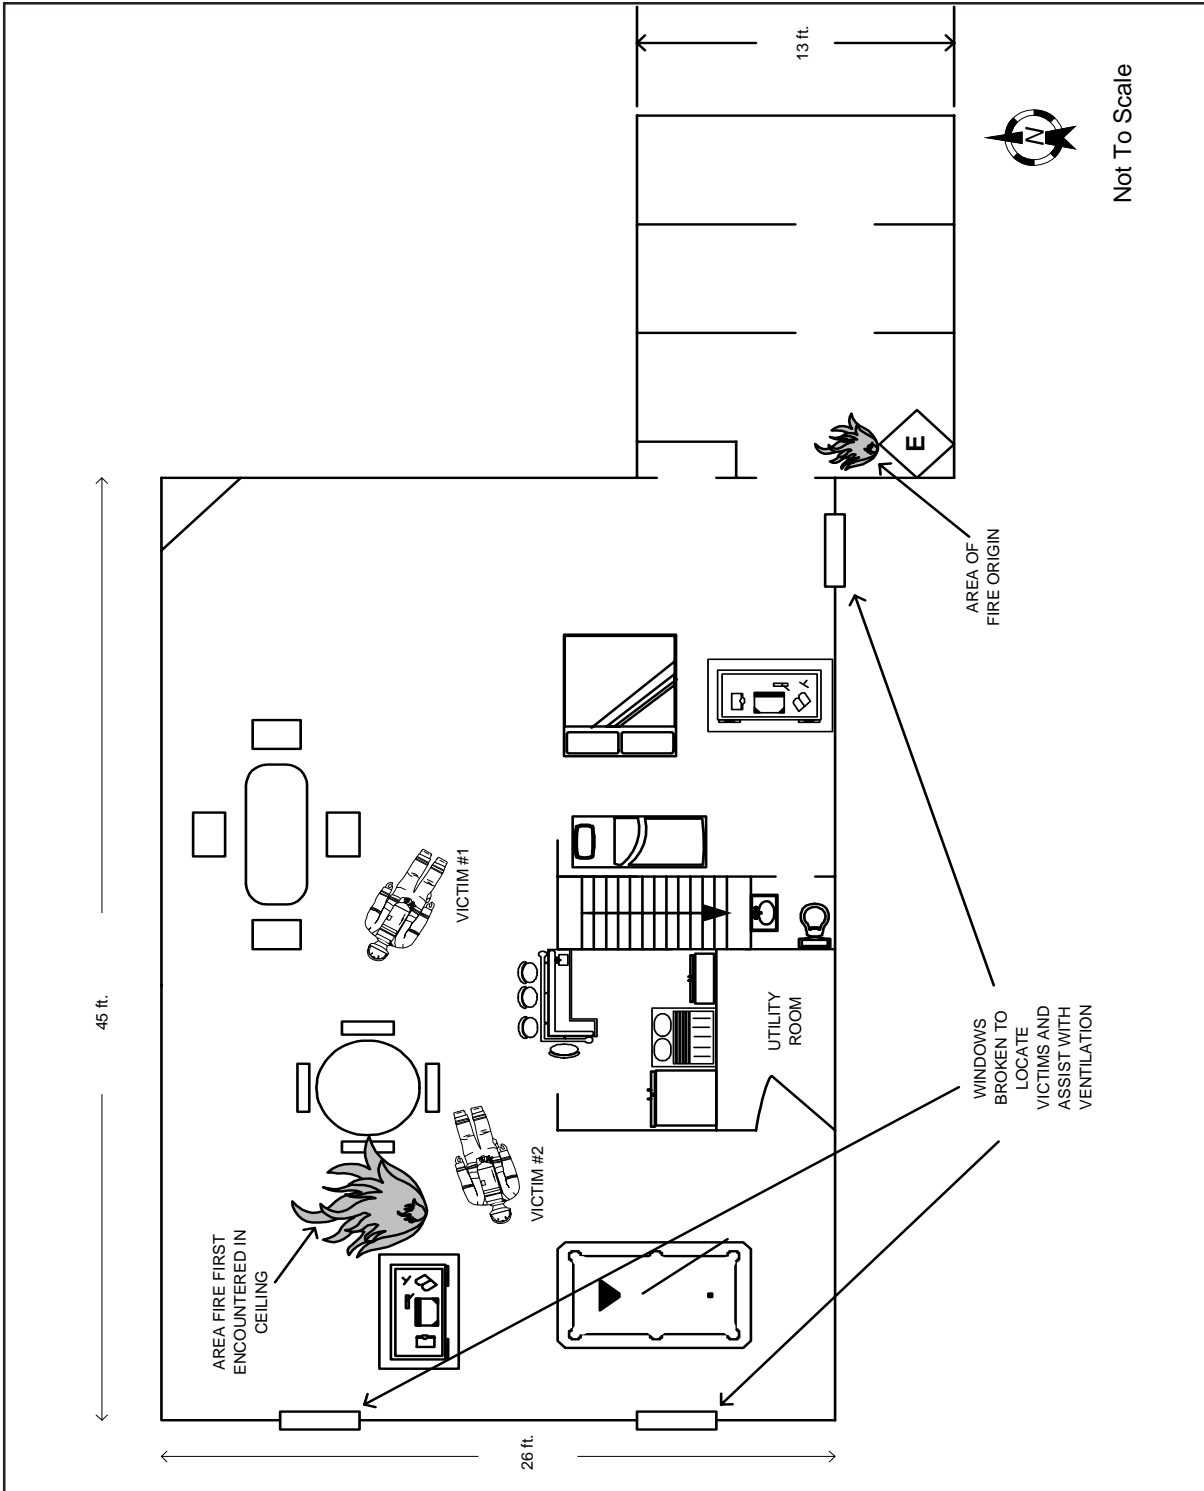
Diagram 3. Basement

Victim #1 and two other fire fighters entered the south-side door to make the first entry into the basement. The crew took a 1 ½-inch hoseline with them. At the foot of the stairs, they saw fire on the ceiling to the west (Diagram 3). The crew opened the nozzle and pushed the fire back. One of the fire fighters left the basement to retrieve halogen lights and flashlights and to inform the Assistant Chief that they had a working basement fire. With one low air alarm sounding, the crew exited the basement after
