Supermarket Fire Claims the Life of One Career Fire Fighter and Critically Injures Another Career Fire Fighter - Arizona

Fatality Assessment and Control Evaluation Investigative Report #F2001-13

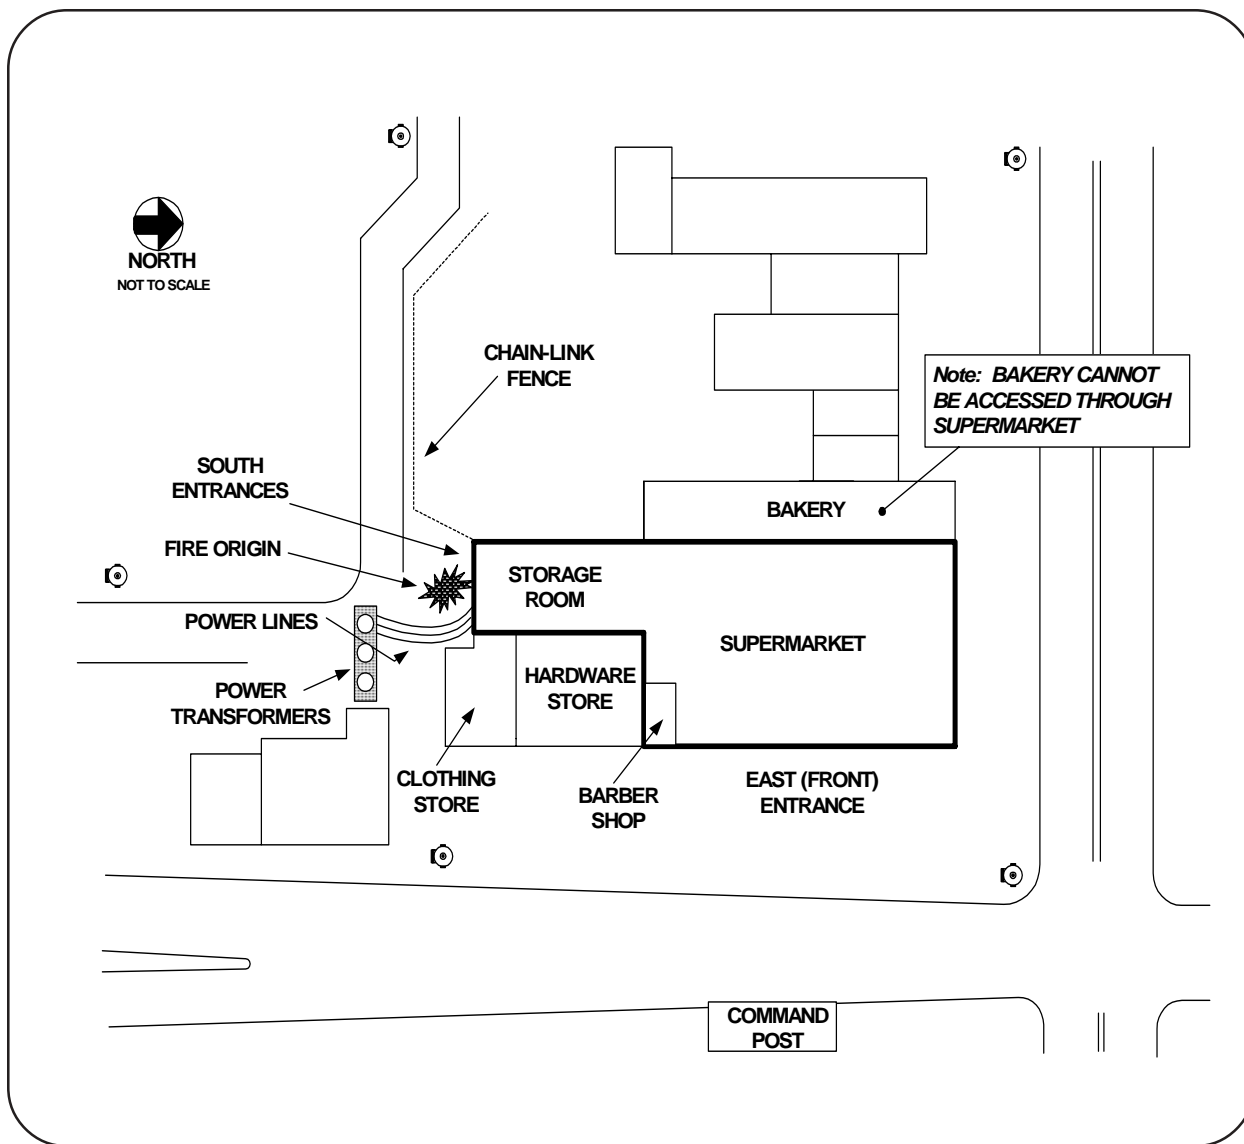
Diagram 1. Strip Mall Layout

Structure. The structure was a 27,905-square-foot, L-shaped supermarket that was part of a strip mall (Diagram 1). The structure had a slab concrete foundation and masonry block walls with steel beams and posts. The roof system consisted of open web steel trusses covered with wood, foam, and tar asphalt roofing. The ceiling height throughout the supermarket and lower-level storage area was approximately 20 feet. Second-floor platforms located above the coolers and the first-floor storage

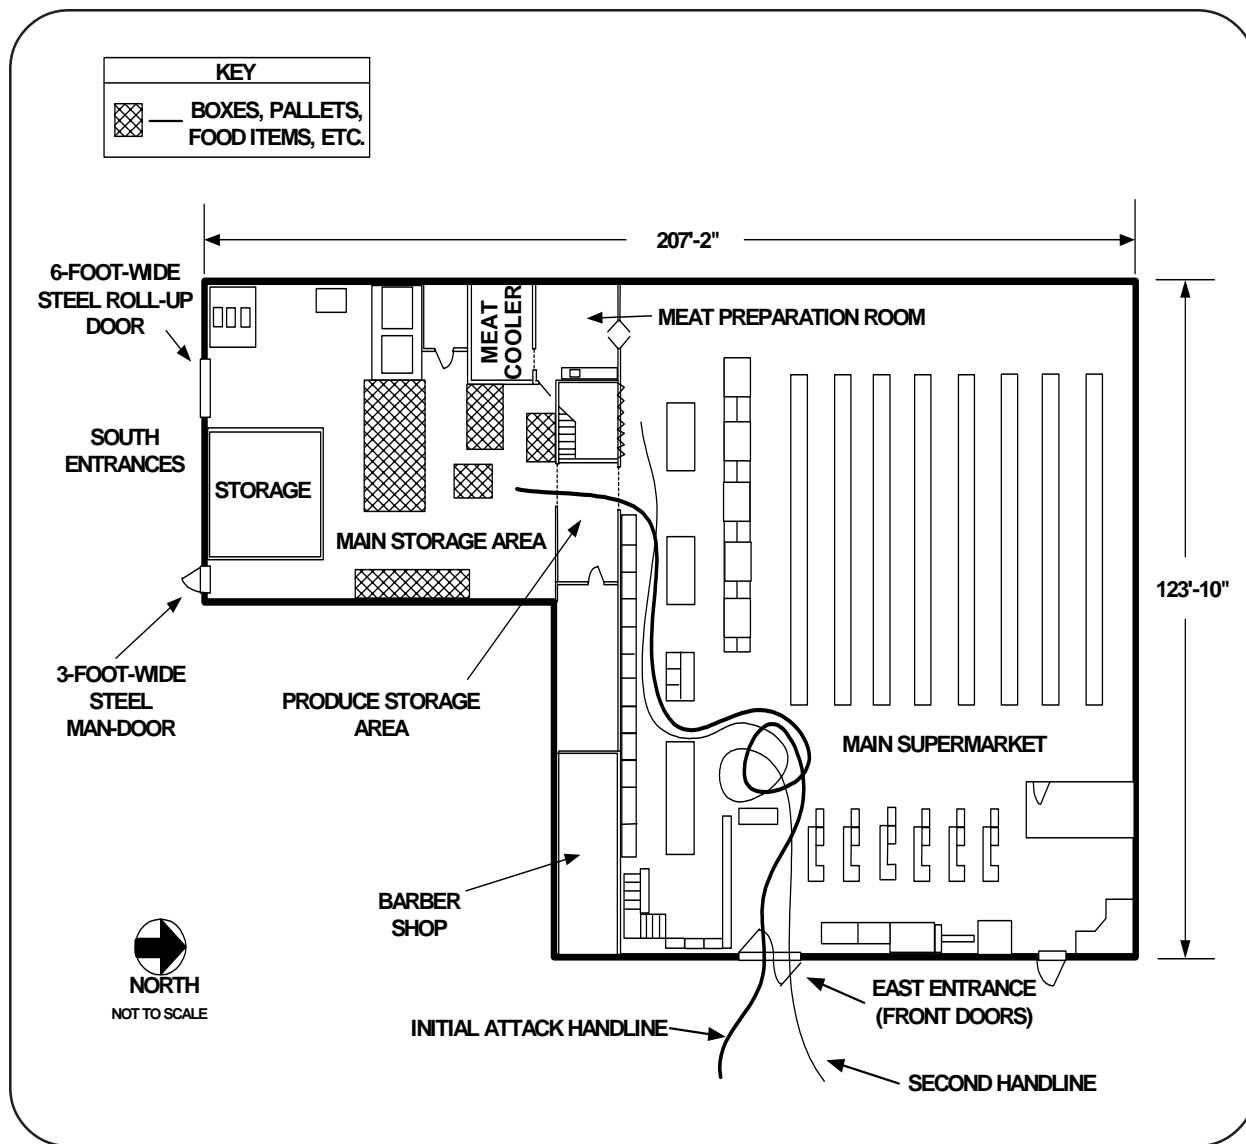
Diagram 2. Supermarket Layout

At 1714 hours, Engine 14, Engine 3, and Rescue 3 advanced a handline into the produce storage area, and Engine 3 advanced a second handline through the supermarket toward the meat preparation room, which was located along the west wall of the structure (Diagram 2). Conditions in the supermarket

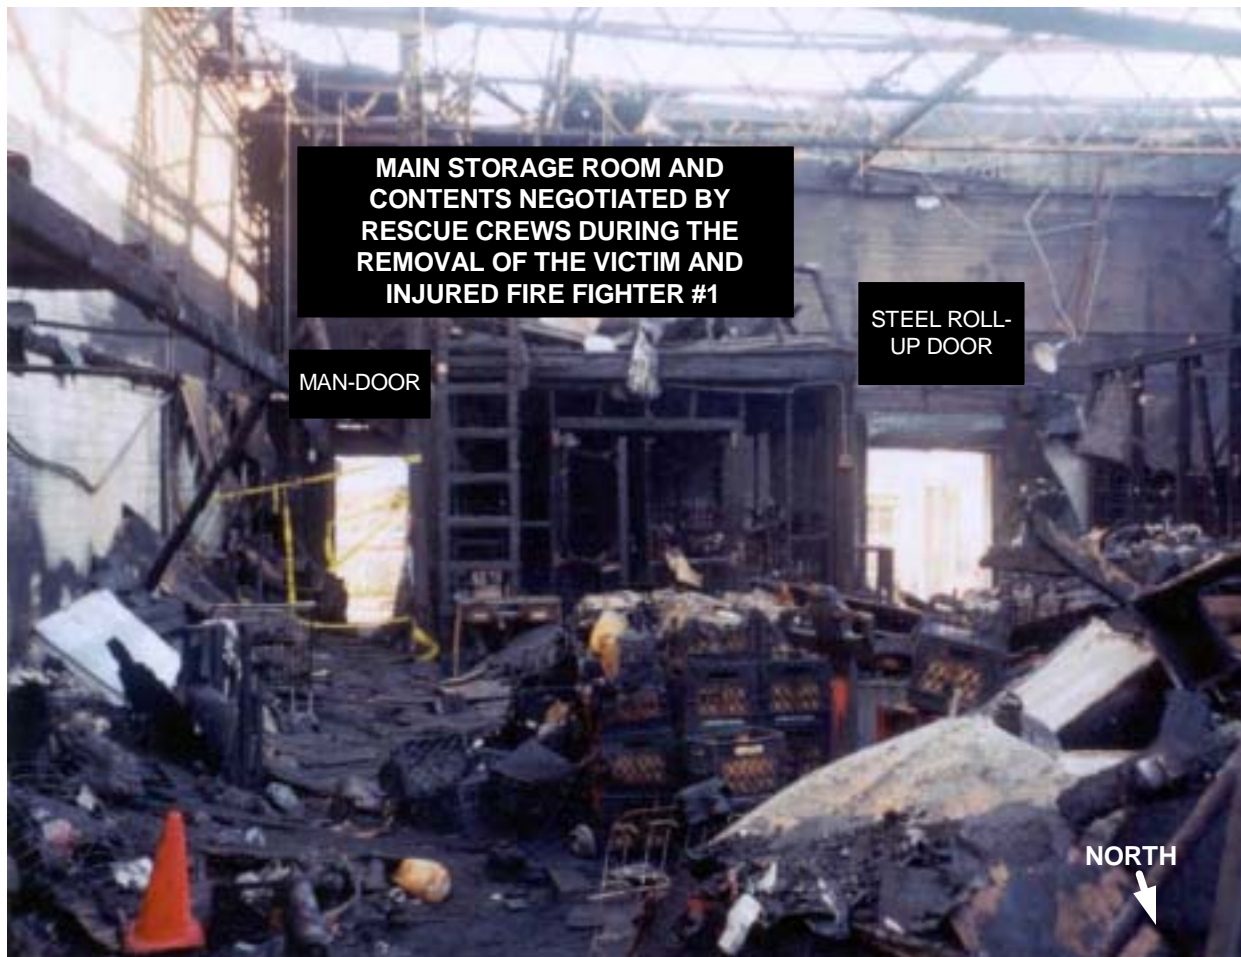
Photo 2. Main Storage Room

NOTE: The IC and first-arriving units were unaware that the supermarket was L-shaped and could be accessed from the east and south sides of the building. The east side was the main entrance to the shopping area of the supermarket and the south side—directly behind the clothing and hardware stores—was the location of the man-door and roll-up door entrances to the main storage area of the supermarket (Photo 2).

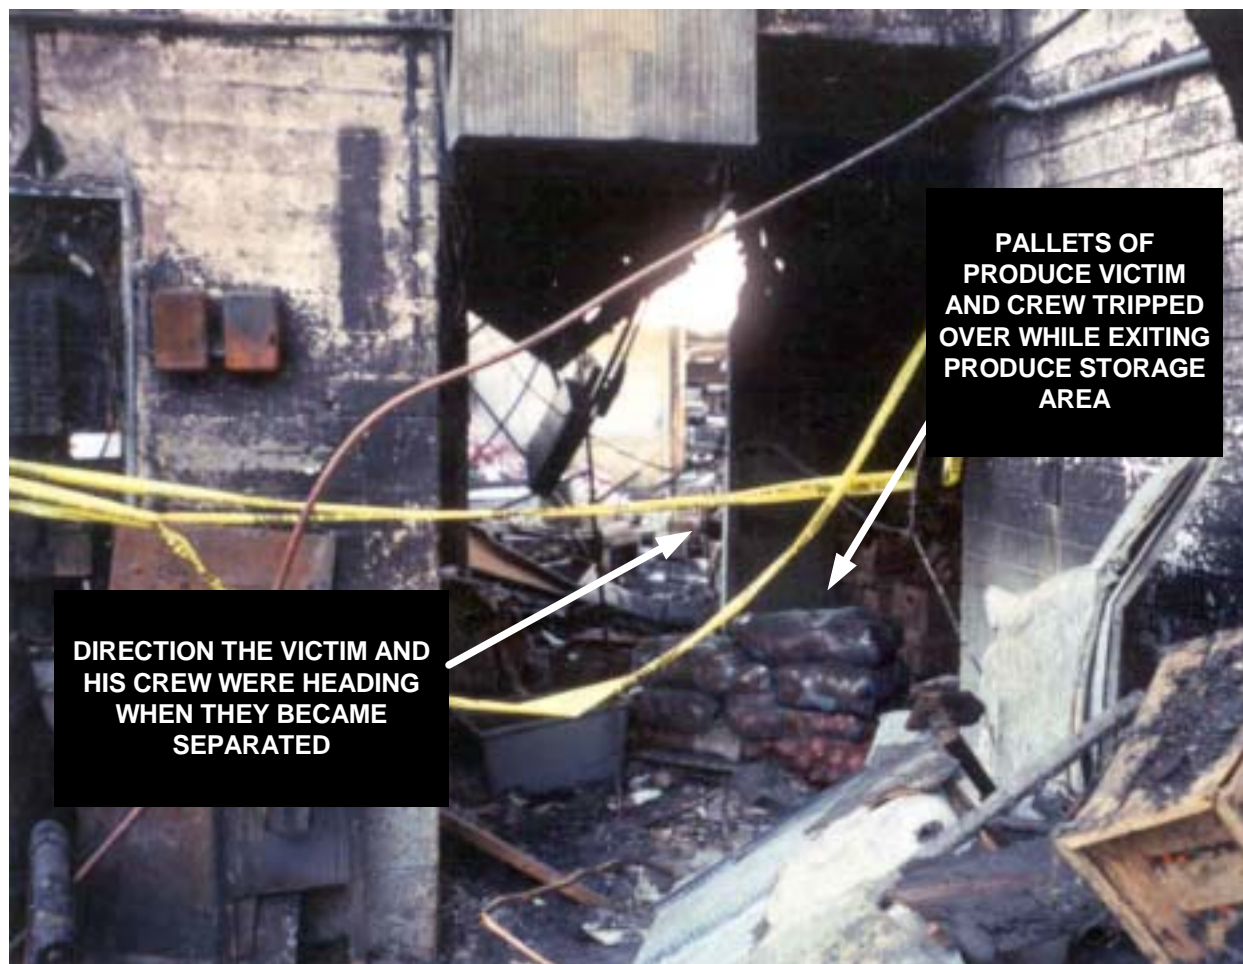
Photo 3. View of Produce Storage Area

deteriorated as the structure began to fill with thick, black smoke. The crew from Engine 14, an officer and fire fighter from Engine 3, and a fire fighter from Rescue 3 were operating in the produce storage area (Photo 3). Another fire fighter from Rescue 3 (Injured Fire Fighter #1) and crew members from Engine 3 were on the second handline in the supermarket. *NOTE: The crew from Ladder 24 cut a 6-foot by 6-foot ventilation hole in the roof over the storage area and then exited the roof because they were running low on air.*
