NIOSH
Fire Fighter Fatality Investigation
and Prevention Program

February 28, 2002

Career Fire Fighter Dies After Falling Through the Floor Fighting a Structure Fire at a Local Residence - Ohio

Fatality Assessment and Control Evaluation Investigative Report #F2001-16

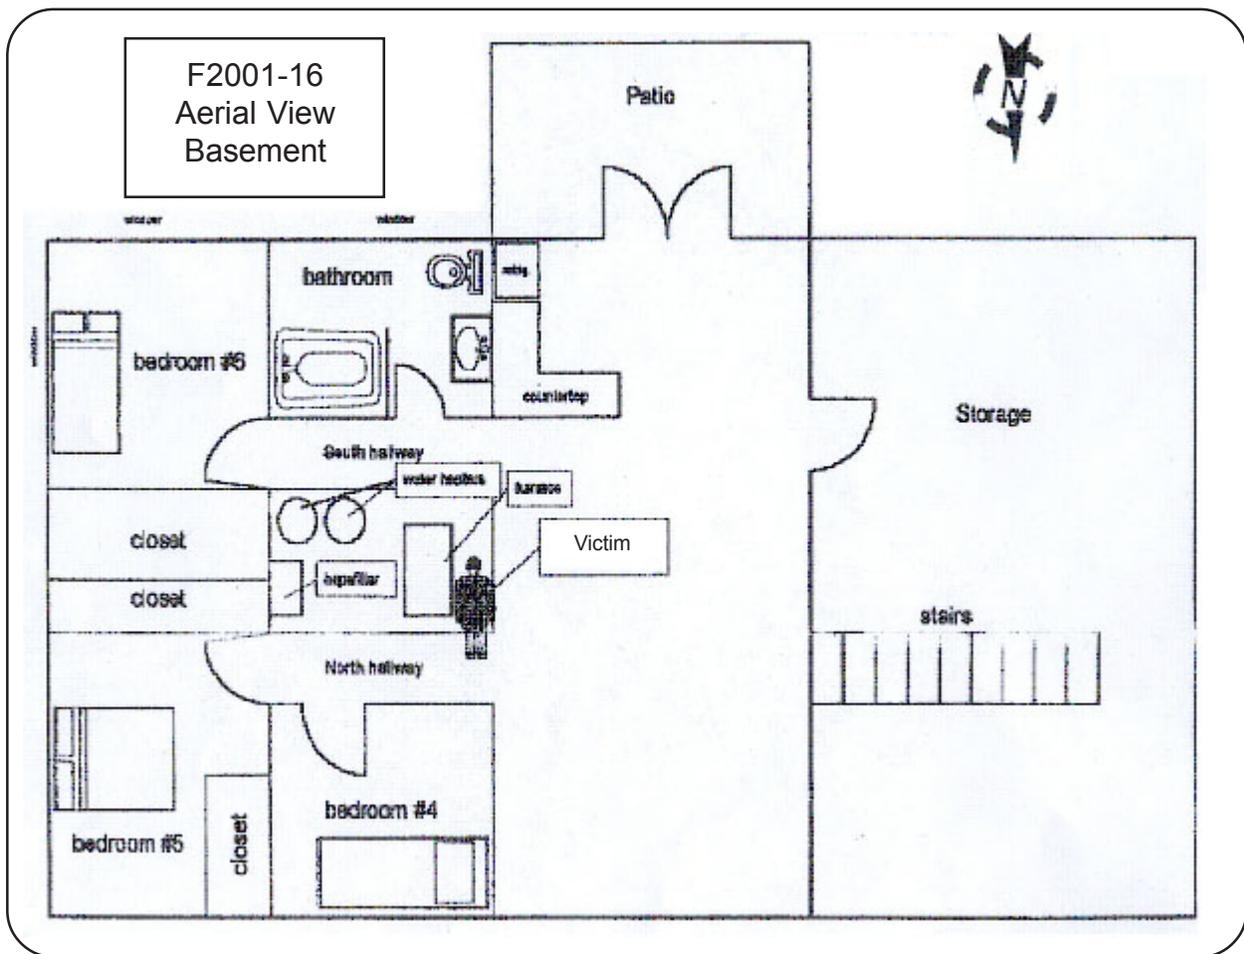
Drawing #3

Assistant Chief assembled a crew consisting of himself, the E-70 OIC, a Lieutenant from a mutual aid company and Fire fighter #6 to conduct the search of the basement. The rear entrance to the basement was unlocked and did not show any fire (See Drawing #3). Since there was light smoke, the Assistant Chief did not don his SCBA and was able to see across the basement. The search was completed very quickly and an "All Clear" was radioed to the IC. The IC, unaware of the clear visibility, ordered a second search. The Assistant Chief and his crew entered again, taking a thermal imaging camera to conduct a more thorough search. The "All Clear" was given for the basement a second time and the crew exited. The Assistant Chief directed his crew to the garage to look for fire extension and provide suppression. The IC gave the second order for an emergency evacuation over the radio and sounded several long blasts on the air horn to signal the evacuation. A full personnel accountability report (PAR) was received at this time and the operation was to be strictly defensive. Neighbors were still approaching the fire fighters and screaming that there were occupants inside the structure. The IC ordered another search of the structure, but instructed the crews not to commit too far. The Assistant Chief assembled a crew consisting of E-70 OIC, a Lieutenant from Engine 105 and Fire fighter #3 to enter the basement and conduct a search for the occupants with the thermal imaging camera. At this time, visibility for the crew in the basement was very poor and the intense heat was limiting the effectiveness of the thermal imaging camera, causing the screen to "white out." The crew radioed an "All Clear" to the IC and exited the structure. The third emergency evacuation signal was sounded. At this time, Fire fighter #2 and the Lieutenant from Engine 69 were taking turns operating the nozzle of a 1 3/4 inch handline on an exterior attack through the front windows. The Lieutenant and Fire fighter #2 came to the
