A Summary of a NIOSH fire fighter fatality investigation

March 21, 2002

Career Fire Fighter Dies After Becoming Trapped by Fire in Apartment Building - New Jersey

Fatality Assessment and Control Evaluation Investigative Report #F2001-18

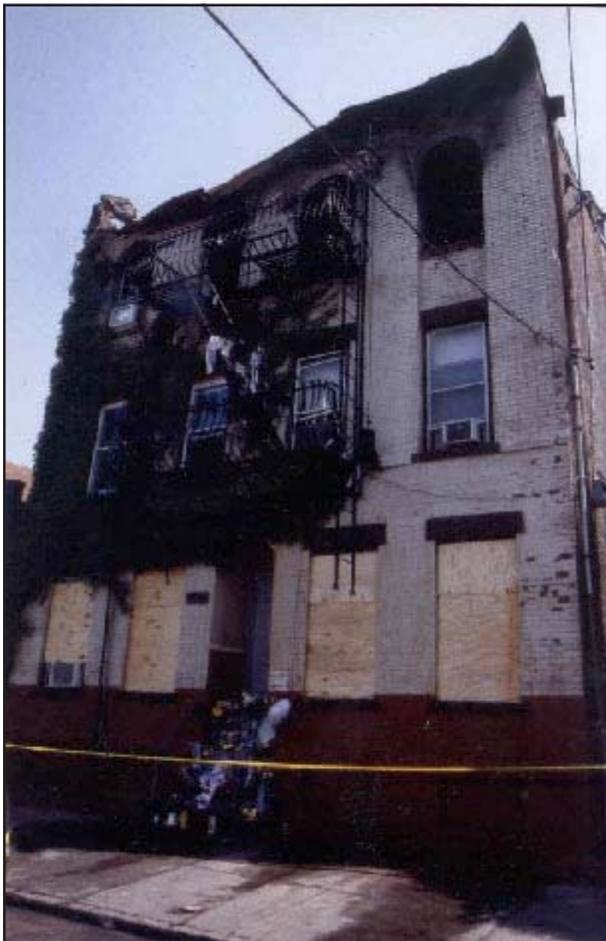
Building involved in fire

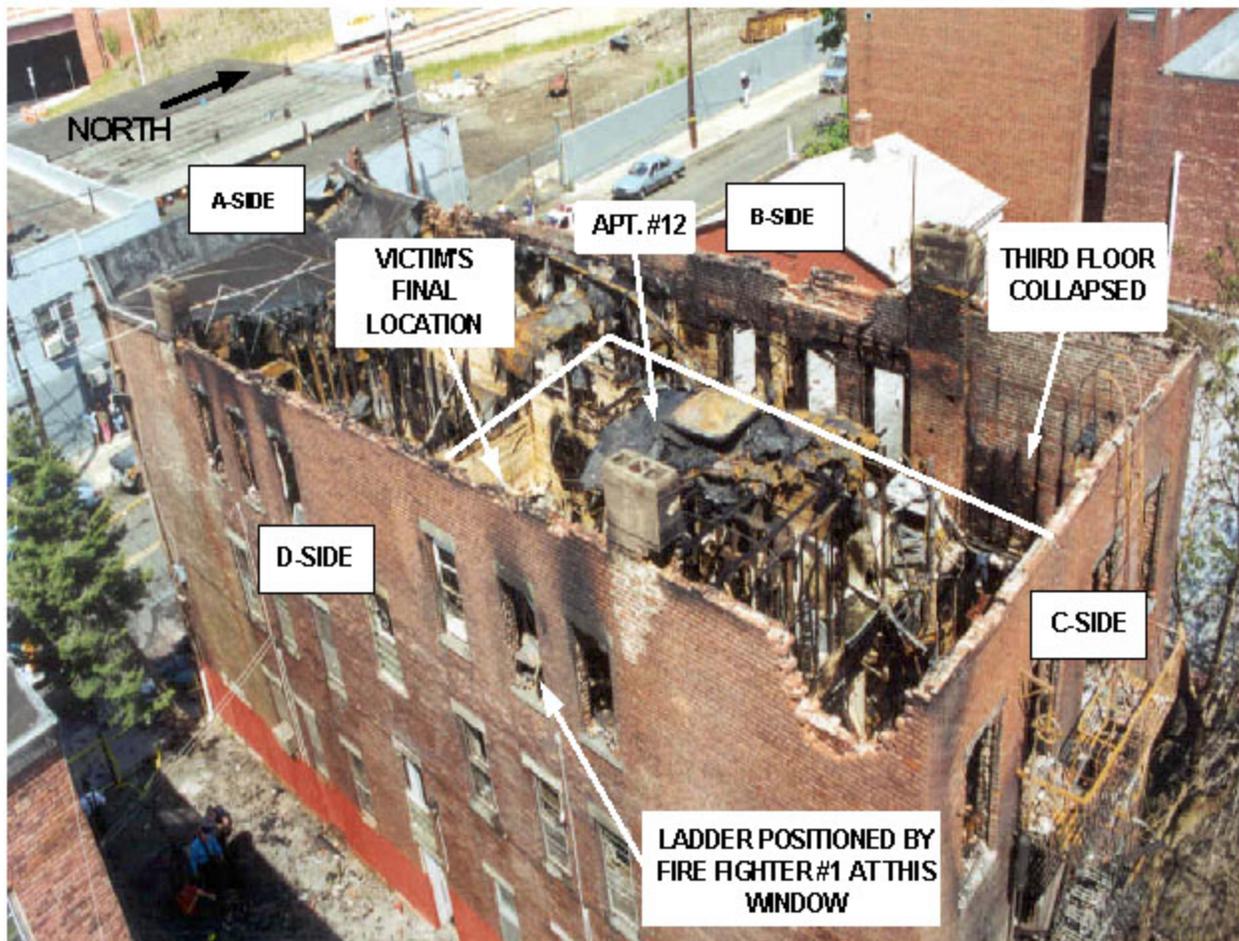
PHOTO. F2001-18

A site visit was conducted and the incident site photographed. The site of the incident is a three-story apartment building of ordinary construction. The building's exterior walls were constructed of noncombustible materials (brick), and the floors, roof, and interior partitions were made of combustible materials (wood). Each floor has four apartments.

Photo. Site of Incident

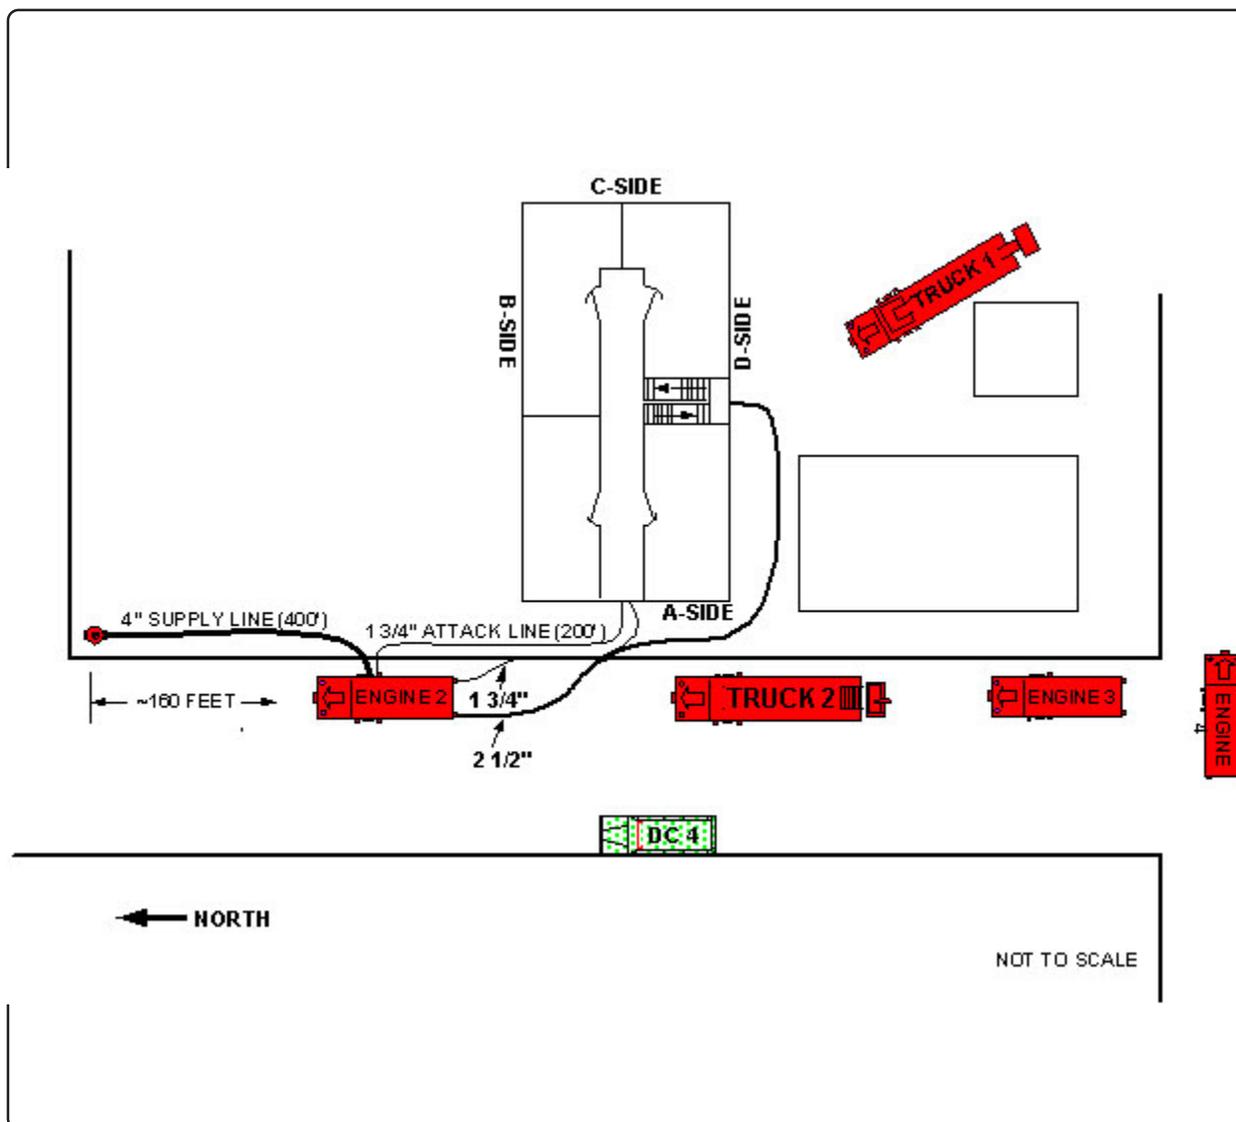
of the third-floor landing as a reference for their point of egress. At 2045 hours, fire fighters stretched a 1 3/4-inch backup line from Engine 2 to the second floor. At 2046 hours, members of a mutual-aid company began responding to the incident. At 2047 hours, the IC called Central Dispatch and requested Truck 1, which responded with a Lieutenant, driver, and a fire fighter. The victim radioed Engine 2 that he was trapped on the third floor. *Note: For approximately the next 70 seconds, the only radio traffic was between the IC and the Truck 1 officer, who were discussing the assignment and placement for Truck 1 upon their arrival. The IC and the Truck 1 officer did not discuss the victim. The fire department has only one radio channel available to be used as the tactical and fireground channel.* At 2049 hours, the victim radioed Truck 2, reporting that he could not breathe and that he was trapped on the third floor. The victim radioed a third transmission that he was on the third floor, trapped, and needed help. The Lieutenant from Engine 3 heard the victim's third radio transmission and called "Mayday - Mayday" over the radio. The victim made a fourth transmission that he was on the third floor, trapped, and needed help. Central Dispatch transmitted, "We got a Mayday, Mayday. Dispatch, Dispatch to Deputy 4. We got a Mayday calling from the third floor." Command acknowledged Central Dispatch's notification of the Mayday. Trying to determine the victim's location, the Lieutenant from Engine 3 maintained radio contact with him. The victim responded that he was on the third floor, upstairs, and to the right. At 2050 hours, the victim radioed that there was heavy fire and that he couldn't get out. Approximately 1 minute later, he radioed that he was running out of air. The Lieutenant made numerous calls for a line to be brought up to the third floor. At 2052 hours, Truck 1 arrived and parked in the lot on the D-Side of the fire building (See Diagram 1). Approximately 13

*Diagram 1. Aerial View of Incident Scene
 F2001-18*

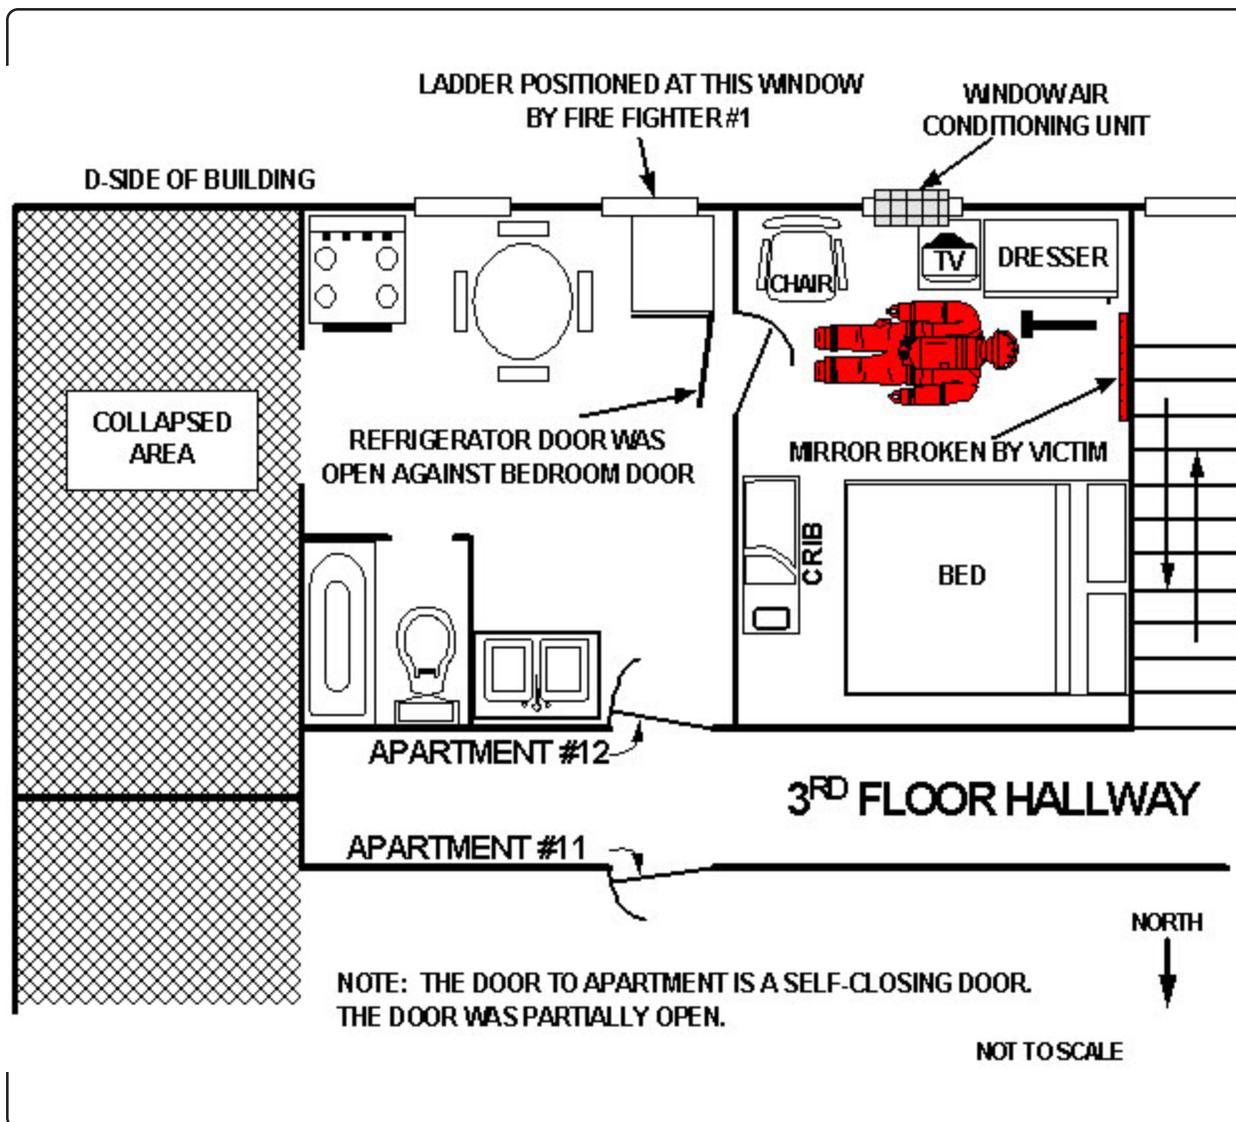
was using a thermal imaging camera when a member of the team heard a PASS device coming from Apartment #12. The FAST entered Apartment #12 and discovered the refrigerator door open in front of the door to the bedroom where the victim was found (See Diagram 2 and Photo). The victim was lying face down on his PASS device, which was activated but barely audible. The victim was unresponsive and not breathing. *Note: There was a wall-mounted mirror in the bedroom that had been broken by the victim. The victim had struck the mirror and the wall numerous times with his sledgehammer. The mirror may have appeared to the victim to be a window.* Paramedics responded to the third floor where they pronounced the victim dead. The victim was then removed from the building at approximately 2300 hours.

Diagram 2. Aerial View of Apartment Where Victim Was Found
F2001-18
