## Hardware Store Explosion Claims the Lives of Three Career Fire Fighters - New York

## Fatality Assessment and Control Evaluation Investigative Report #F2001-23

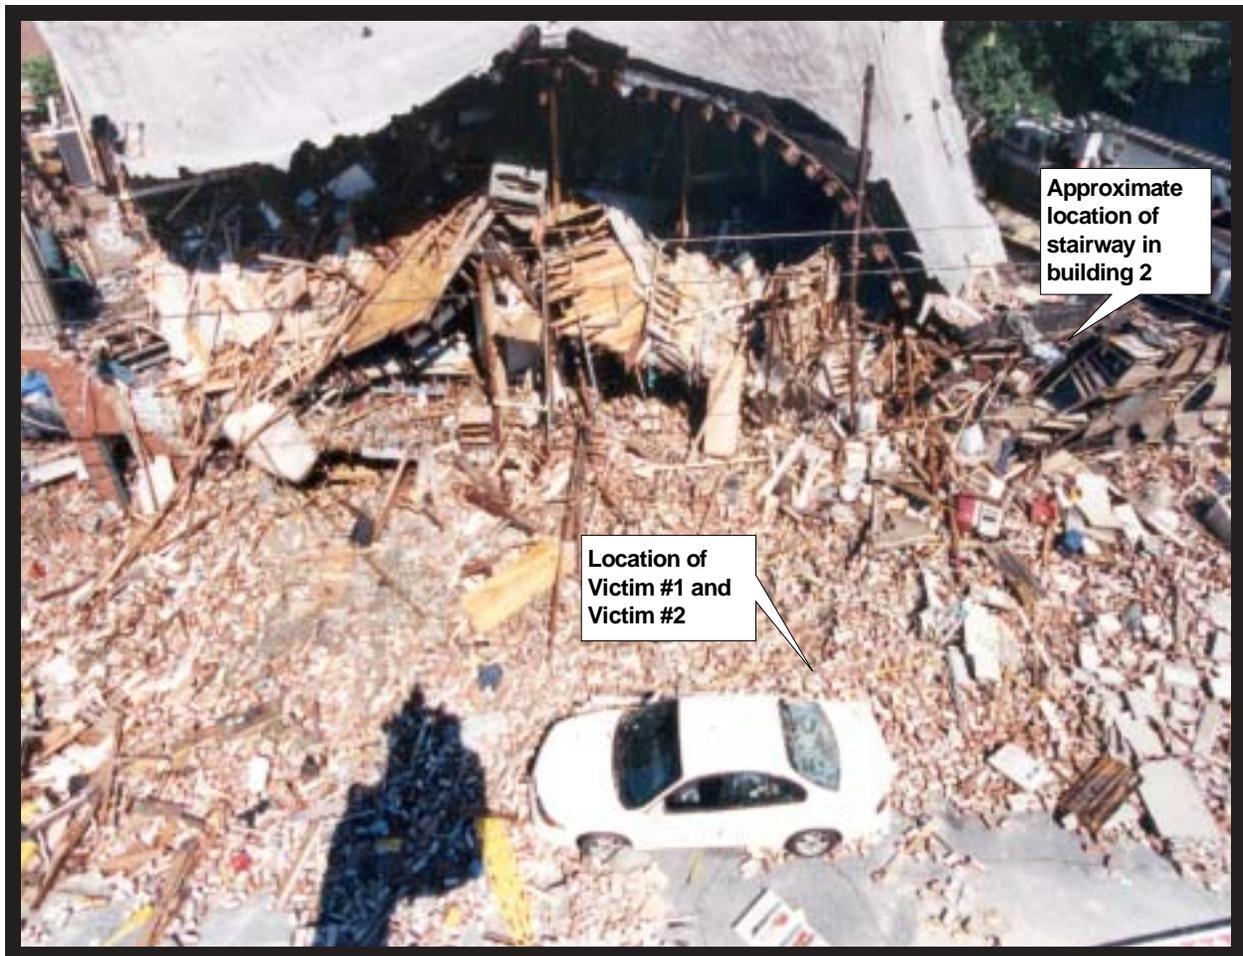
The IC and the SOC Chief were blown into the street by the blast from the explosion. Battalion 45 and the forcible-entry crew on the Exposure 3 side were blown from the doorway into the backyard. The explosion collapsed the Exposure 2 wall, burying the Chauffeur from Ladder 163 (Victim #3), the OV from Ladder 116, and the Chauffeur from Rescue 4 (Victim #1), who were conducting venting operations (see Photo 1). Squad 288 and additional crew members on the first floor were lifted off their feet, and they landed in the rubble created by the explosion, which led them to believe they were blown into the cellar. They were able to exit through the debris of the Exposure 2 wall (see Photo 2). Victim

#2 radioed that he was trapped in the cellar under the stairs. *Note: It is believed that Victim #2 was on the first-floor landing at the top of the stairs to the cellar in Building 1 and was blown into the cellar down the stairway by the explosion (see Photo 1).*

*Photo 1. Collapse of Building from Side 2*

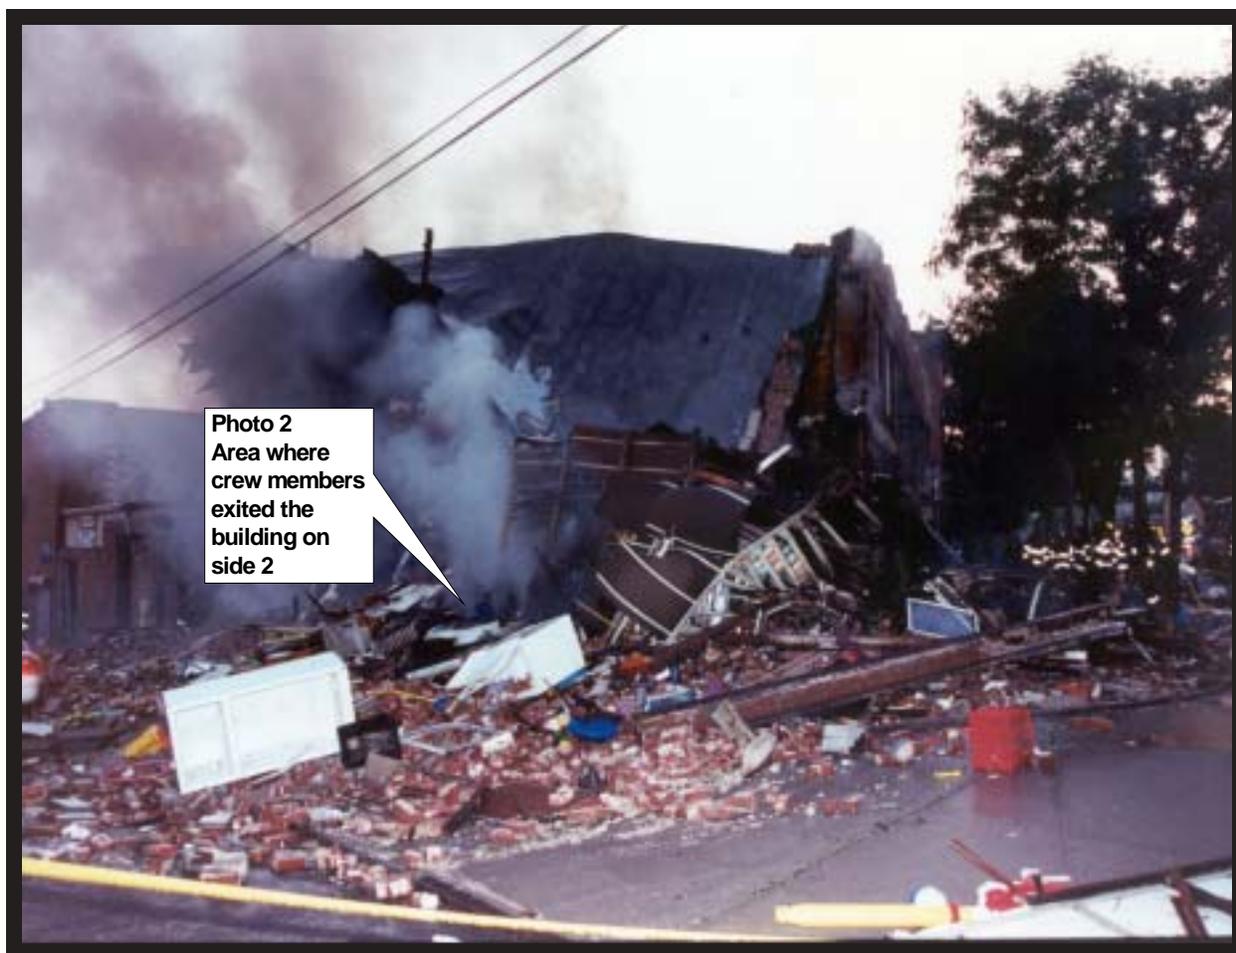
*Photo 2. Exit Location from Side 2*

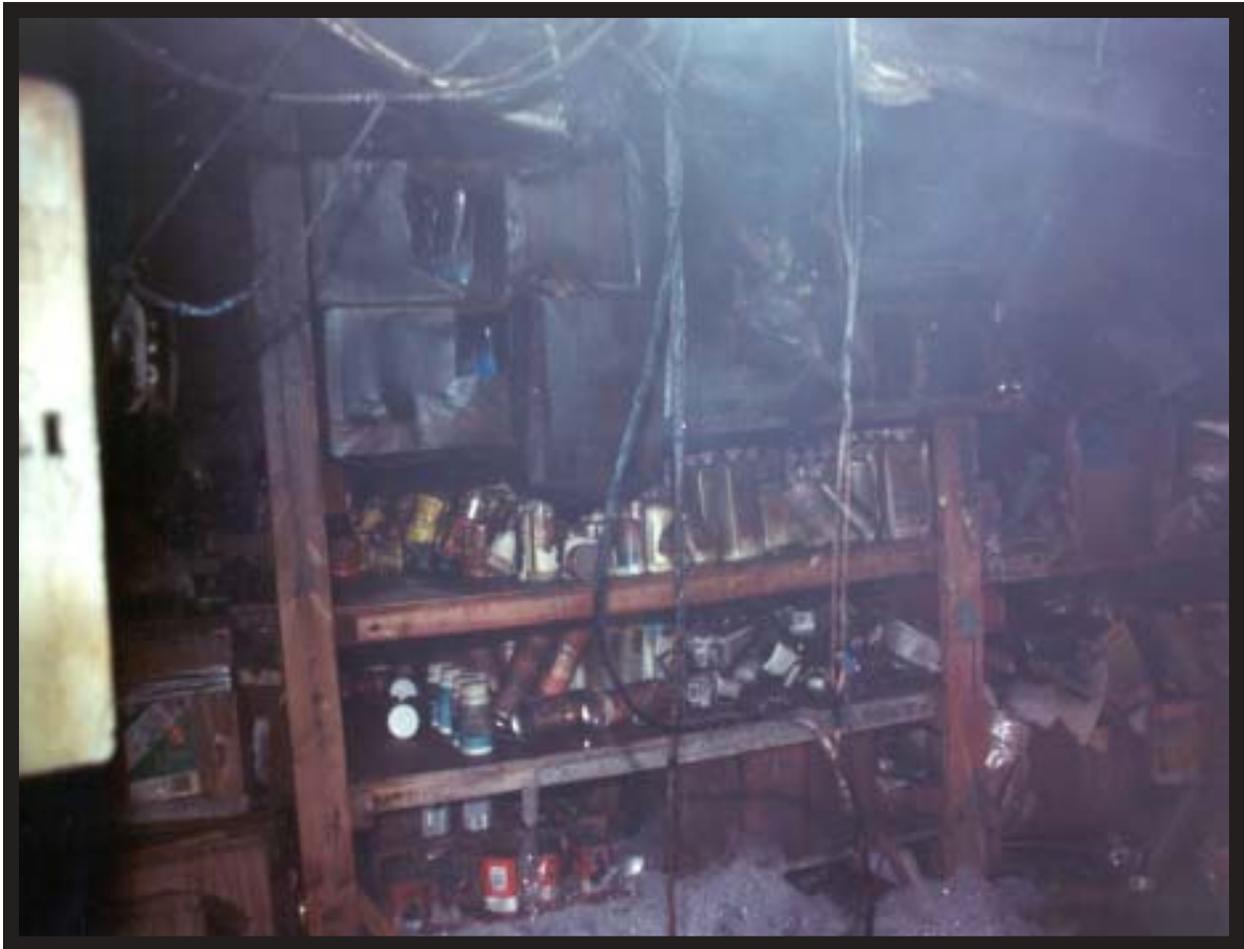
The hardware store had a considerable volume of hazardous/flammable materials, stored in the cellars of both buildings (Photo 3):

Local codes are adopted or developed to safeguard against the loss of lives and property to the specific conditions that can be found throughout an area. In this incident, the city had developed rules prohibiting the storage and use of propane or liquefied petroleum gases (LPG) below grade. At a minimum, there were 142 14 oz. cylinders stored in the cellar area under Building 1 and Building 2. The fire door in the common or party wall that provided cellar level access between Building 1 and Building 2 was blocked open. Building owners should adhere to guidelines set forth by the local authority having jurisdiction regarding the storage of hazardous/flammable materials. They should also ensure that safeguards such as a fire door are maintained and operational. If the fire door was operational, it may have provided additional time for the protection of the cylinders of propane, mapp gas and oxygen that were being stored in the cellar of Building 2.

*Photo 3. Example of Hazardous/Flammable Materials Stored in Cellar*

***Recommendation #6: Building owners should follow guidelines of the local authority having jurisdiction regarding the storage of hazardous/flammable materials and ensure that all existing safeguards are operational.<sup>6,7</sup>***

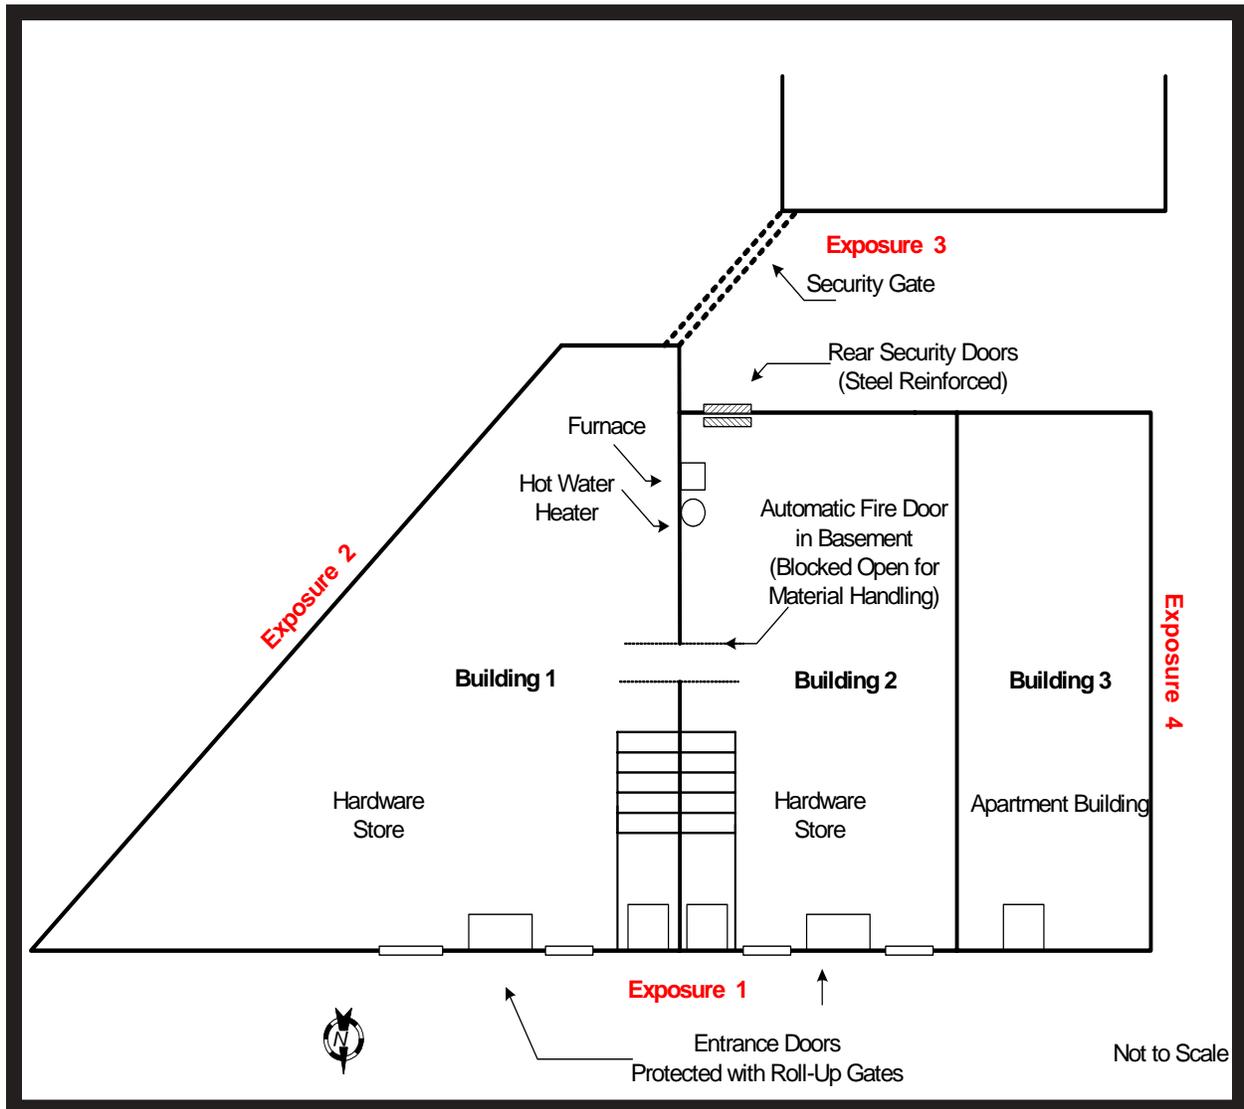
Figure 1. Aerial View of Building Layout

A civilian led the Captain from Squad 288 through a downstairs apartment in Building 3 to a cellar door in the Exposure 3 side of Building 2 (see Figure #1). The Captain heard the fire crackling behind the cellar door and transmitted to Central Dispatch a working structure fire. *Note: The fire origin was a flammable liquid (gasoline) that was accidentally spilled outside the rear security door of the cellar on Exposure 3. The gasoline traveled underneath the door and its vapors were believed to be ignited by the pilot light of a hot water heater located inside the cellar of Building 2.* When the Captain returned to Exposure 1, members of Squad 288 were pulling a 1 3/4-inch handline off their rig to the front of the structure. The Captain from Squad 288 informed them that the fire was in the hardware store and ordered them to stretch a 2 1/2-inch handline. The Roof Man from Squad 288 took a saw and performed forcible entry on the security gates that protected the two front entrance doors.

Between the hours of 1425 and 1430 Battalion 49, Engine 262, Engine 260, Ladder 116, Ladder 117, Ladder 163, Rescue 4, Battalion 45 and Engine 312 arrived on the scene. Battalion 49 assumed Incident Command (IC) and began his walk-around to check for conditions and fire extension throughout the structure. As the IC was walking down the Exposure 2 side, a civilian informed the IC that fire fighters would probably have better access to the fire through the rear of the structure, the Exposure 3 side. The IC instructed Engine 262 to stretch a handline to the rear of the structure for a possible entry into the cellar through a door on the Exposure 3 side. The cellar door was accessed through the security gate between the Exposure 2 and Exposure 3 side (see Figure #1).

A fire fighter from Squad 288 and a fire fighter from Rescue 4 (Victim #2) then forced a door in Building 2 to gain access to the second-floor office and storage area (see Figure #1). The fire fighters conducted a search of the second-floor, which had light smoke conditions. The fire fighter from Squad 288 then returned to the first floor to assist on the 2½-inch line into the Exposure 1 side.
