Hardware Store Explosion Claims the Lives of Three Career Fire Fighters - New York

Fatality Assessment and Control Evaluation Investigative Report #F2001-23

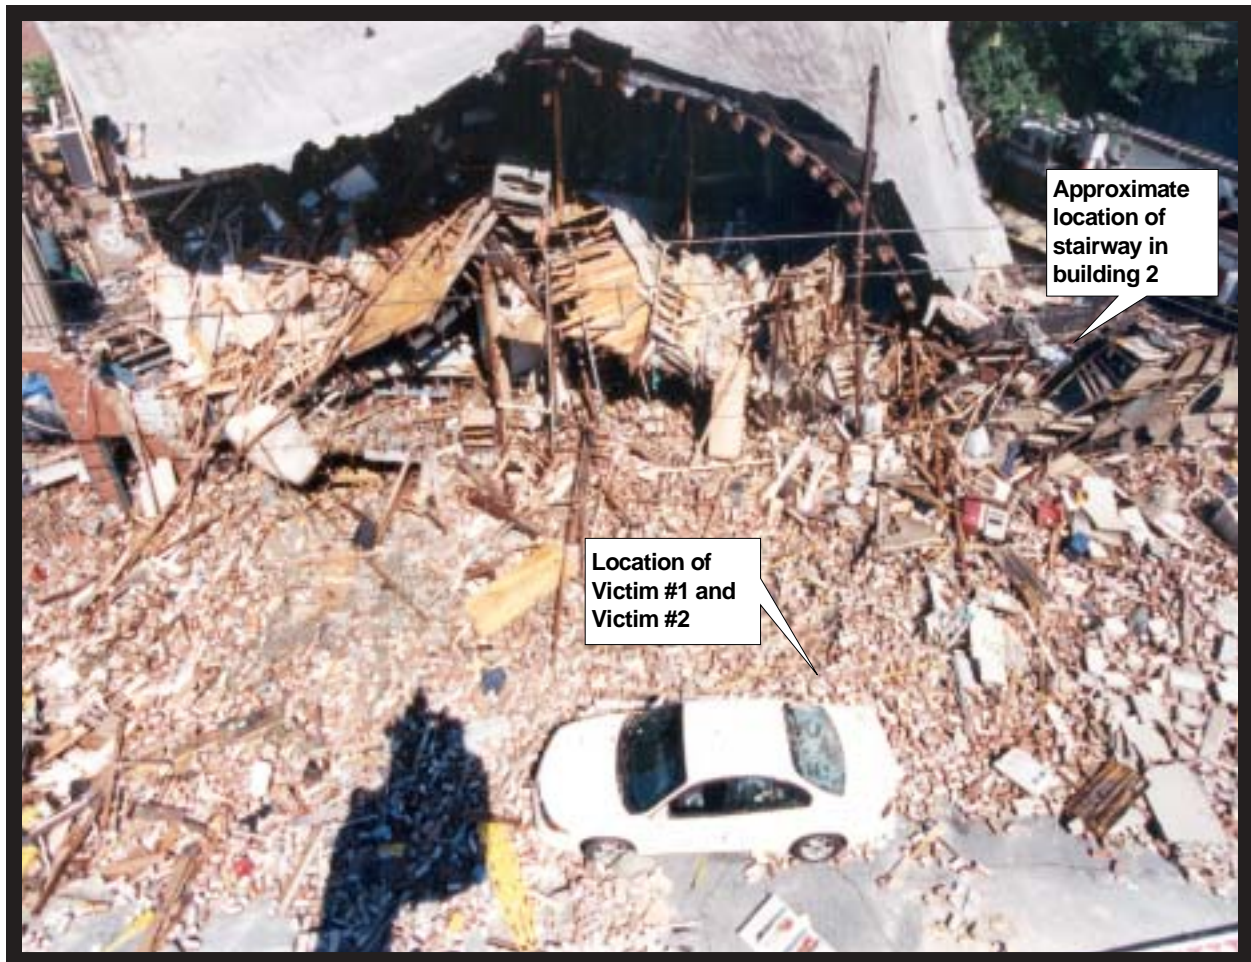
The IC and the SOC Chief were blown into the street by the blast from the explosion. Battalion 45 and the forcible-entry crew on the Exposure 3 side were blown from the doorway into the backyard. The explosion collapsed the Exposure 2 wall, burying the Chauffeur from Ladder 163 (Victim #3), the OV from Ladder 116, and the Chauffeur from Rescue 4 (Victim #1), who were conducting venting operations (see Photo 1). Squad 288 and additional crew members on the first floor were lifted off their feet, and they landed in the rubble created by the explosion, which led them to believe they were blown into the cellar. They were able to exit through the debris of the Exposure 2 wall (see Photo 2). Victim

#2 radioed that he was trapped in the cellar under the stairs. *Note: It is believed that Victim #2 was on the first-floor landing at the top of the stairs to the cellar in Building 1 and was blown into the cellar down the stairway by the explosion (see Photo 1).*

Photo 1. Collapse of Building from Side 2

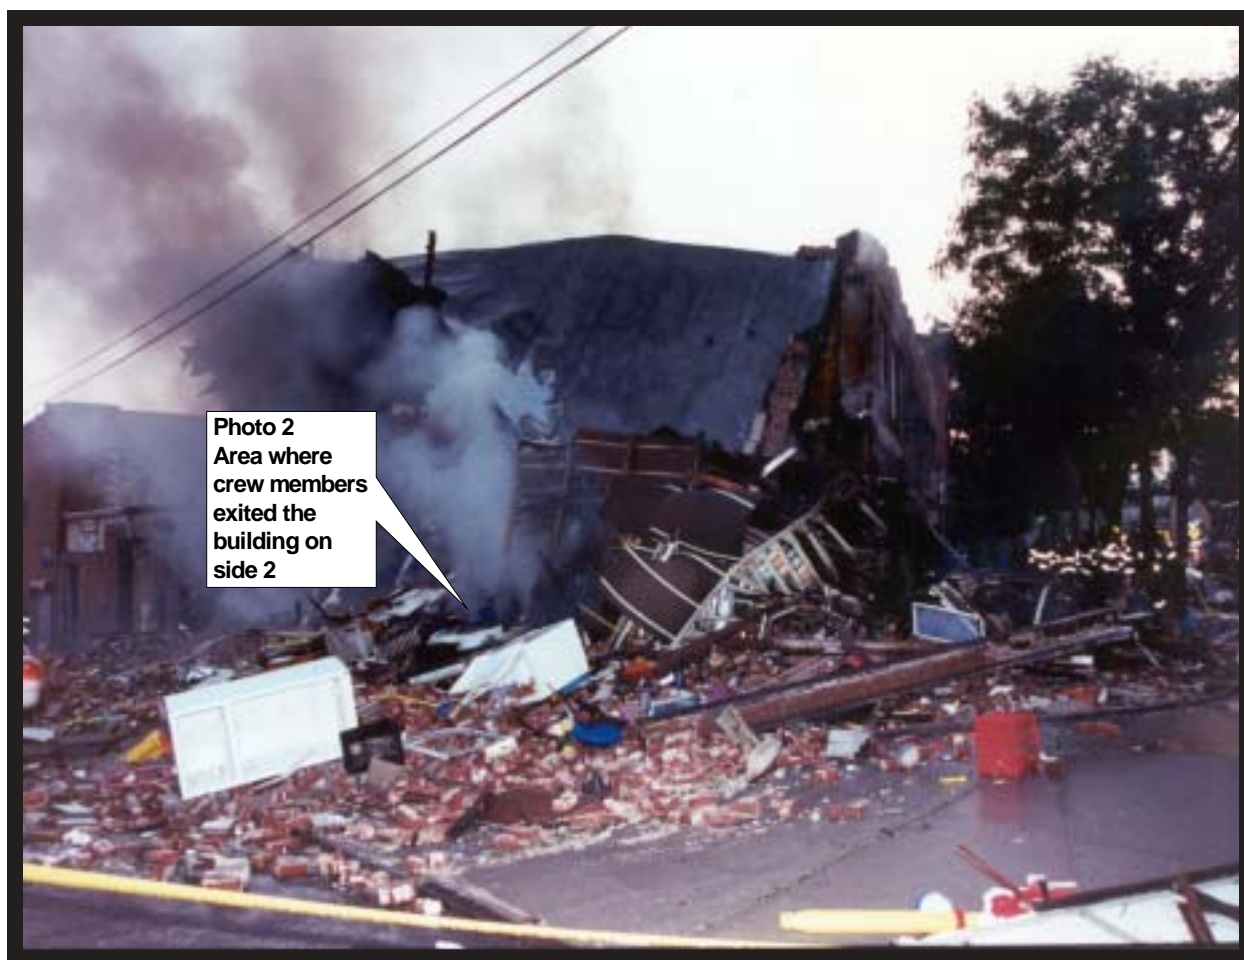
Photo 2
Area where
crew members
exited the
building on
side 2

Photo 2. Exit Location from Side 2

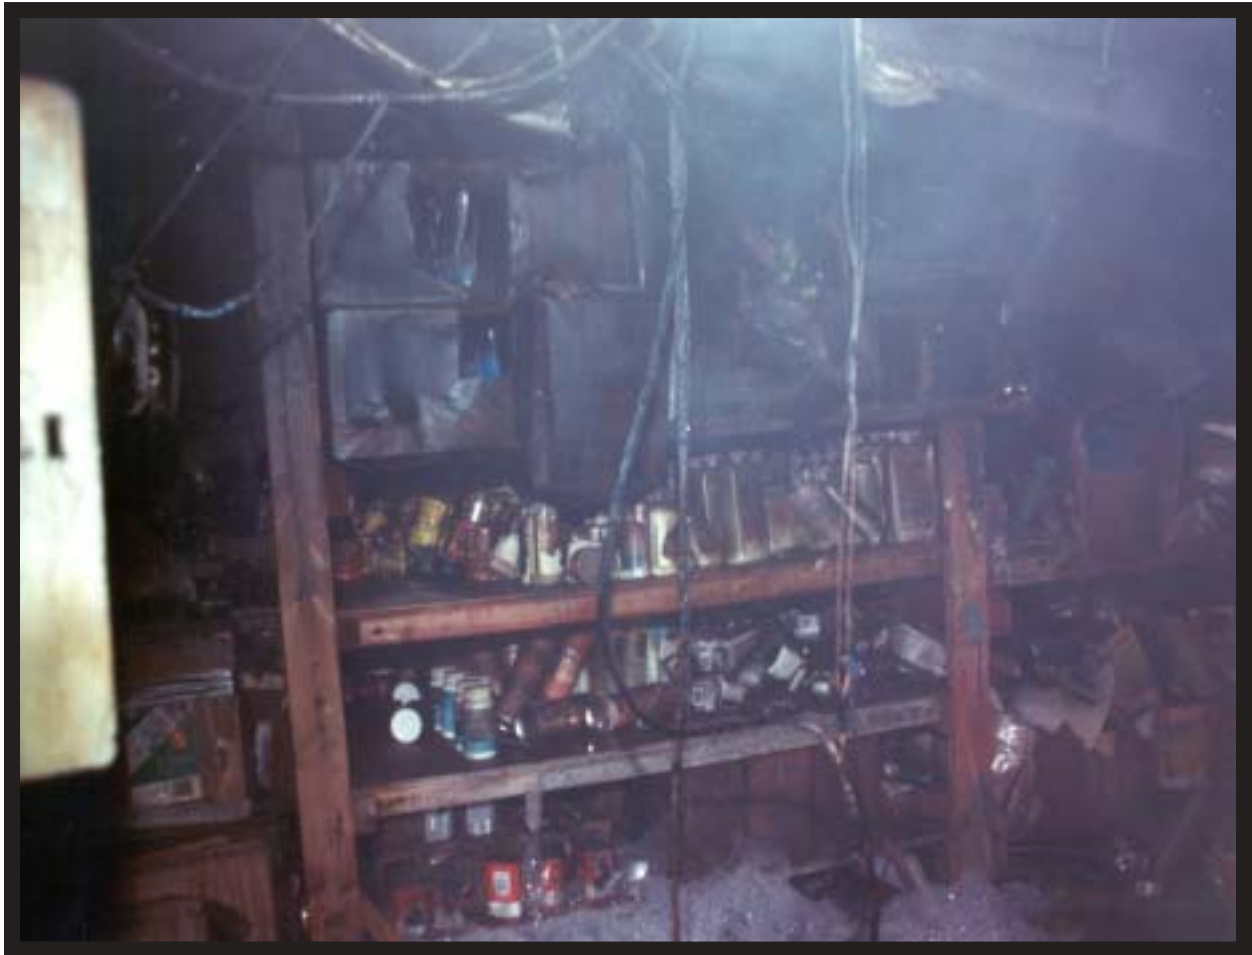
The hardware store had a considerable volume of hazardous/flammable materials, stored in the cellars of both buildings (Photo 3):

Local codes are adopted or developed to safeguard against the loss of lives and property to the specific conditions that can be found throughout an area. In this incident, the city had developed rules prohibiting the storage and use of propane or liquefied petroleum gases (LPG) below grade. At a minimum, there were 142 14 oz. cylinders stored in the cellar area under Building 1 and Building 2. The fire door in the common or party wall that provided cellar level access between Building 1 and Building 2 was blocked open. Building owners should adhere to guidelines set forth by the local authority having jurisdiction regarding the storage of hazardous/flammable materials. They should also ensure that safeguards such as a fire door are maintained and operational. If the fire door was operational, it may have provided additional time for the protection of the cylinders of propane, mapp gas and oxygen that were being stored in the cellar of Building 2.

Photo 3. Example of Hazardous/Flammable Materials Stored in Cellar

Recommendation #6: Building owners should follow guidelines of the local authority having jurisdiction regarding the storage of hazardous/flammable materials and ensure that all existing safeguards are operational.^{6,7}

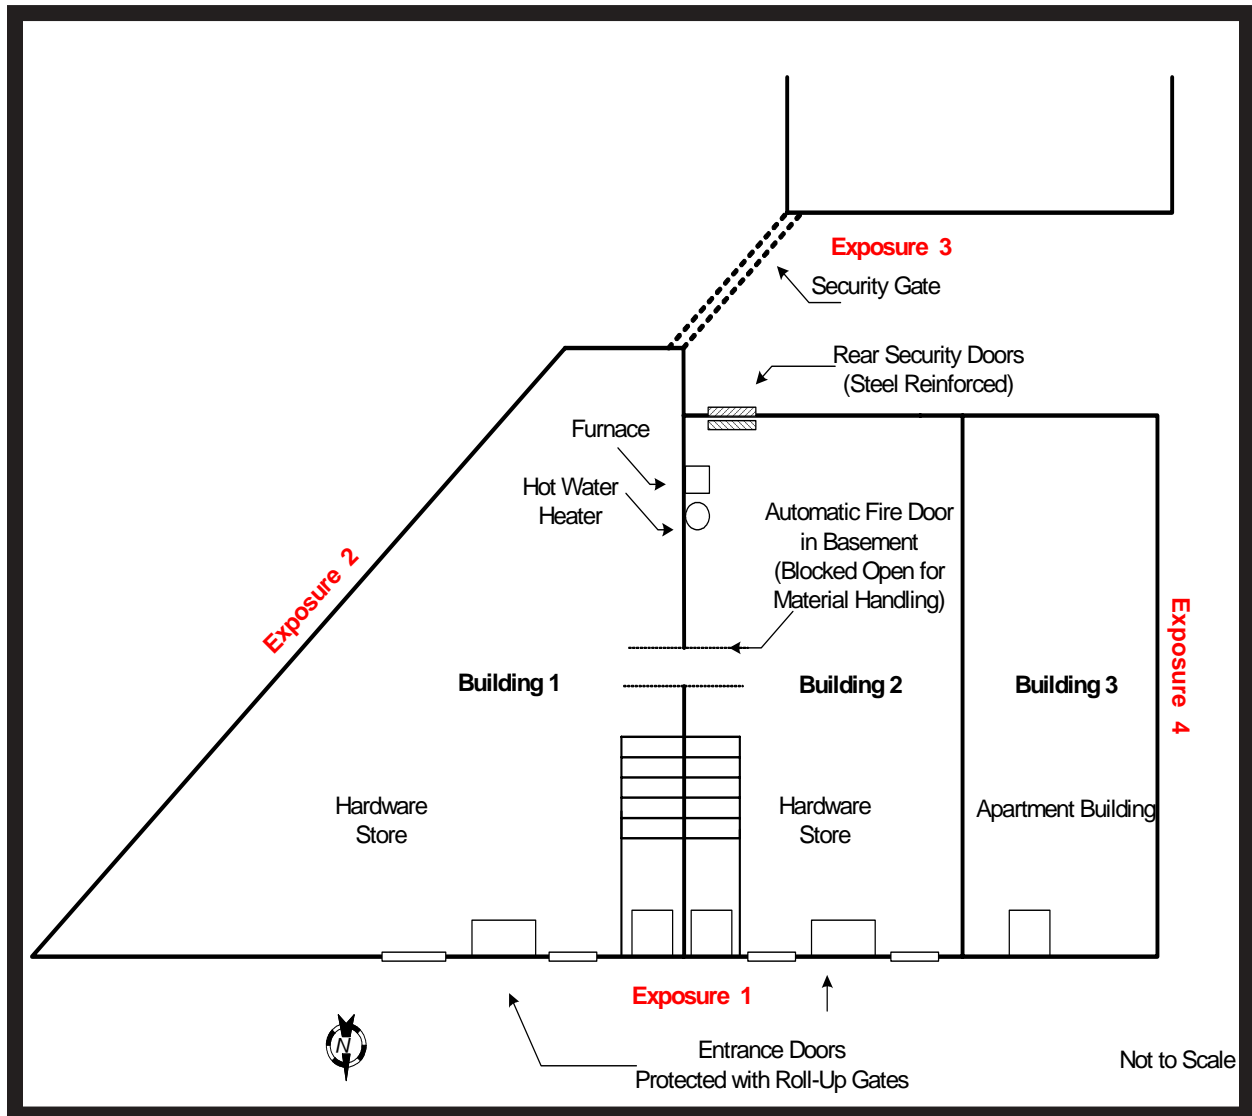
Figure 1. Aerial View of Building Layout

A civilian led the Captain from Squad 288 through a downstairs apartment in Building 3 to a cellar door in the Exposure 3 side of Building 2 (see Figure #1). The Captain heard the fire crackling behind the cellar door and transmitted to Central Dispatch a working structure fire. *Note: The fire origin was a flammable liquid (gasoline) that was accidentally spilled outside the rear security door of the cellar on Exposure 3. The gasoline traveled underneath the door and its vapors were believed to be ignited by the pilot light of a hot water heater located inside the cellar of Building 2.* When the Captain returned to Exposure 1, members of Squad 288 were pulling a 1 3/4-inch handline off their rig to the front of the structure. The Captain from Squad 288 informed them that the fire was in the hardware store and ordered them to stretch a 2 1/2-inch handline. The Roof Man from Squad 288 took a saw and performed forcible entry on the security gates that protected the two front entrance doors.

Between the hours of 1425 and 1430 Battalion 49, Engine 262, Engine 260, Ladder 116, Ladder 117, Ladder 163, Rescue 4, Battalion 45 and Engine 312 arrived on the scene. Battalion 49 assumed Incident Command (IC) and began his walk-around to check for conditions and fire extension throughout the structure. As the IC was walking down the Exposure 2 side, a civilian informed the IC that fire fighters would probably have better access to the fire through the rear of the structure, the Exposure 3 side. The IC instructed Engine 262 to stretch a handline to the rear of the structure for a possible entry into the cellar through a door on the Exposure 3 side. The cellar door was accessed through the security gate between the Exposure 2 and Exposure 3 side (see Figure #1).

A fire fighter from Squad 288 and a fire fighter from Rescue 4 (Victim #2) then forced a door in Building 2 to gain access to the second-floor office and storage area (see Figure #1). The fire fighters conducted a search of the second-floor, which had light smoke conditions. The fire fighter from Squad 288 then returned to the first floor to assist on the 2½-inch line into the Exposure 1 side.
