## **Career Fire Fighter Dies From Injuries When Stationary Fill Tank Becomes Over-Pressurized and Suffers Catastrophic Failure - California**

### **SUMMARY**

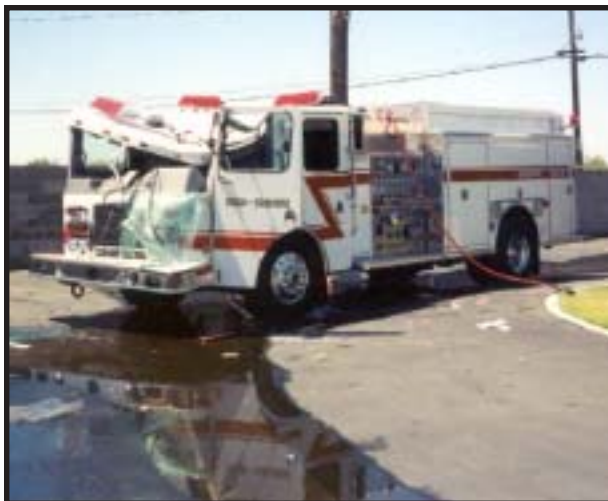
*Vehicle involved in the incident.*

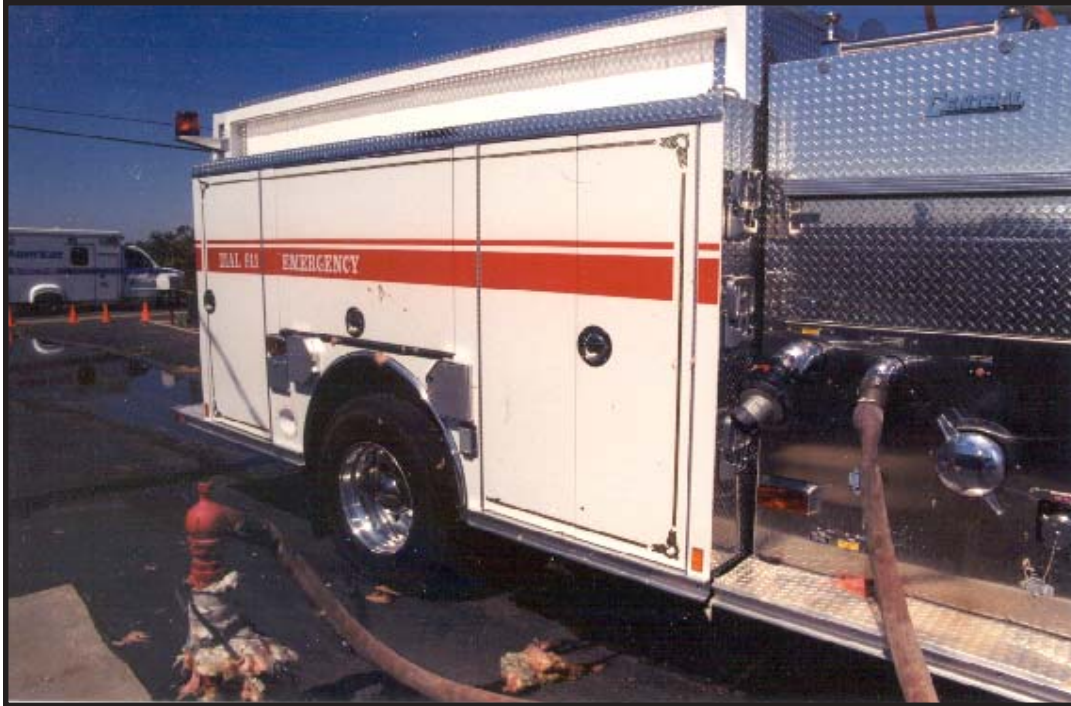
The incident occurred at the station house as two fire fighters were filling the engine water tank. The department had received a new engine on July 24, 2001. The engine had a single-stage pump system. The engine incorporated two discharge connections along with inlet tank fill connections on each side (Photo 1). The department's other engines had discharge connections on both sides and inlet fill connection only on the left (pump panel) side. The

They connected one end of the hose to the hydrant and the other end to the Number 4 discharge on the passenger side (Photo 1). Fire fighters reportedly filled the new engine using the same procedure the previous day to perform the pump acceptance test. After connecting, they opened the hydrant valve and went around the engine to the pump panel, where they opened the Number 4 discharge valve and the tank fill valve, allowing water to flow into the engine tank. After filling the tank about one-half full, they pulled off one of the booster lines and handed it to the off-duty fire fighter's son. The victim engaged the booster pump switch inside the cab, and the off-duty fire fighter—still at the pump panel—pulled the booster pump valve and the left side booster line discharge. His son then opened the booster line to flow water. The off-duty fire fighter said that the booster line had very little pressure and was producing a stream similar to the flow of a garden hose. He throttled up and shut the tank fill valve, and the pressure increased in both the pump and booster line. The off-duty fire fighter stated that the pressure gauge registered about 150 psi. As the pressure increased, an adequate stream of water began to flow from the booster line. Shortly thereafter, the victim and the off-duty fire fighter saw a large amount of water flow from underneath the engine in the direction of the passenger side of the engine. Thinking that the fill line had burst, the off-duty fire fighter immediately turned down the throttle at the pump panel as the victim went to the cab to shut off the booster pump and the engine. The off-duty fire fighter stated that shortly after, he heard a loud crash and saw the engine shaking. He turned and saw the stationary fill tank rolling across the parking lot and the victim lying on the ground near the door on the driver's side. It is believed that an over-pressure produced by the running booster pump caused a catastrophic failure and propelled the tank into the air. A nearby civilian witness stated that the fill tank was propelled about 100 feet into the air. The tank landed on the engine cab, crushing

*Photo 1. Illustrates the engine's passenger side discharge panel. It also depicts the fill line connected to the #4 discharge and water holding tank's hydrant.*

***Recommendation #2: Fire departments should ensure that engine water tanks are filled using the inlet tank fill connections(s).***

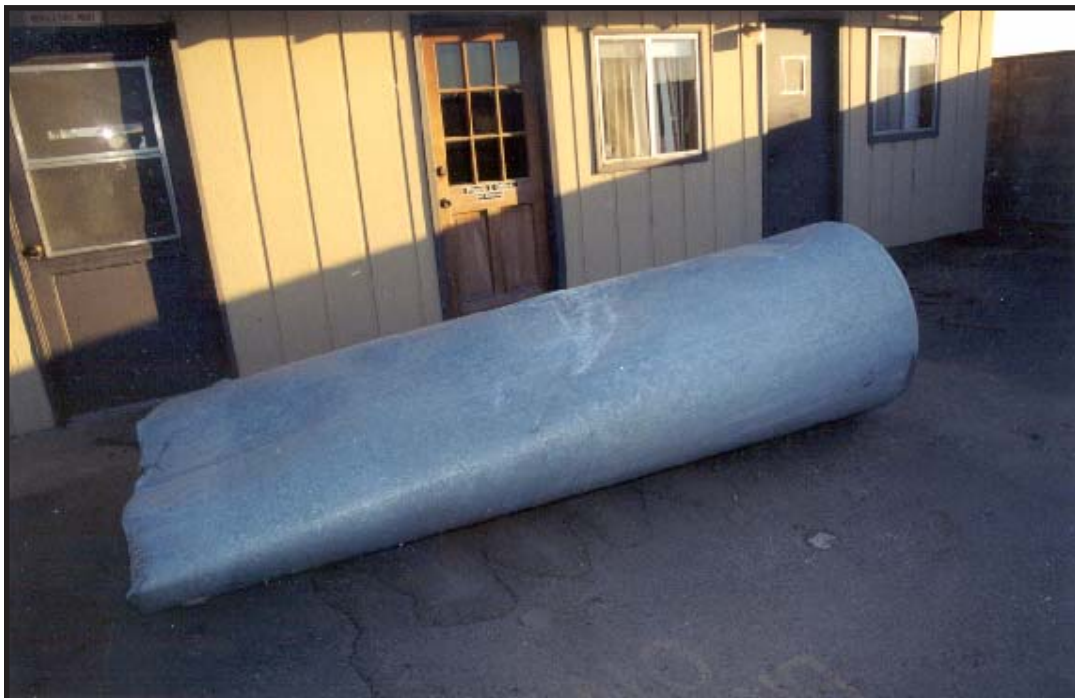
The stationary fill tank, a 525-gallon self-supporting steel tank (Photo 2 and Diagram 3), was positioned on a concrete slab foundation. The tank was plumbed to an 80-gallon-per-minute electric pump which pumped well water into the tank. The tank was equipped with a pressure gauge that read a maximum pressure level of 100 psi and an air release valve located near the pressure gauge in the middle of the tank. It was also plumbed to a hydrant valve which did not incorporate a clapper valve or check valve (a valve designed to prevent water from backfilling into the tank). The tank was not equipped with a "rupture disc" for pressure relief. There was no pressure relief mechanism installed in or on the tank that was adequate to relieve pressure from an engine's pump because the two were never considered as a system in the design.

*Photo 2. The 525-gallon steel water holding tank involved in this incident.*

Since this incident, the stationary fill tank has been replaced, and new plumbing has been installed which incorporates a clapper or check valve to prevent backfilling of water or additional pressure buildup from the engine pump.

***Recommendation #3: Fire departments should ensure that stationary fill tanks are fitted with a clapper valve or check valve to prevent backfilling or back pressure.***

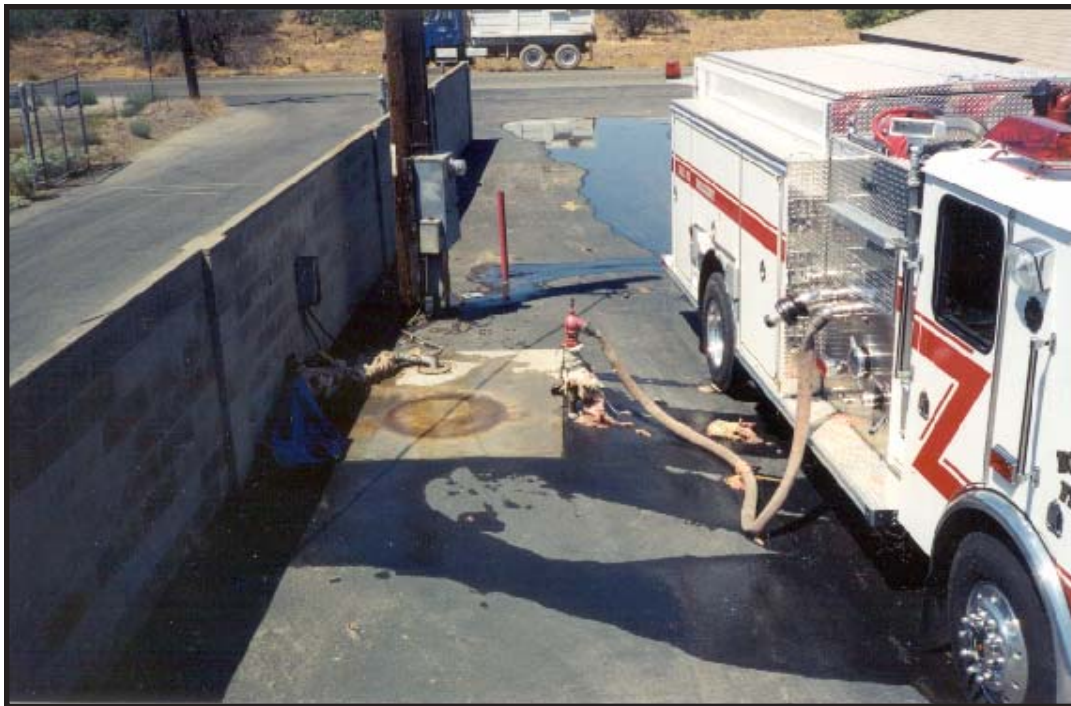
At about 1345 hours, the off-duty fire fighter and his son pulled the engine around to the stationary fill tank, positioning the passenger side of the engine next to the fill tank. Due to the station's layout, the fire fighters had to position the passenger side of the new engine near the stationary fill tank (Diagram 2 and Photo 3). The off-duty fire fighter and the victim retrieved a modified filling hose outfitted with female connections on both ends, one for hooking to the engine discharge and the other for hooking to the hydrant. This hose was adapted to fit the other engines. This modified filling hose was used because the departments' other engines only had a discharge connection on the passenger side of the existing engines. The new engine, however, was equipped with an inlet tank fill (non-pressurized fill) connection on the passenger side.

*Photo 3. Illustrates the original placement of the water holding tank, the hydrant, and the plumbing system in relation to the passenger side of the engine.*

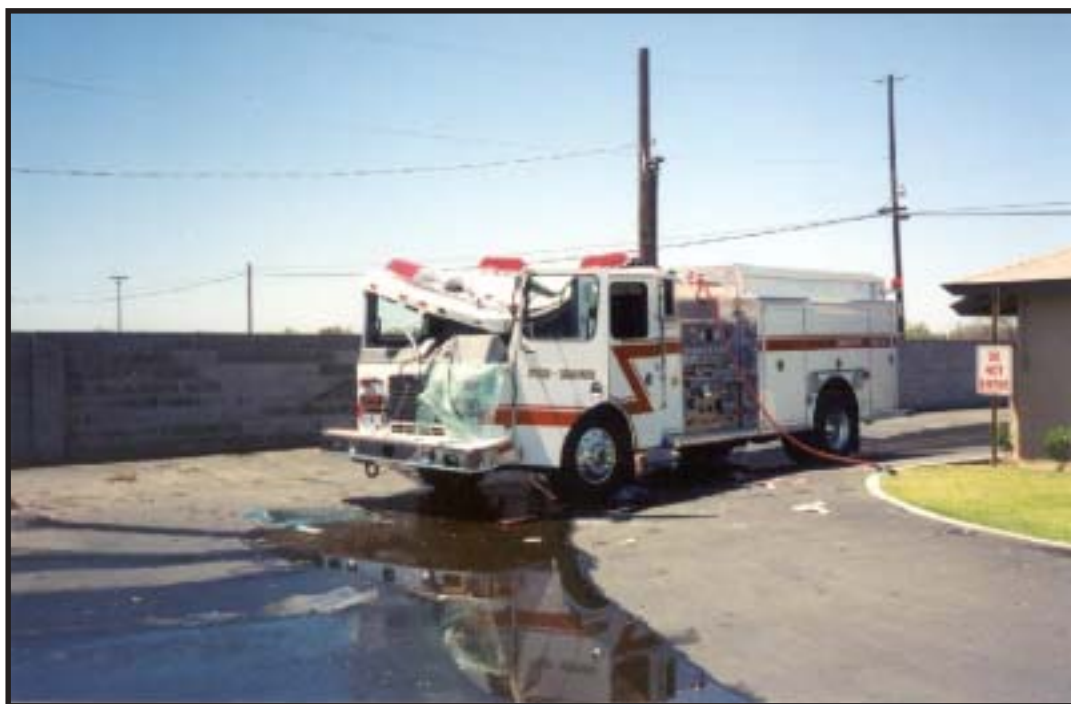
it (Photo 4). The tank had separated into two sections, and the bottom portion of the tank—the smaller of the two sections—was propelled over a small wall. It came to rest against a fence about 30 feet from its original position on the concrete slab. It is not clear whether the victim was struck by the fill tank or by the crushed cab.

*Photo 4. Depicts the point of impact by the holding tank on the cab of the engine.*

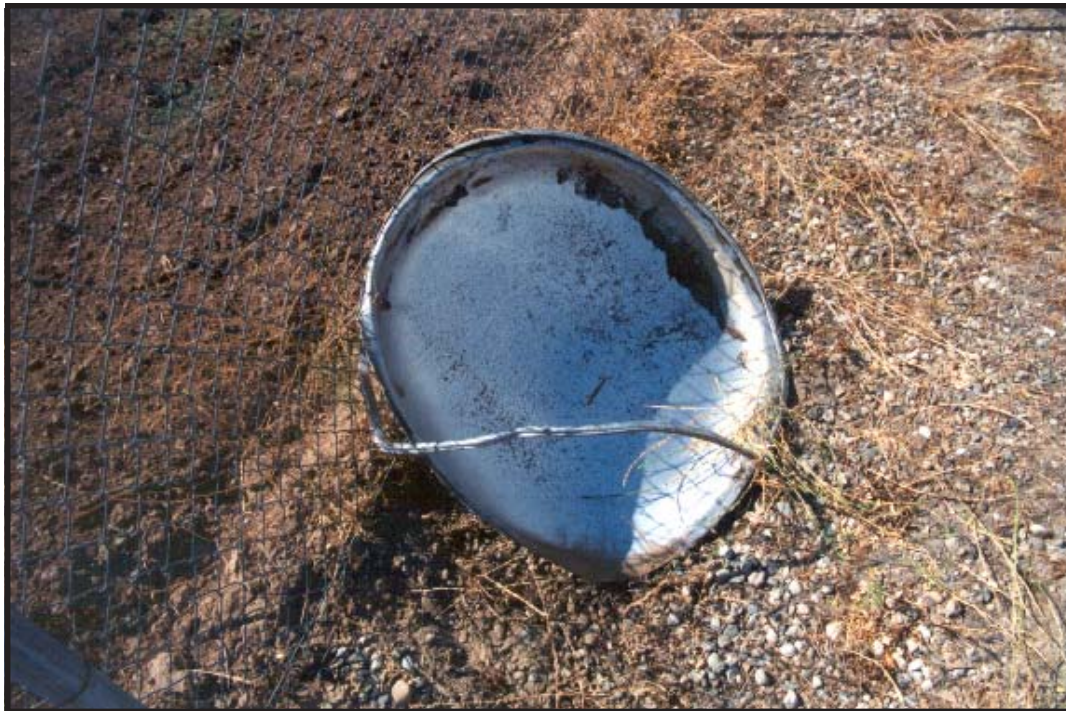
When the booster pump was engaged, the tank fill valve, the Number 4 discharge valve (which controlled the discharge connection from the engine to the hydrant) and the booster line valve were all open. It was stated that there was very low pressure on the booster line at this time. It is possible that low pressure existed because the tank fill valve was open, which would have allowed a recirculating pattern. Once the tank fill valve was shut, the pump then pressurized the Number 4 discharge connected to the hydrant and stationary fill tank. With no clapper or check valve present to prevent backfilling or back pressure, the stationary fill tank became pressurized and failed at the bottom near the seam (Photo 5).

*Photo 5. Illustrates that the holding tank failed near the bottom seam.*

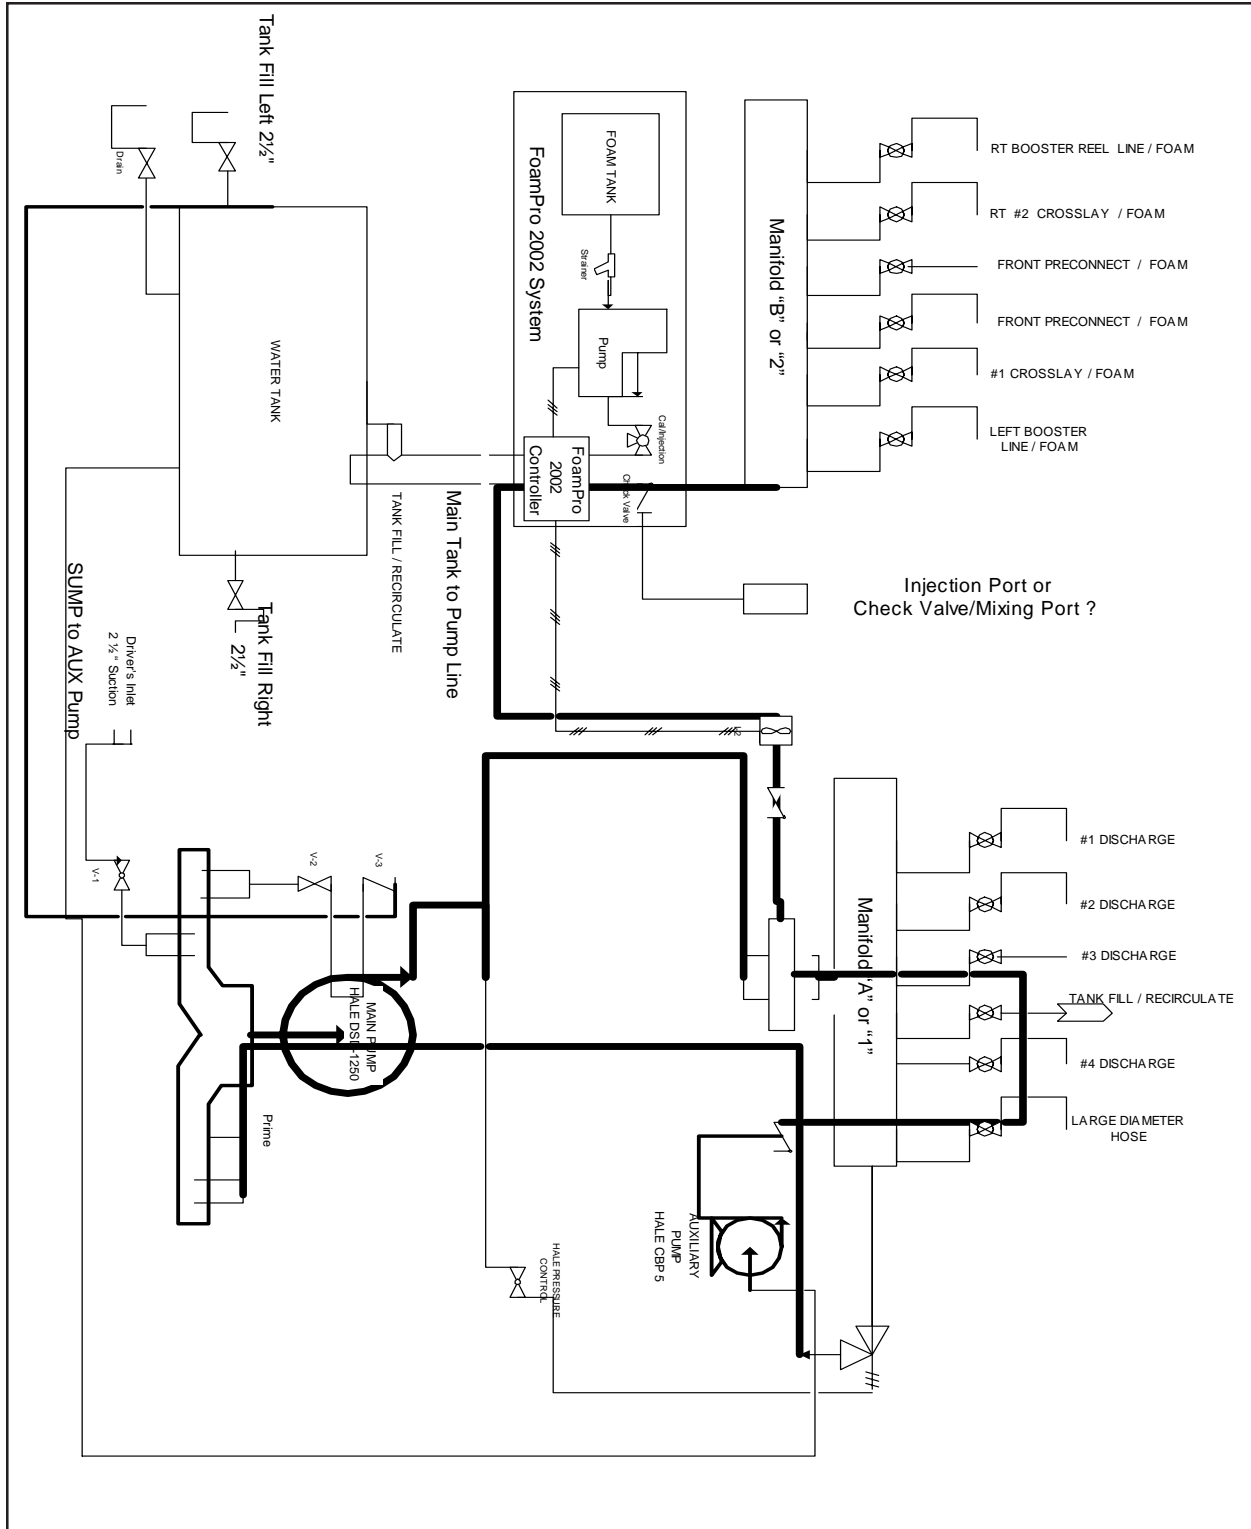
Diagram 1. Plumbing Diagram

The plumbing system connected to the pumps on the new engine appeared to be inadequate according to National Fire Protection Association (NFPA) standards. Specifically, a check valve that would prevent any backflow of pressure created by the booster pump (which would back flow through the midship pump and out one of the intake suction connections) was not incorporated into the system. Although investigators do not believe this was a contributing factor in this incident, under certain circumstances it could lead to equipment damage, severe fire fighter injuries, or even death of a fire

According to the design of the engine's plumbing system (Diagram 1), the auxiliary pump is capable of charging the booster lines as well as all other discharges in both manifolds (A & B). The booster pump also was able to flow foam through all discharges connected to manifold B. Fire fighters stated that they were unaware that the engine pump was designed so that the booster pump would charge all of these discharges until after the incident occurred; however, the specifications in the contract requested this configuration. Their older engines were

- A pressure safety valve for venting to the atmosphere was not present on the intake manifold. A pressure relief valve—used as a back pressure control valve—dumped into the main pump intake; however, this did not provide pressure control to the driver’s side inlets for the large diameter intake manifold.
- A check valve was not visibly present between the main pump and the intake suction which would allow possible back pressure from the booster pump to the intake suction. NFPA 1901 15-5 states that any discharge outlets that are fed by lines from both the auxiliary pump and the main pump shall have check valves in both supply lines.

The evaluation concluded that the auxiliary pump was being fed into the main pump, which was connected to inlet connections. There was no visible check valve present to prevent back pressure from the auxiliary pump through the main pump to these inlets. It was also concluded that this would not prevent back pressure through the discharge that was being used in this incident. Discharges should not be used to fill the engine water tank. The appropriate intake connections should be used and should have check valves in place to avoid any such back pressure.

***Recommendation #5: Manufacturers and fire departments should ensure that fire apparatus are designed and built according to NFPA standards.<sup>2</sup>***

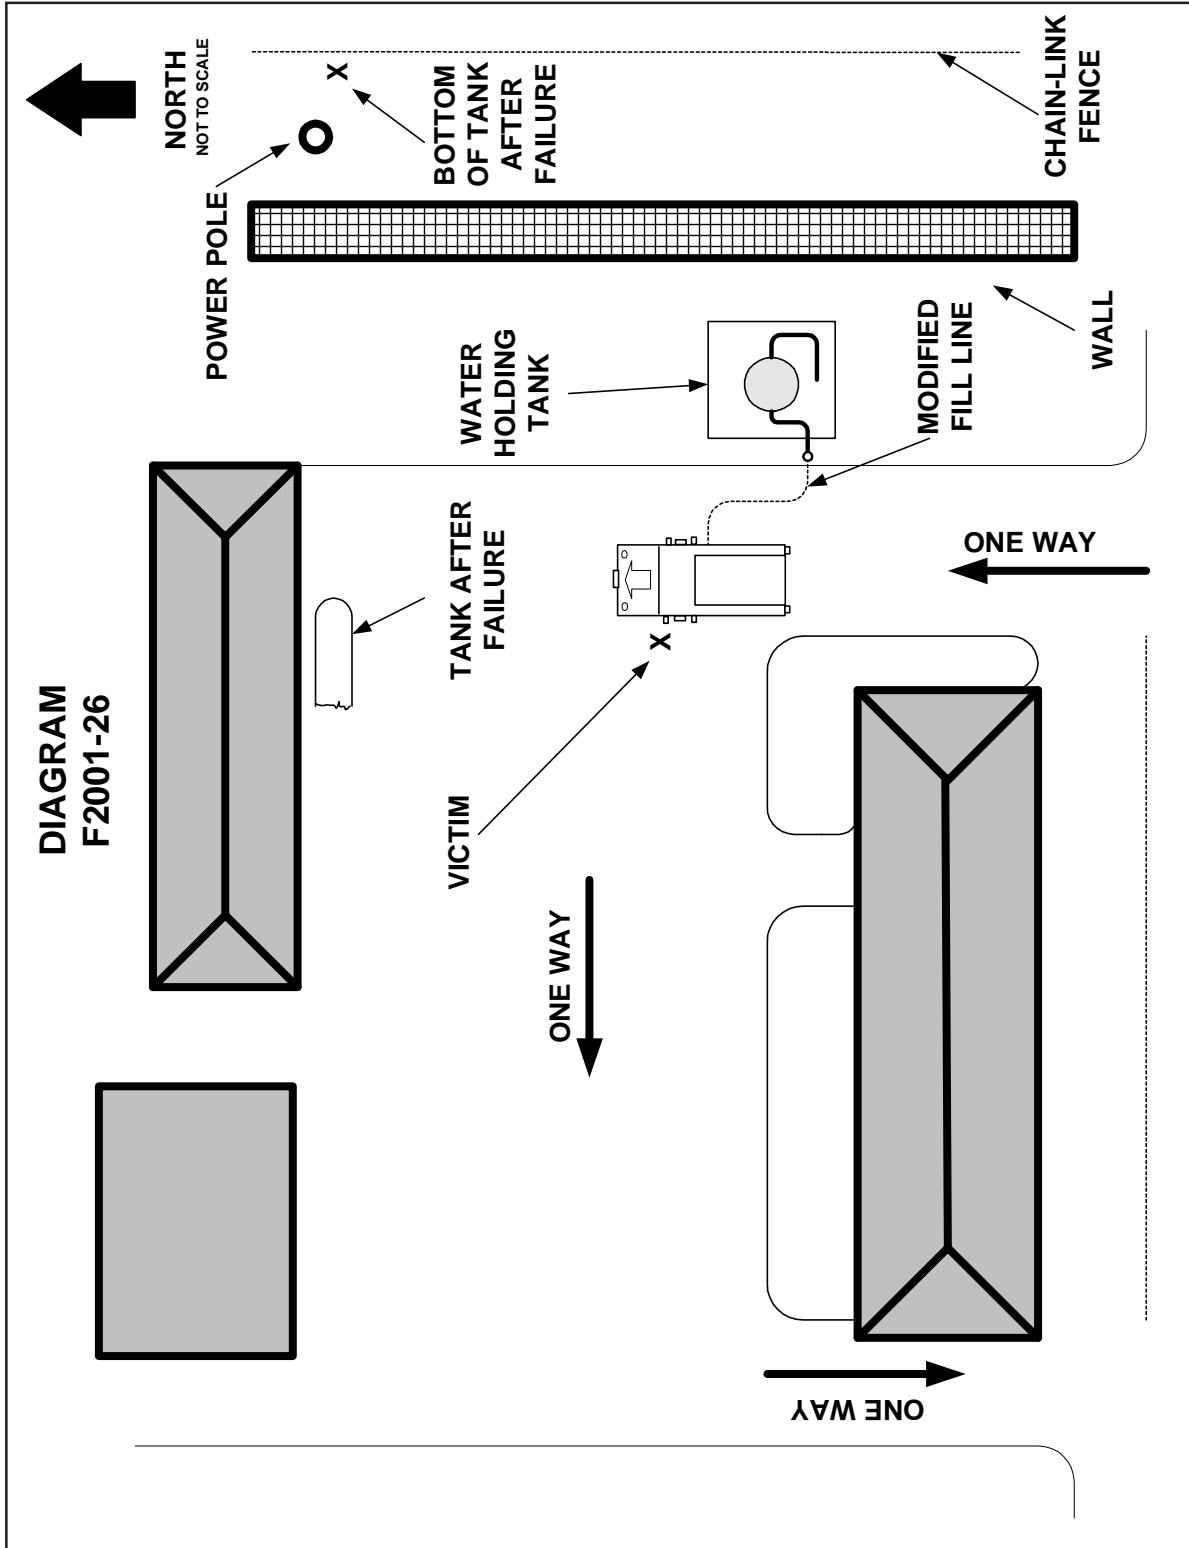
Diagram 2. Location of incident

discharge connections were used to fill the engine tank. This procedure was used because the fire department personnel had to position their engines on a one-way throughway (Diagram 2) with the passenger side (right side) adjacent to the stationary tank or hydrant. In positioning the engines in this manner, they would have to use the discharge connection to fill the engine water tank because their engines (except for the new engine involved in the incident) were not equipped with an inlet tank fill connection on both sides.
