**NIOSH**  
Fire Fighter Fatality Investigation  
and Prevention Program

# Death in the line of duty...

October 21, 2002

## **High-Rise Apartment Fire Claims the Life of One Career Fire Fighter (Captain) and Injures Another Career Fire Fighter (Captain) - Texas**

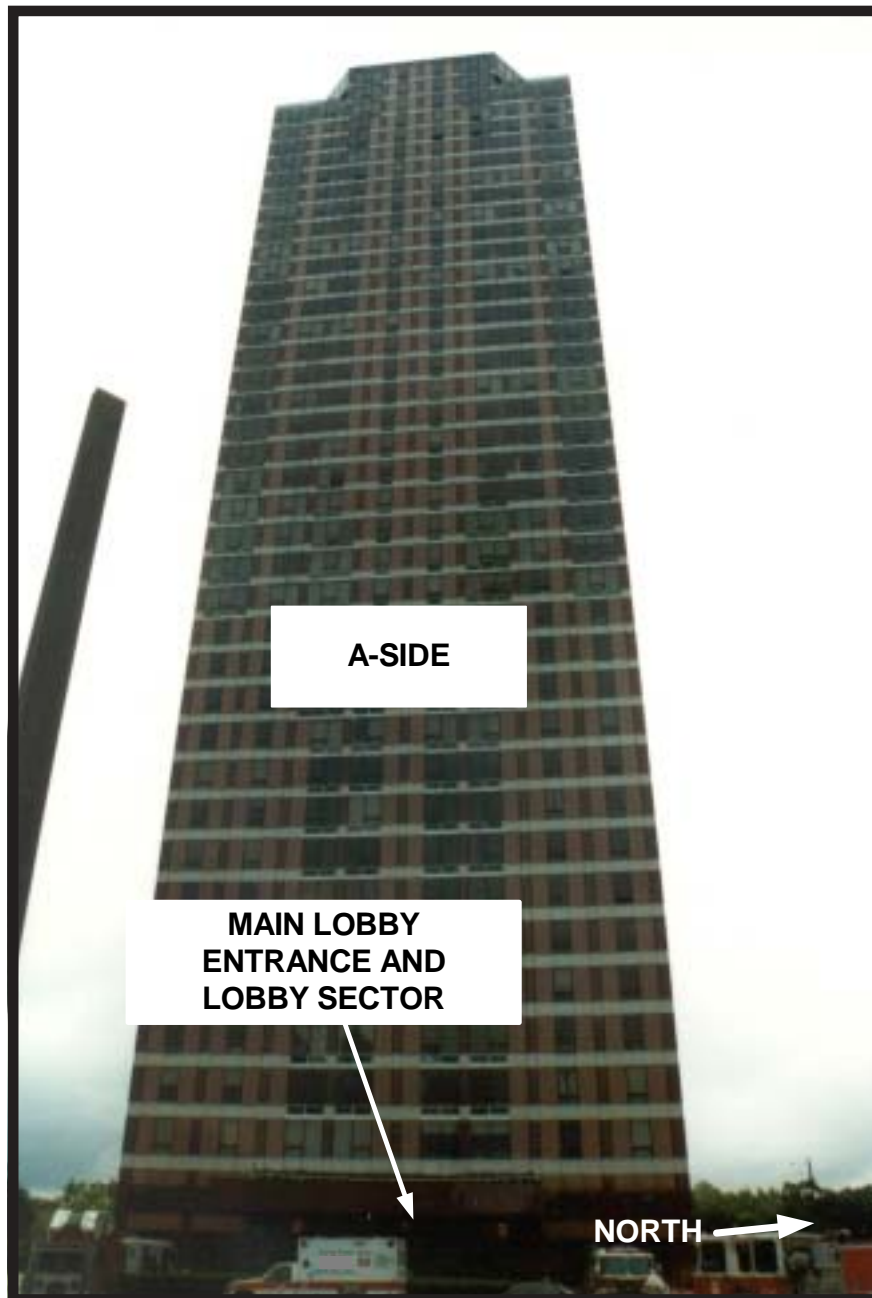
**Structure.** The incident site is a high-rise apartment building that was built in 1980. There are 41 stories above grade and 1 story below grade (Photo 1). The first floor consists of a main lobby area, service facilities, conference rooms, and office space (Diagram 1). Storage units are located on the second floor. Floors 3 through 15 contain 8 apartment units each (Diagram 2). The remaining floors have four apartment units each. All floors are served by four passenger elevators and two service elevators. Two stairwells (“B” stairwell [top and bottom are pressurized] and “C” stairwell [top only is pressurized]) open to the roof and to the ground level on the C-side of the building (Diagram 1). Standpipe outlets are located in each of the two stairwells. Neither stairwell has communication capabilities. All common areas are sprinklered, but not individual apartments. *NOTE: This incident occurred in a city where automatic sprinkler systems were not required in this building when it was issued a building permit in 1980. Requirements for mandatory sprinklering of high-rise buildings were required for all new high-rises permitted after 1981. Automatic sprinklers are now required throughout the entire building in all new high-rise buildings.*

*Photo 1. View of A-Side of Building*

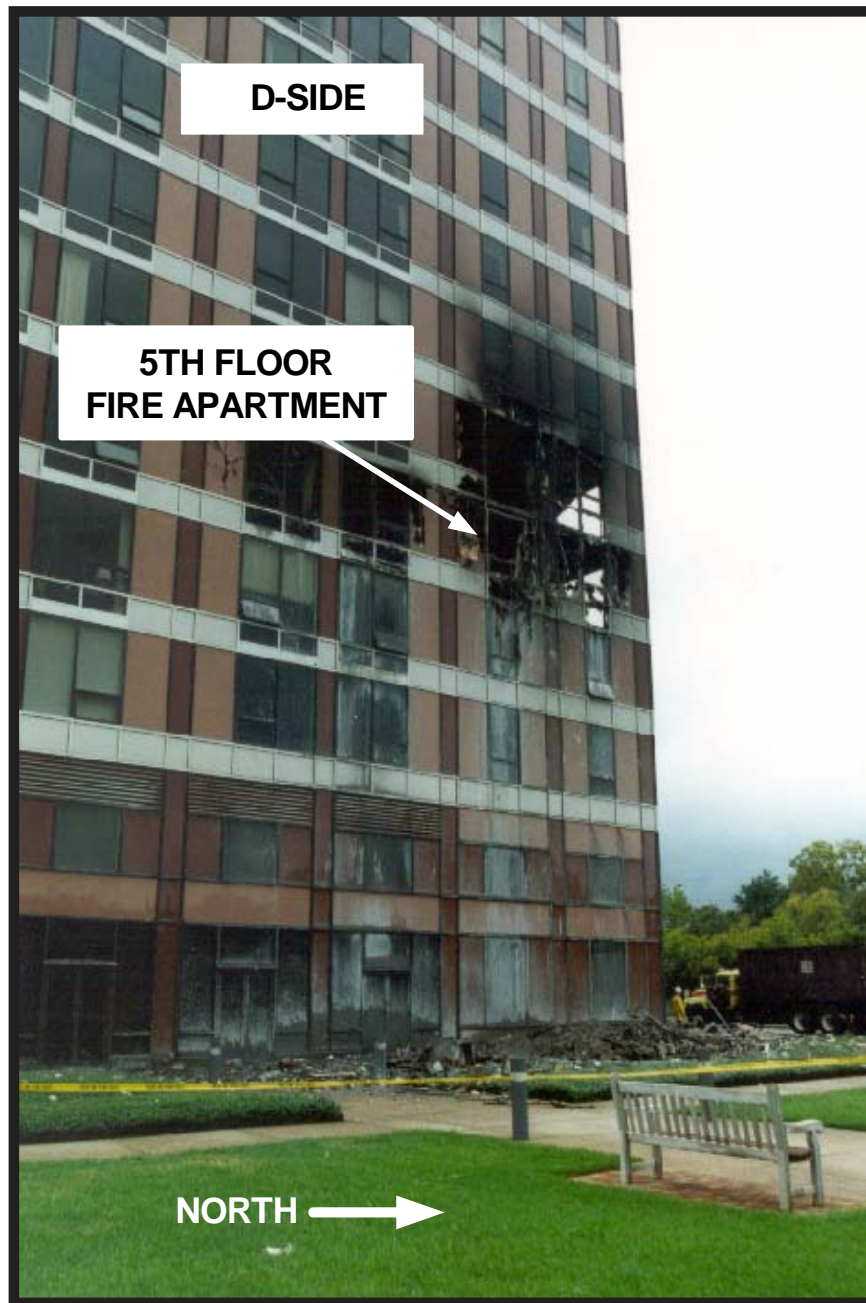
*Photo 2. View of D-Side of Building*

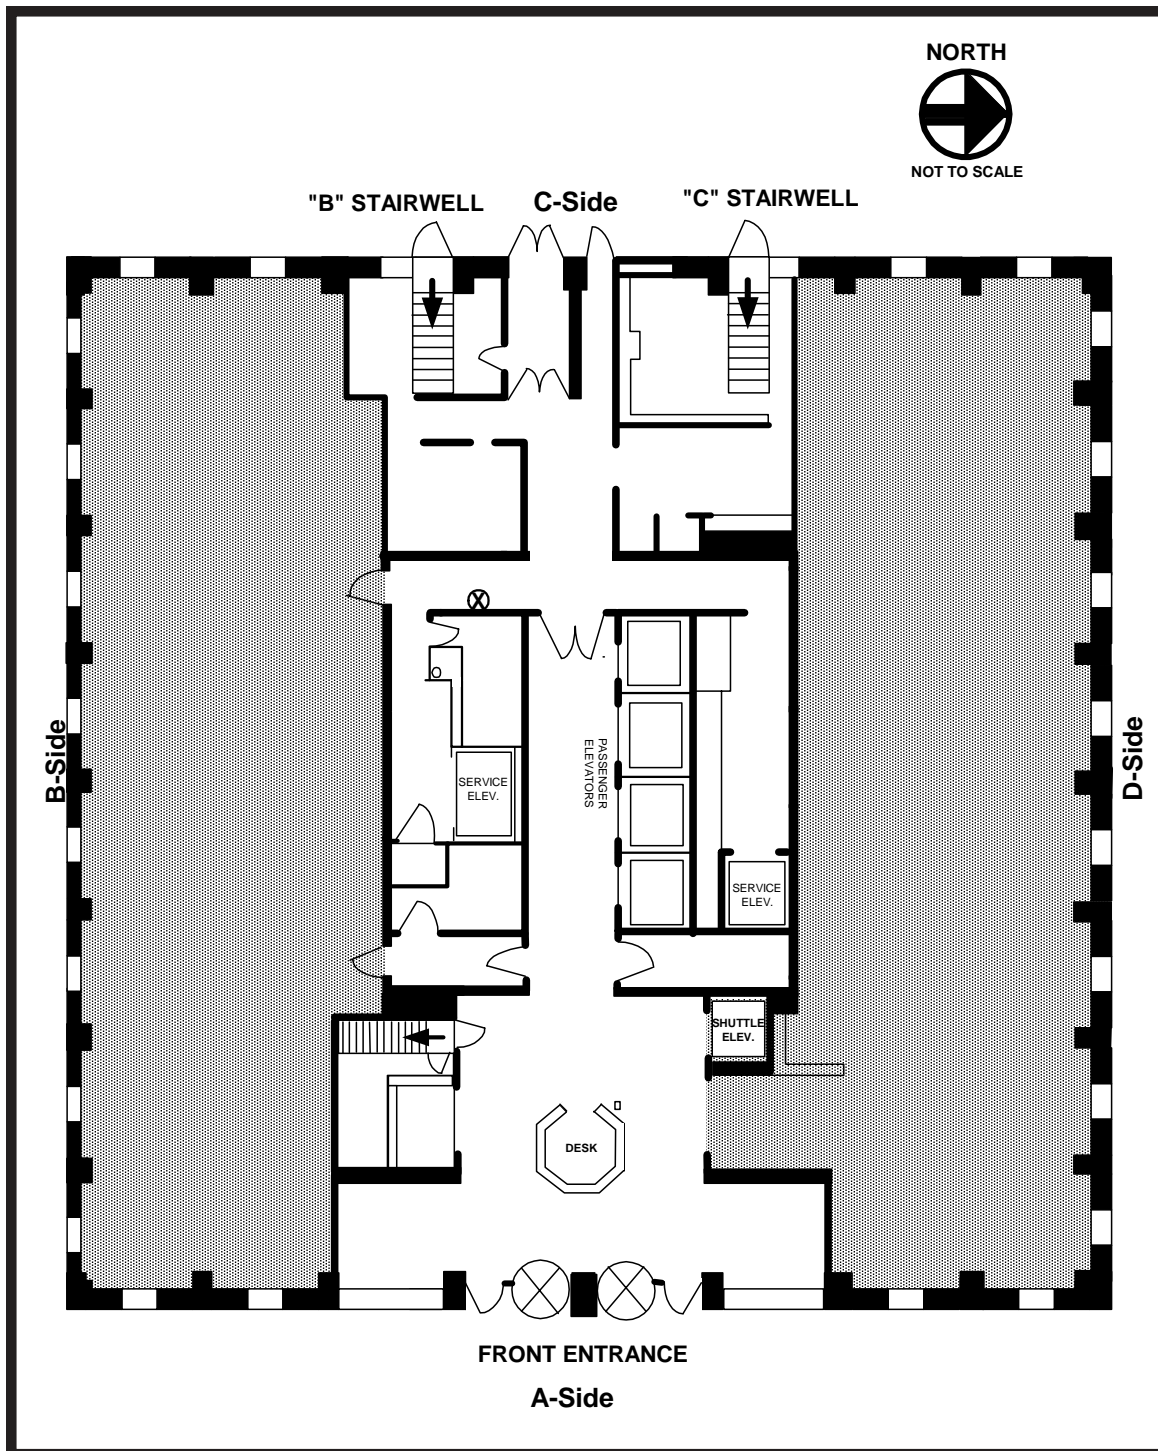
Diagram 1. Lobby Layout

At 0536 hours, rescue crews brought the victim down to the ground floor and out to the C-side of the building (Diagram 1). Fire fighters began cardiopulmonary resuscitation (CPR) efforts on the victim. The victim was transported in Ambulance 2 to an area hospital where he was pronounced dead at 0615 hours.

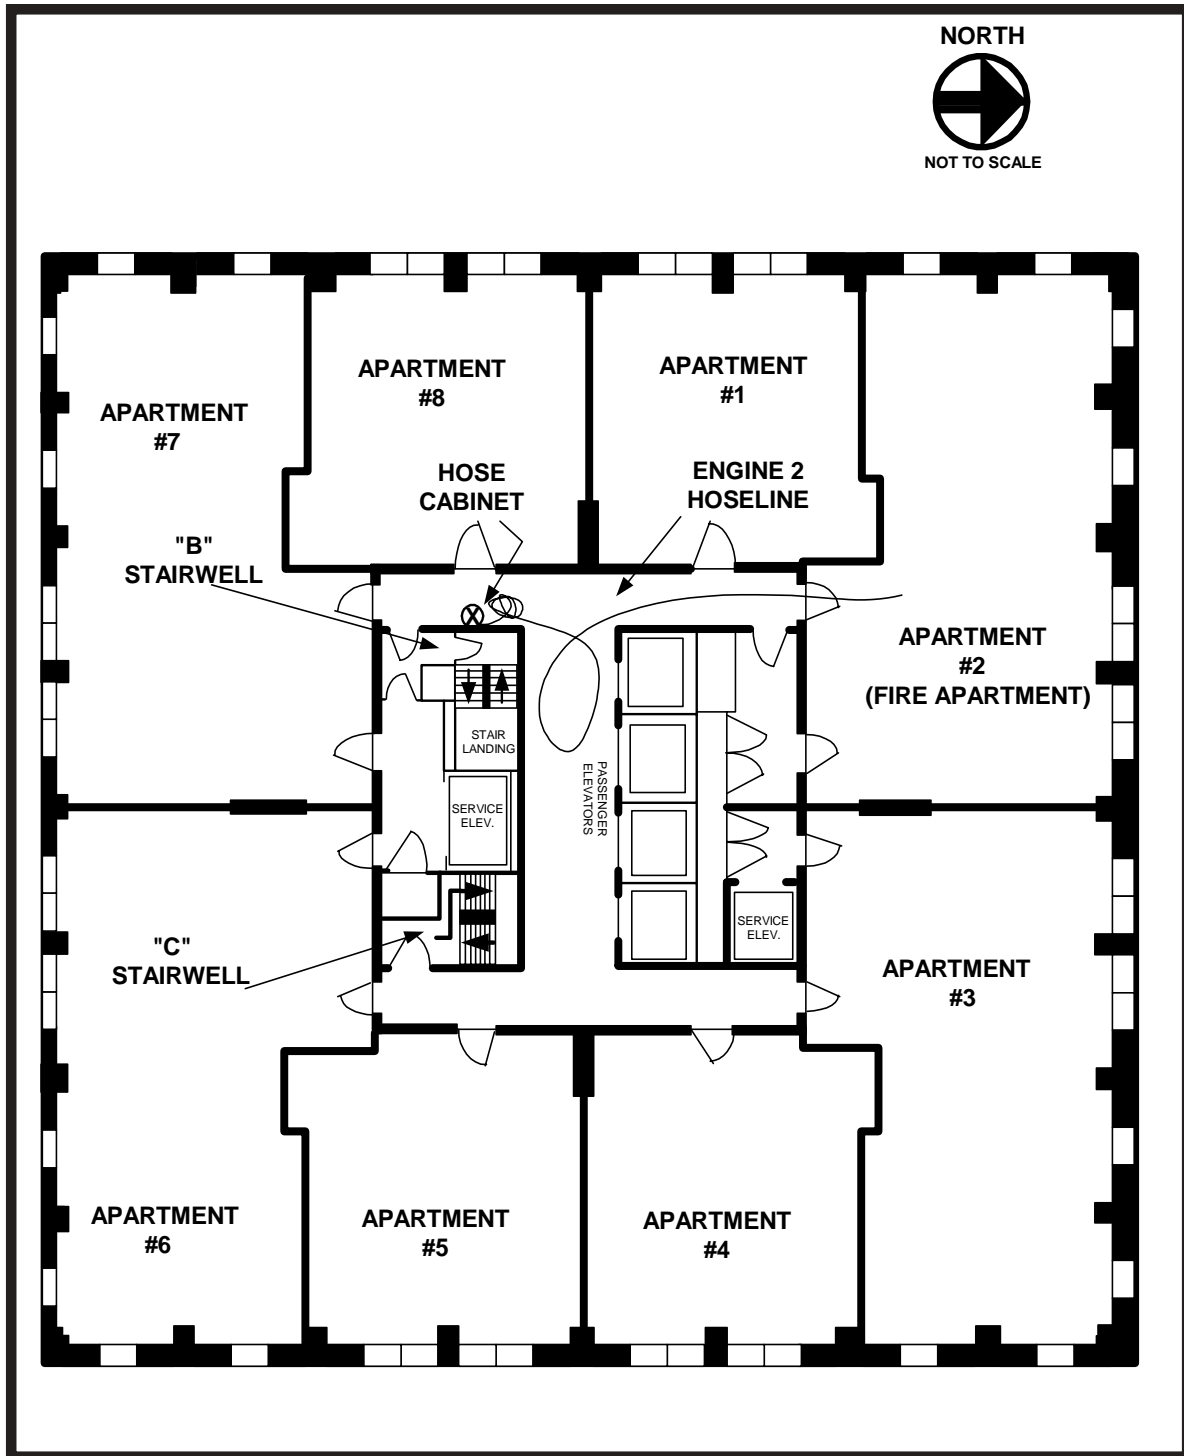
Diagram 2. 5th Floor Layout

At 0448 hours, units were dispatched to a high-rise apartment building for a reported fire alarm. At 0452 hours, Central Dispatch notified responding units that multiple calls had been received confirming a fire on the fifth floor. At 0453 hours, Engine 2 arrived on the scene and reported to Central Dispatch that they had heavy fire showing from the exterior of the building (Photo 2). The victim instructed the Dispatcher to “go ahead and give him a second alarm.” *NOTE: The second alarm was dispatched at 0456 hours.* The victim, a fire fighter, and the engineer/operator from Engine 2 entered the main lobby and met with the security guard. *NOTE: The victim and Fire Fighter #1 had on their full ensemble of turn-out gear and SCBAs, while the engineer/operator was in his station uniform.* The security guard informed the crew that the fire was on the fifth floor. The security guard led the Engine 2 crew to the fifth floor via the B-stairwell (Diagram 1 and 2). The victim searched for the apartment where the fire was located while the fire fighter and engineer/operator connected 100 feet of 1 3/4-inch hoseline to the hose cabinet (Diagram 2 and Photo 3).

backup before entering the fire apartment (Diagram 2 and 3).

*area near the elevators in large loops and was piled in the hallway (Diagram 2 and 3). Intense heat and zero visibility at the opposite end of the hallway from the fire apartment may have made it appear to the victim that they had gotten turned around and were heading back toward the apartment and not the emergency stairwell.* Captain #1 informed the victim that they were near the hose cabinet and were heading toward the emergency stairwell. The victim, who was following Captain #1, turned and headed in the opposite direction (toward the fire apartment). *NOTE: Captain #1 sustained burns to his wrist and lower back before reaching the emergency stairwell.* At 0509 hours, the victim radioed, "Emergency, we need help on the fifth floor." Central Dispatch advised command that they had a call for help on the fifth floor. At 0510 hours, the victim radioed, "Engine 2, we're trapped on the fifth floor. Engine 2, help." The IC radioed lobby sector asking if they had received Engine 2's message. Lobby sector confirmed that they had received the message and requested additional companies for the rescue. At 0512 hours, Central Dispatch notified all companies that they had a Mayday on the fifth floor and toned out a third alarm. At 0512 hours, the victim radioed, "Engine 2, we're trapped on the fifth floor". *NOTE: The third alarm dispatched, at 0512 hours, four Engines, two Ladder Trucks, one District Chief, one Shift Commander, and one Cascade Unit.* At 0513 hours the victim made his final radio transmission, "Engine 2, emergency, we're...(the rest of the transmission was unintelligible)."

imaging camera was found in the hallway by the Captain of Rescue 11, but when he attempted to use it, the screen went completely white. The Captain and a fire fighter from Rescue 11 then heard the victim's personal alert safety system (PASS) device sounding. They located the victim in the common area near the elevators (Diagram 3). The victim did not have his helmet or face mask on when the Rescue 11 crew members reached him. The crew members checked for a pulse (a pulse was not detected) and noted that the victim was not breathing. They immediately began to move the victim down the hallway toward the B-stairwell. Engine 60 crew members assisted in bringing the victim down the hallway. Additional fire fighters had now reached the fifth floor and were assisting in the removal of the victim. As the victim was being moved from the hallway into the stairwell, two fire fighters from Rescue 11 became separated from their crew. The two fire fighters crawled into the service elevator area, and after running low on air, radioed command that they were trapped. The two fire fighters were able to locate a floor plan posted near the service elevator, and after determining the floor layout, they entered the stairwell and exited the building (Diagram 2 and Diagram 3).
