NIOSH
Fire Fighter Fatality Investigation
and Prevention Program

A Summary of a NIOSH fire fighter fatality investigation

October 21, 2002

High-Rise Apartment Fire Claims the Life of One Career Fire Fighter (Captain) and Injures Another Career Fire Fighter (Captain) - Texas

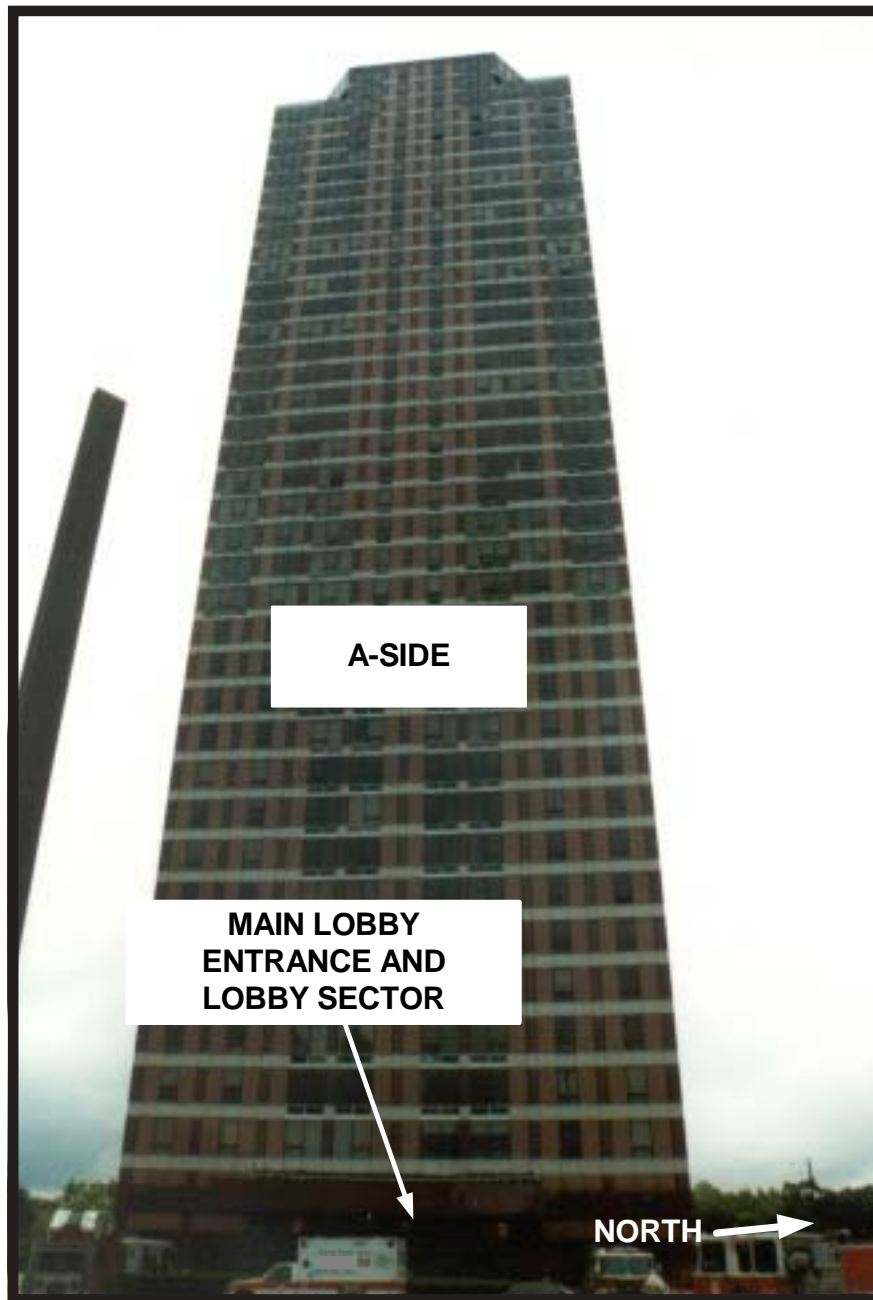
Photo 1. View of A-Side of Building

Structure. The incident site is a high-rise apartment building that was built in 1980. There are 41 stories above grade and 1 story below grade (Photo 1). The first floor consists of a main lobby area, service facilities, conference rooms, and office space (Diagram 1). Storage units are located on the second floor. Floors 3 through 15 contain 8 apartment units each (Diagram 2). The remaining floors have four apartment units each. All floors are served by four passenger elevators and two service elevators. Two stairwells (“B” stairwell [top and bottom are pressurized] and “C” stairwell [top only is pressurized]) open to the roof and to the ground level on the C-side of the building (Diagram 1). Standpipe outlets are located in each of the two stairwells. Neither stairwell has communication capabilities. All common areas are sprinklered, but not individual apartments. *NOTE: This incident occurred in a city where automatic sprinkler systems were not required in this building when it was issued a building permit in 1980. Requirements for mandatory sprinklering of high-rise buildings were required for all new high-rises permitted after 1981. Automatic sprinklers are now required throughout the entire building in all new high-rise buildings.*

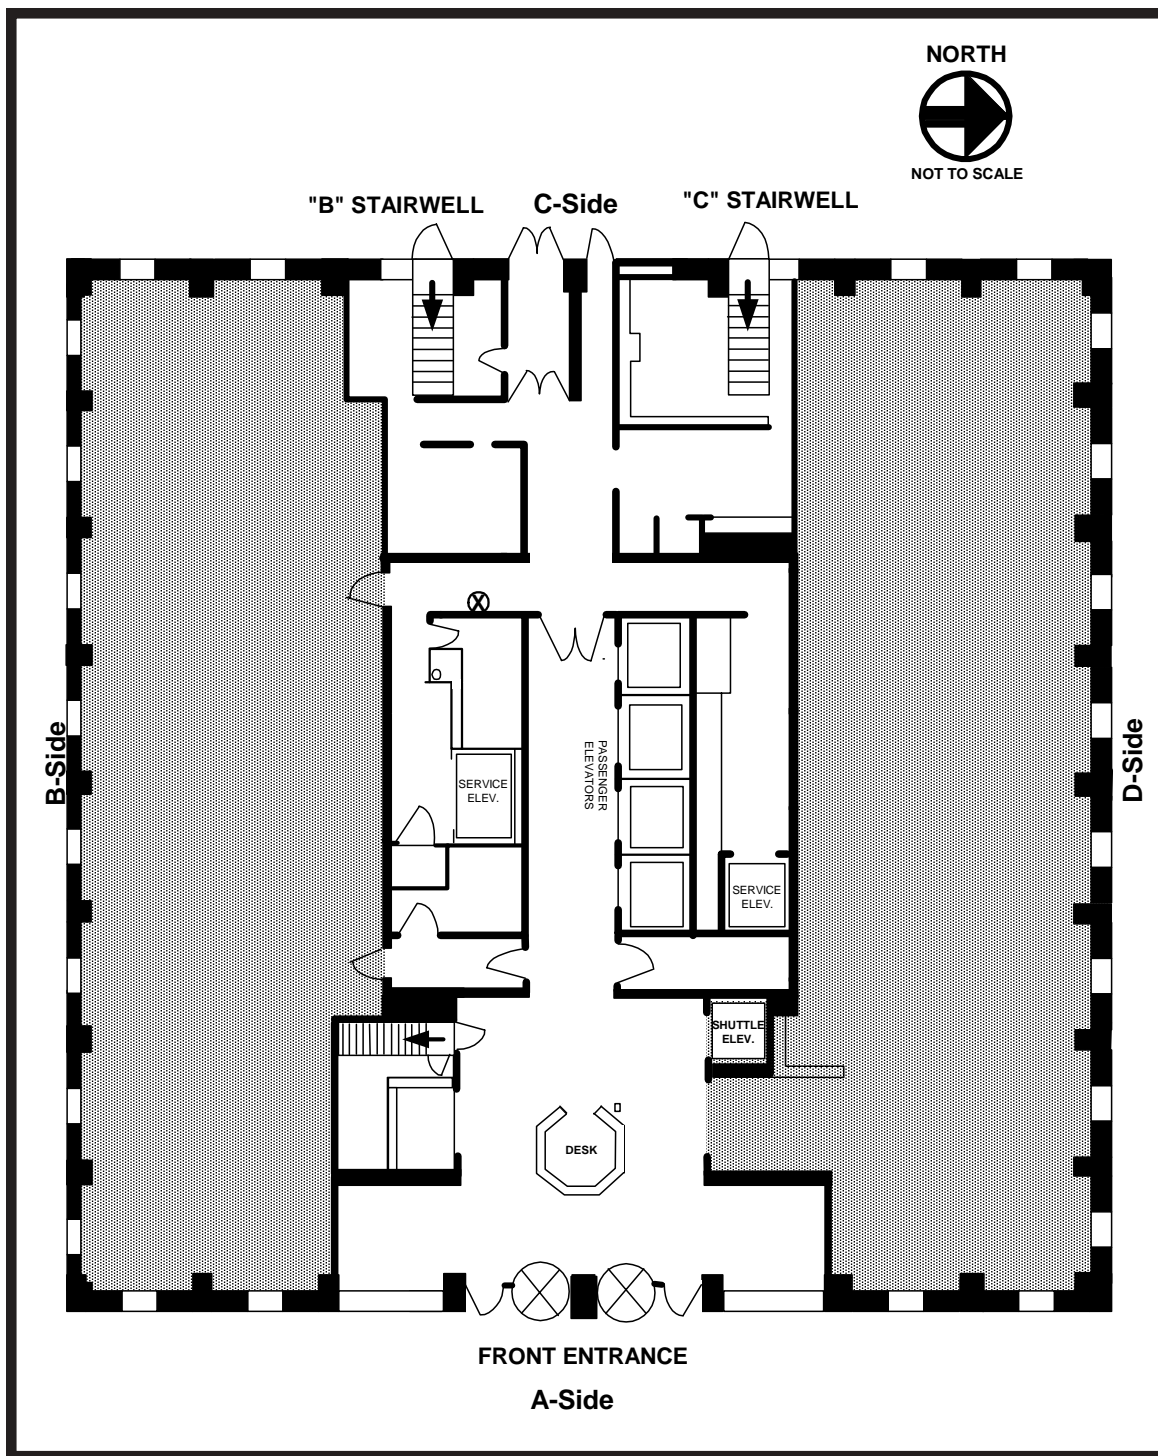
Diagram 1. Lobby Layout

At 0536 hours, rescue crews brought the victim down to the ground floor and out to the C-side of the building (Diagram 1). Fire fighters began cardiopulmonary resuscitation (CPR) efforts on the victim. The victim was transported in Ambulance 2 to an area hospital where he was pronounced dead at 0615 hours.

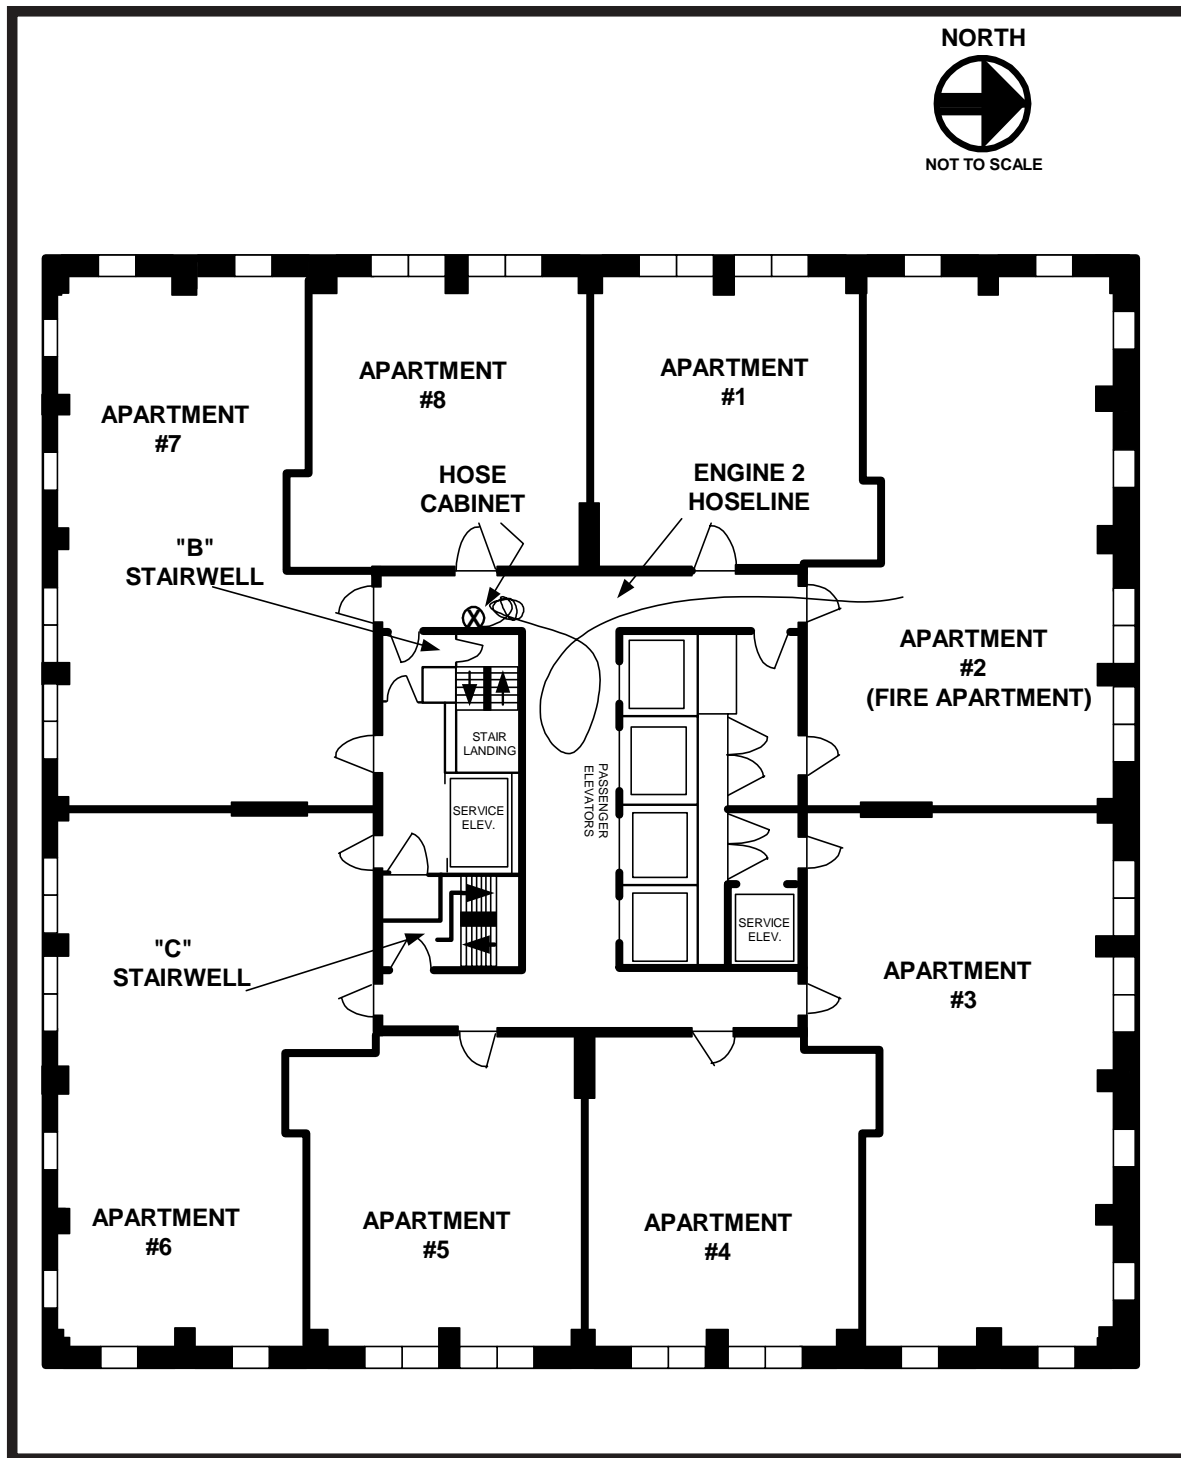
Diagram 2. 5th Floor Layout

backup before entering the fire apartment (Diagram 2 and 3).

area near the elevators in large loops and was piled in the hallway (Diagram 2 and 3). Intense heat and zero visibility at the opposite end of the hallway from the fire apartment may have made it appear to the victim that they had gotten turned around and were heading back toward the apartment and not the emergency stairwell. Captain #1 informed the victim that they were near the hose cabinet and were heading toward the emergency stairwell. The victim, who was following Captain #1, turned and headed in the opposite direction (toward the fire apartment). *NOTE: Captain #1 sustained burns to his wrist and lower back before reaching the emergency stairwell.* At 0509 hours, the victim radioed, "Emergency, we need help on the fifth floor." Central Dispatch advised command that they had a call for help on the fifth floor. At 0510 hours, the victim radioed, "Engine 2, we're trapped on the fifth floor. Engine 2, help." The IC radioed lobby sector asking if they had received Engine 2's message. Lobby sector confirmed that they had received the message and requested additional companies for the rescue. At 0512 hours, Central Dispatch notified all companies that they had a Mayday on the fifth floor and toned out a third alarm. At 0512 hours, the victim radioed, "Engine 2, we're trapped on the fifth floor". *NOTE: The third alarm dispatched, at 0512 hours, four Engines, two Ladder Trucks, one District Chief, one Shift Commander, and one Cascade Unit.* At 0513 hours the victim made his final radio transmission, "Engine 2, emergency, we're...(the rest of the transmission was unintelligible)."

imaging camera was found in the hallway by the Captain of Rescue 11, but when he attempted to use it, the screen went completely white. The Captain and a fire fighter from Rescue 11 then heard the victim's personal alert safety system (PASS) device sounding. They located the victim in the common area near the elevators (Diagram 3). The victim did not have his helmet or face mask on when the Rescue 11 crew members reached him. The crew members checked for a pulse (a pulse was not detected) and noted that the victim was not breathing. They immediately began to move the victim down the hallway toward the B-stairwell. Engine 60 crew members assisted in bringing the victim down the hallway. Additional fire fighters had now reached the fifth floor and were assisting in the removal of the victim. As the victim was being moved from the hallway into the stairwell, two fire fighters from Rescue 11 became separated from their crew. The two fire fighters crawled into the service elevator area, and after running low on air, radioed command that they were trapped. The two fire fighters were able to locate a floor plan posted near the service elevator, and after determining the floor layout, they entered the stairwell and exited the building (Diagram 2 and Diagram 3).
