Volunteer Fire Fighter Drowns During Multi-Agency Dive-Rescue Exercise - Illinois

Fatality Assessment and Control Evaluation Investigative Report #F2001-35

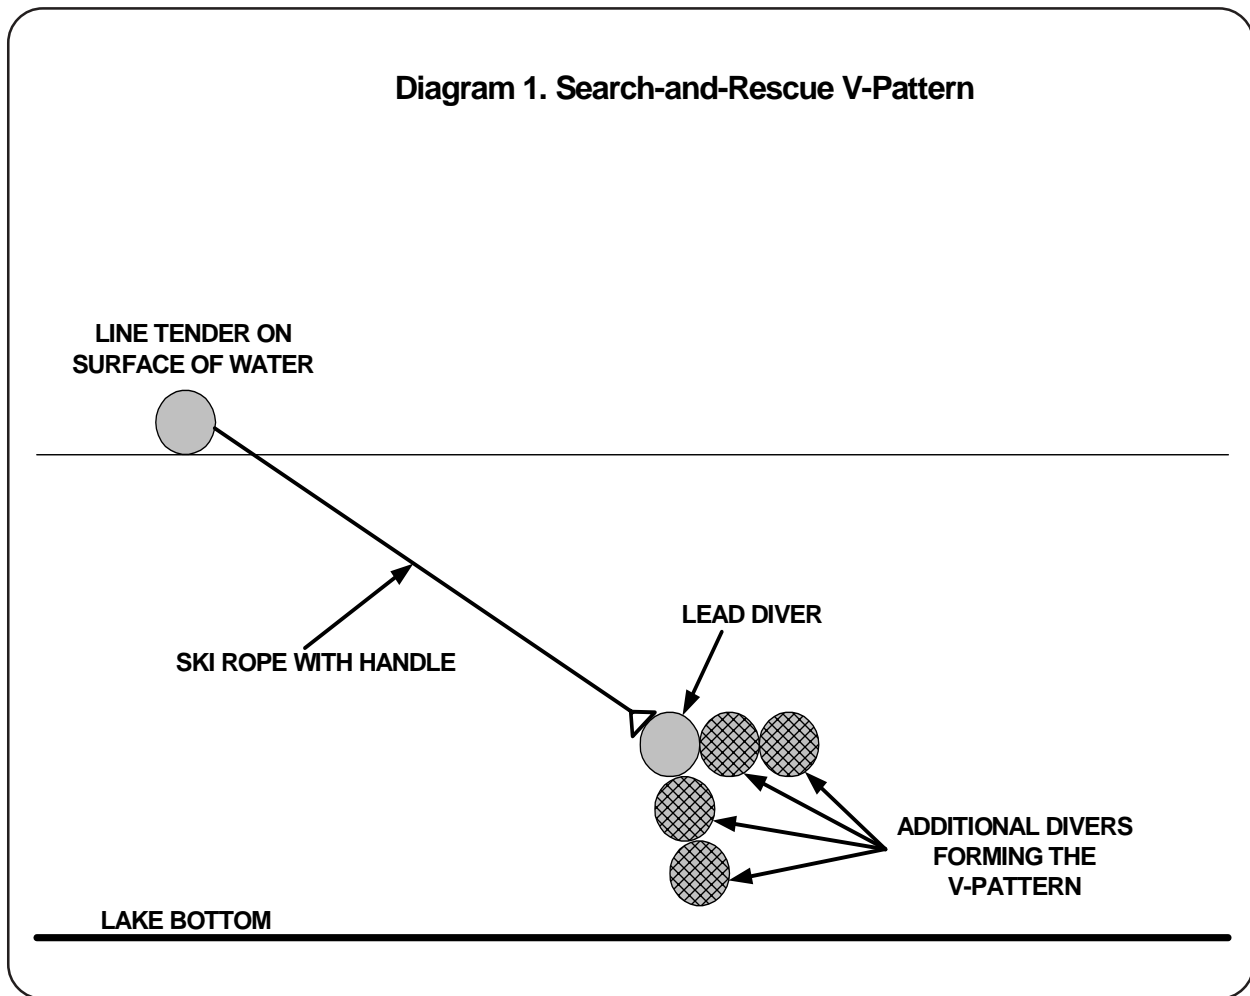
Diagram 1. Search-and-Rescue V-Pattern

The briefing began at 0730 hours at the dive coordinator's fire station with all present except Diver #1. The dive coordinator briefed everyone on the area and the scenario of the overturned boat and the two potential victims. He then described the search pattern to be used (a V-pattern). *Note: The V-pattern uses a ski rope (having a handle on one end) and a line tender on the surface of the water or from a boat. A diver (lead diver) descends to the bottom while holding on to the handle. Additional divers are then assigned to either the lead diver's left or right side by the line tender on the surface. Each diver descends along the ski rope, meets up with the lead diver, and proceeds to his or her assigned position on either the lead diver's left or right side (Diagram 1).* The coordinator then reviewed the hand signals to be used for communicating while underwater.

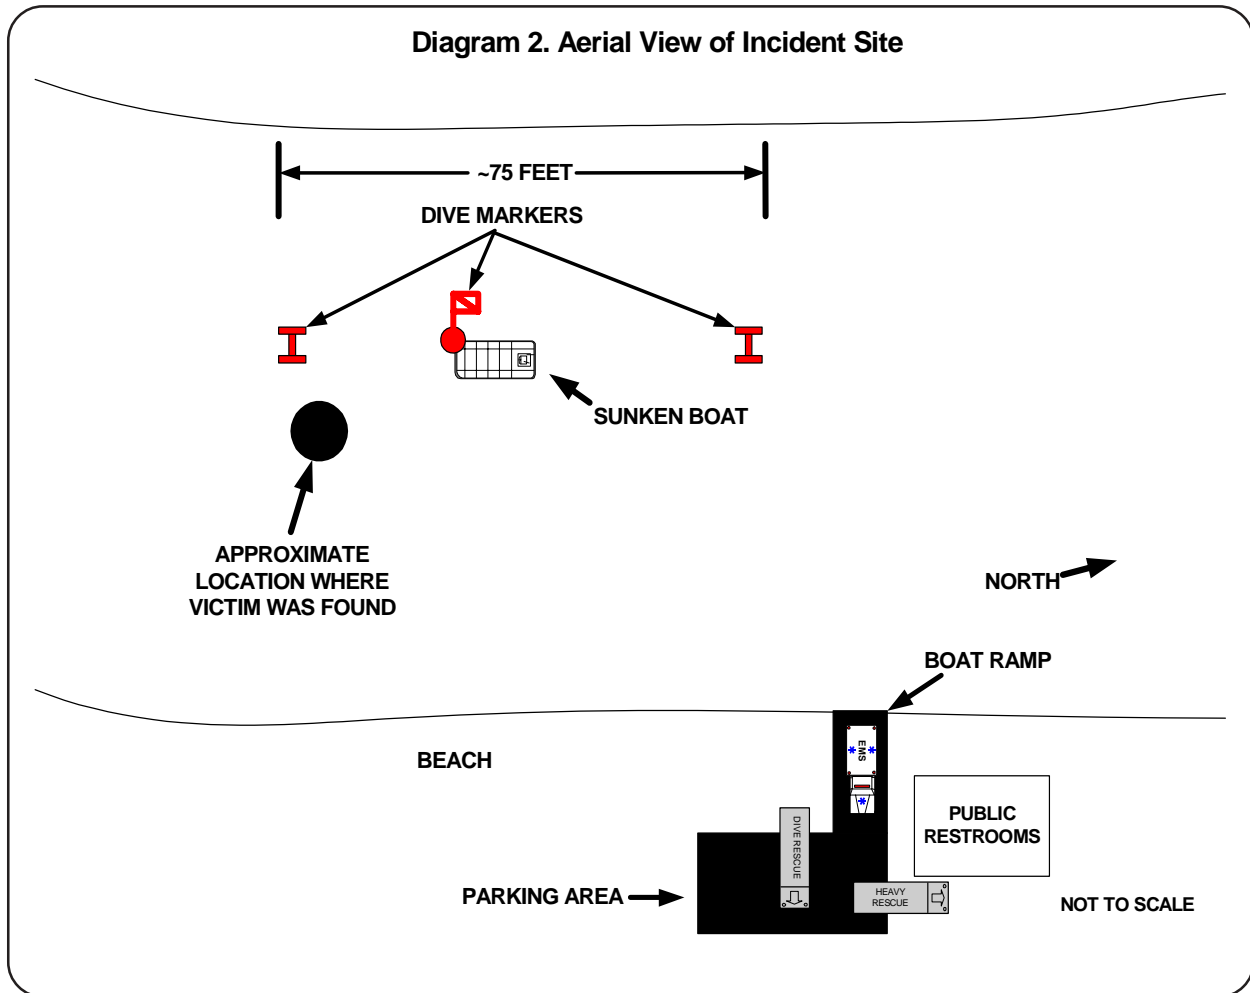
Diagram 2. Aerial View of Incident Site

Diver #2 surfaced to get a lift bag to attach to the sunken boat to be used as an underwater marker. While Diver #2 was putting air into the lift bag, his regulator began free-flowing (a malfunction of the regulator results in a free flow of air rather than a termination of air), causing the lift bag to overinflate. The boat began to rise off the bottom at an angle. Diver #2 and Diver #3 surfaced and told the dive coordinator that the boat had begun to rise from the lake bottom but was lifting at an angle. Diver #2 corrected the problem with his regulator before the two divers descended to release air from the lift bag. The dive coordinator saw the rush of air that had been released from the lift bag. At approximately 1050 hours, the assistant dive coordinator saw two people surface at the shore and walk toward the vehicles. *Note: It was later determined that this was Diver #5 and Diver #6.* The dive coordinator also saw two sets of bubbles in the area that the victim and Diver #1 were searching. Diver #2 and Diver #3 surfaced (on the north side of the pontoon boat) at this time. After completing three to four sweeps near the sunken boat, the victim signaled to Diver #1 that he was going to surface. Approximately 2 to 3 minutes later, Diver #1 surfaced on the south side of the pontoon boat (Diagram 3). The victim was not seen again until he was located at approximately 1215 hours (Photo 1 and Diagram 2).

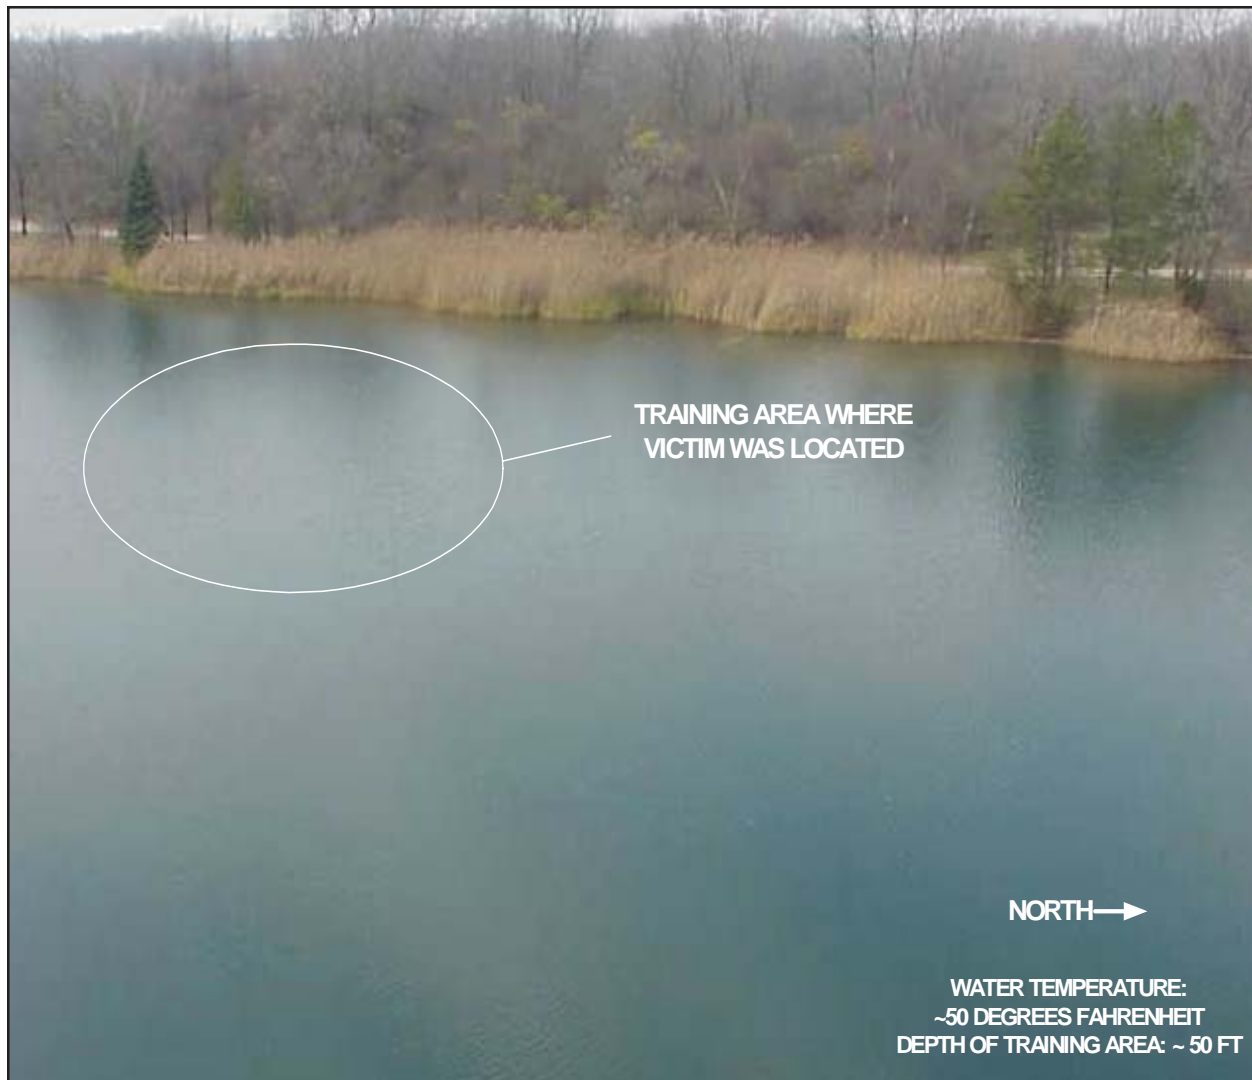
Photo 1. Aerial View of Incident Scene

coordinator began looking for bubbles on the water's surface (Photo 1). Not seeing any bubbles, they scanned the shoreline. Diver #1 then informed them that the victim had passed him the rope bag and had indicated that he was coming to the surface. They yelled to the diver on shore (Diver #4) to see if the victim was with him. He replied that he had not seen the victim. The dive coordinator then drove the pontoon boat to shore, dragging Diver #1 and Diver #2 behind the boat. Diver #3 stayed near the buoy of the sunken boat to search for the victim. When they reached the shore they searched the vehicles and the restrooms but did not find the victim. The dive coordinator then radioed Divers #5 and #6 to see if the victim had left with them. They replied that the victim was not with them. The dive coordinator and divers then realized that the victim must still be in the water. The dive coordinator called Central Dispatch to report that they might have a possible drowning. The dive coordinator set up command and assembled a team for the initial search (Photo 2). Diver #1 and Diver #2 changed out their air tanks and then swam back out to the buoy to conduct a search for the victim. They descended and searched near the sunken boat for approximately 15 to 20 minutes. They ascended and could see additional fire departments and dive crews arriving on the scene. They swam to shore where Diver #2 had his air tank refilled.
